IMPROVEMENTS TO BRING THE CHURCH INTO ADA COMPLIANCE (BATHROOMS, RAMP, ETC.) STRUCTUR

REPORT AND
RECOMMENDATIONS

**ARCHITECTURAL CONDITIONS
AT THE CORNISH MEMORIAL
A.M.E. ZION CHURCH**

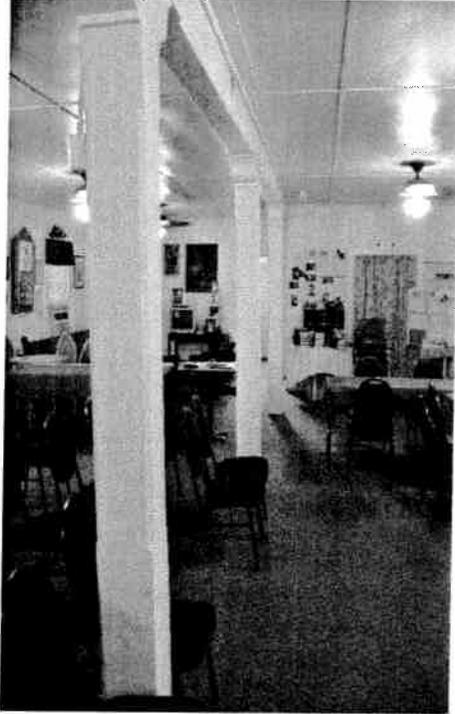
Figure 15 Racked Columns

While the major structural components of the building are in serviceable condition (see the Structural Engineers report), modifications over time have compromised the structural integrity of the church as a whole. This is evident because the building racks (leans) to the Southeast between seven and eight inches (7"-8") to the Northwest from eave to ground at the center of the building side walls (Figure 14) while the front and rear gable walls lean approximately three inches (3"). This is visible from the street and inside the first floor meeting hall where the 8x8 columns are noticeably out of plumb from 1-1/2" to 3-3/4" in ten feet of height (Figure 13).

Wind loads are the most probable cause of the racking.

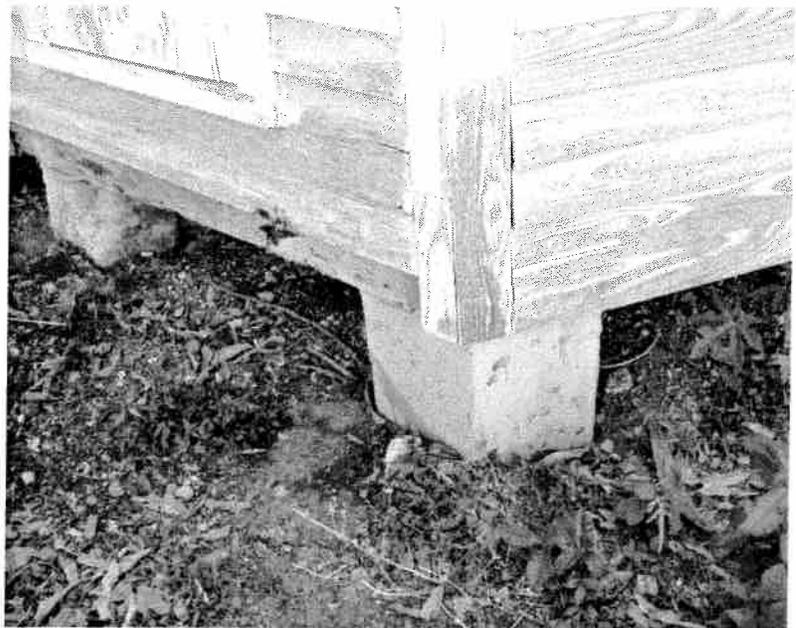
Figure 17 Foundation Piers

The ground floor of the church rests upon the foundation piers, creating an eighteen inch crawl space (Figure 17). Floor framing consists of two central parallel 6"x 9" longitudinal beams 11'-3" apart, traversed with 3"x 10" floor joists spaced eighteen inches apart running from beam to 6"x 7" continuous sills (Figure 18). The floor sheathing, which is also the finish floor and consists of 1x4 (7/8"x 3-7/8") tongue and groove fastened to the floor joists. Intermittently, 2x8s have been added between the floor joists in an effort to stiffen the framing.

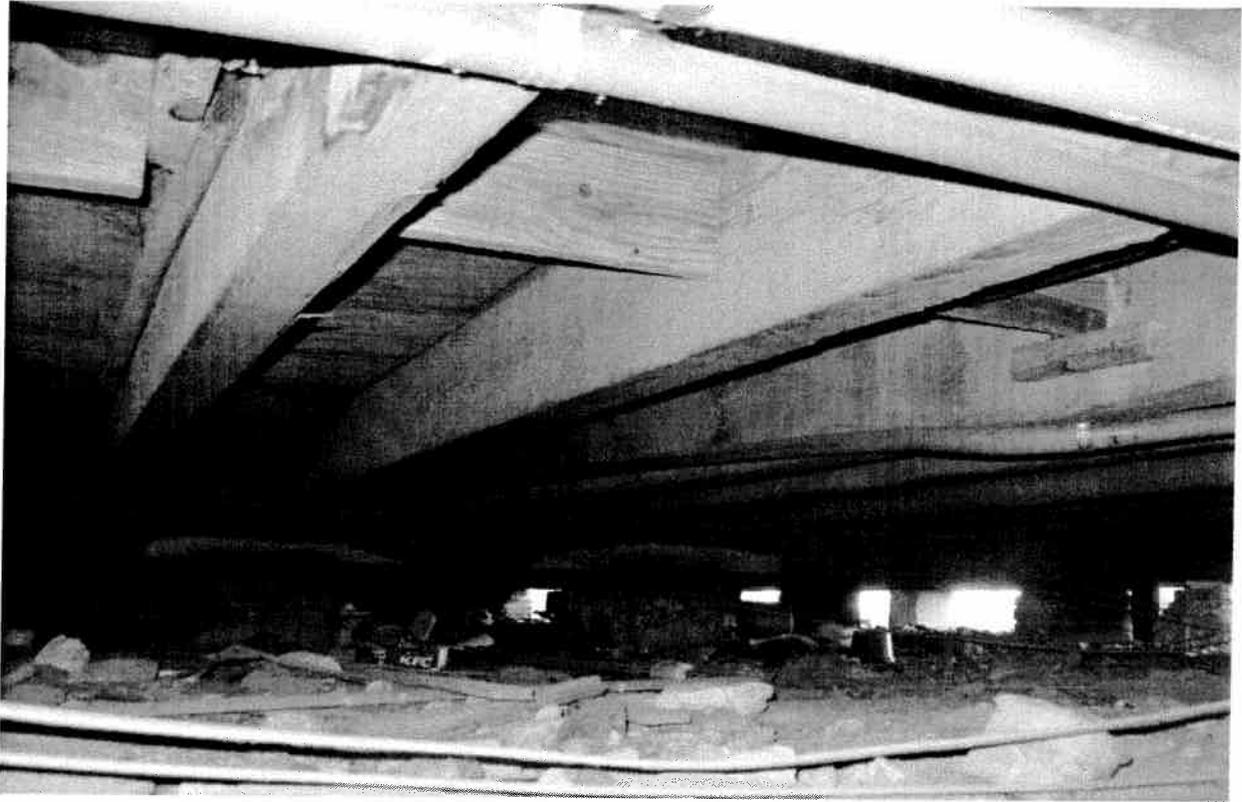
Figure 18 Crawl Space and Ground Floor Framing

Generally, the ground floor framing appears to be dry and in good condition except for what appears to be sill damage at the Southwest corner. It is transversely level at the front

(East) end of the building but progressively settles out of level from the center of the building to the South wall, from 1" at the Southwest corner of the Pastor's office to 6" at South West corner of the building. The building is generally level in the longitudinal axis from the center of the building to the North Wall (Figure 19).

8. Correct the sill and foundation condition at the Southwest Corner to reduce the differential settlement.

Jack and replace the existing sill, and rebuild the foundation below it.

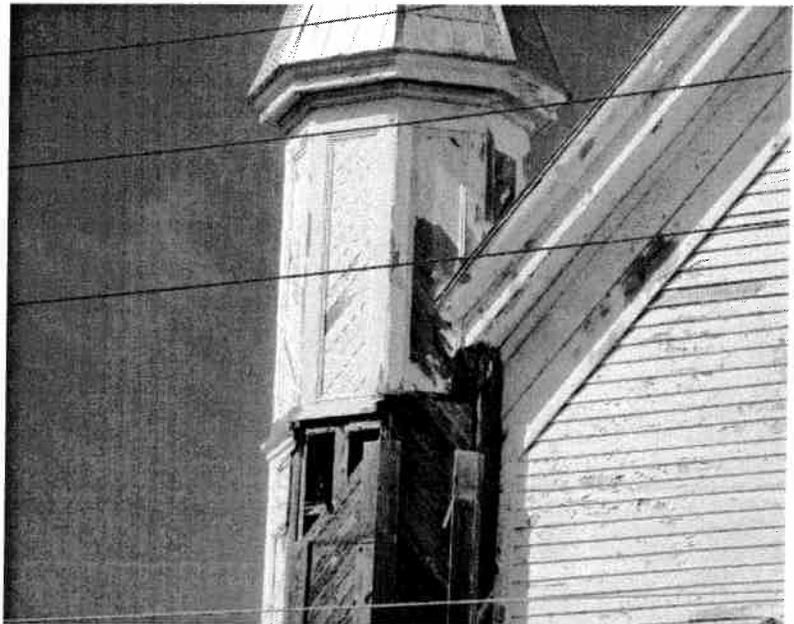
Figure 23 Turret Damage

Turrets are constructed in two ways: the original structure, which was post and beam and, from the 1990 repair work, with pressure-treated 2x4 materials. The 1990 framing has deteriorated significantly more than the original. The turret sheathing consists of 1x6 diagonal boards and is exposed to view as paneling between trim boards. Contemporary sheet metal connectors have been added to some of the timbers. The turrets have suffered deterioration more than any other major building component (Figure 23).

7. Rebuild and repair the corner turrets.

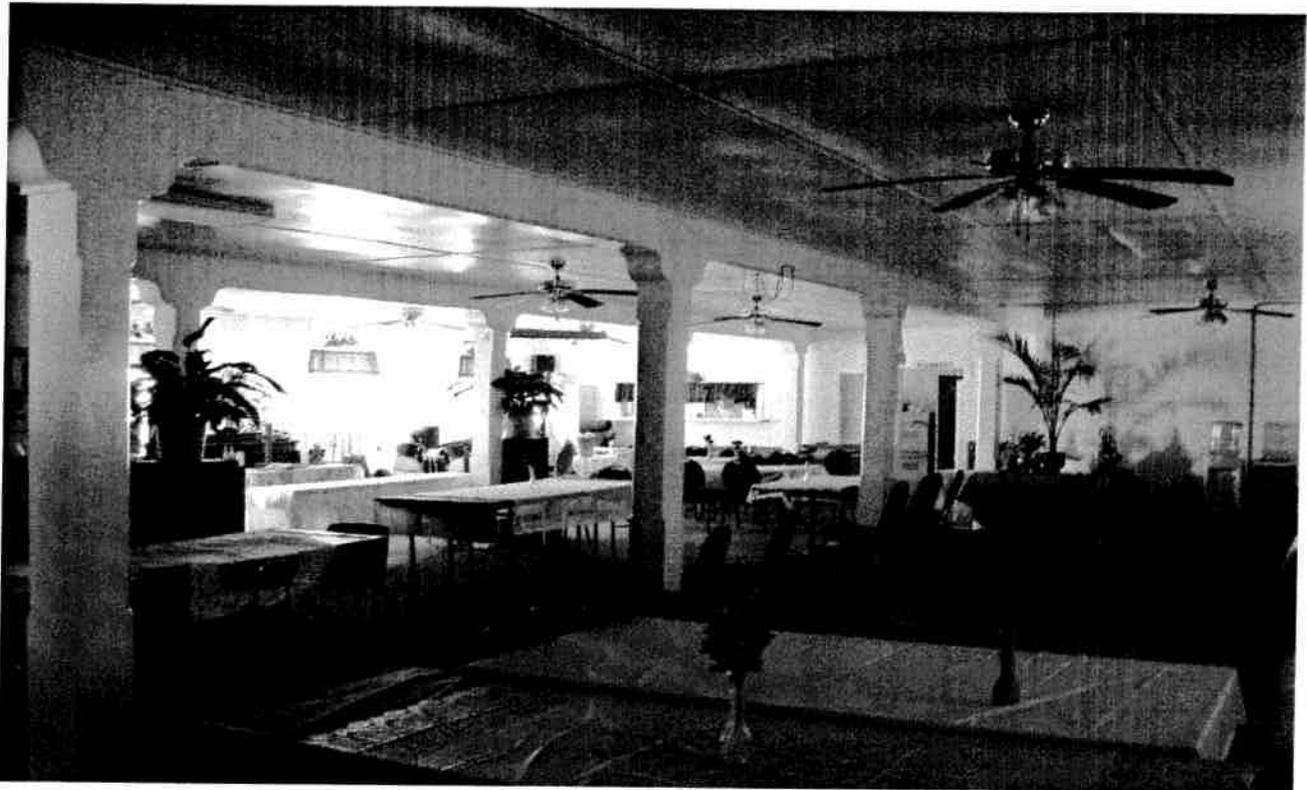
Figure 24 Second Floor Supporting Columns (View of Fellowship Hall)

from beam to exterior wall. The second floor floor sheathing, which is also the finish floor (floor boards), consists of tongue and groove 1x4s (7/8"x 3-7/8"). Their condition is poor, with extensive termite damage.

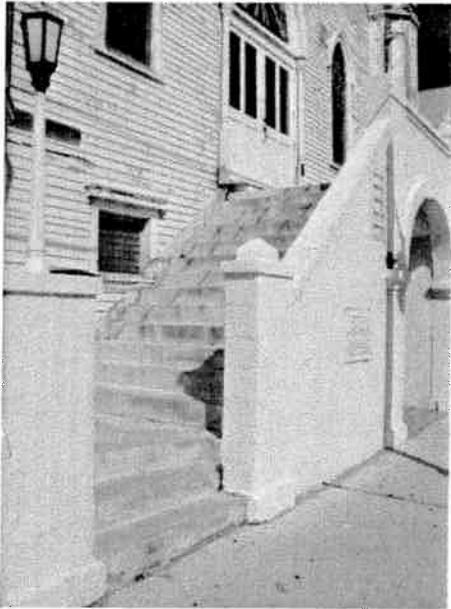
Figure 27 Stairs

Spalling, a sign of corrosion of steel within concrete. The stairs do not meet the Florida Building Code for tread and riser proportions or handrail provision and can be considered hazardous (Figure 27).

10. Repair/rebuild the concrete stair at the front of the church.

The only area explored for damage is the top landing slab and because it is seriously damaged from spalling it can be assumed that other areas could be damaged as well. Thus the repair of the stair could be extensive, even requiring it being partially or completely rebuilt.

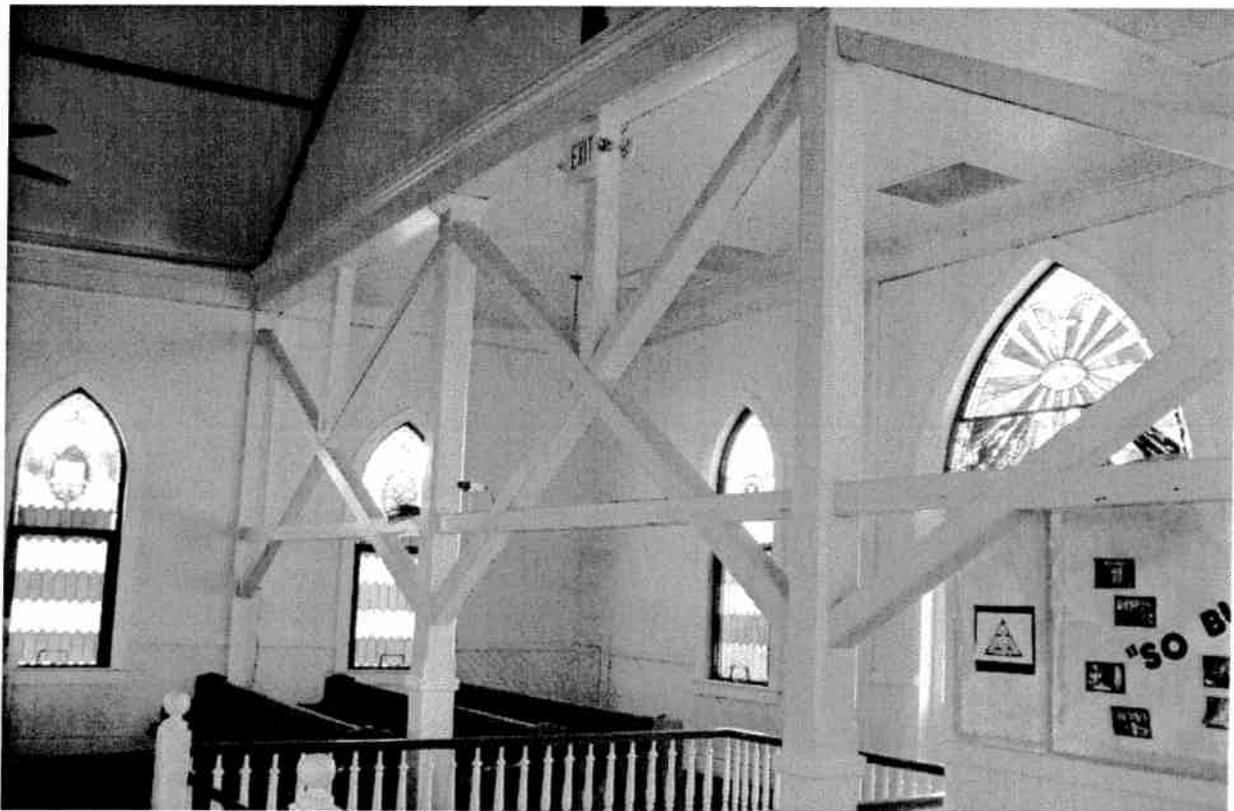
Figure 30 Truss-Like Structure

It is reasonable to believe that the rod and cables were an integral part of the original builder's structural design and that their removal is a cause of the church's lean to the Northwest, as well as the deflection observed in the bottom chords of the roof truss.

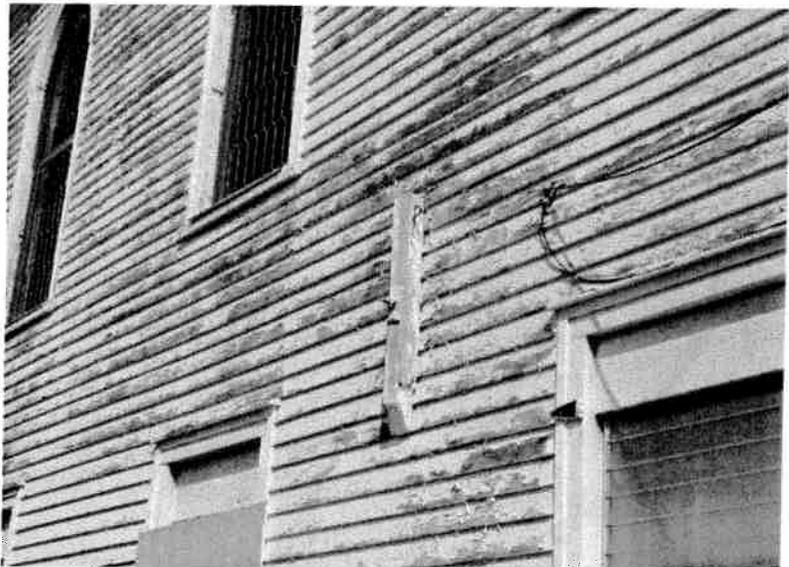
Figure 31 Exterior Wall

There is minor evidence of mildew on the interior walls, but the exterior siding, having lost so much of its paint suffers from dry rot, insect damage, and damage from exposure to the elements (Figure 31).

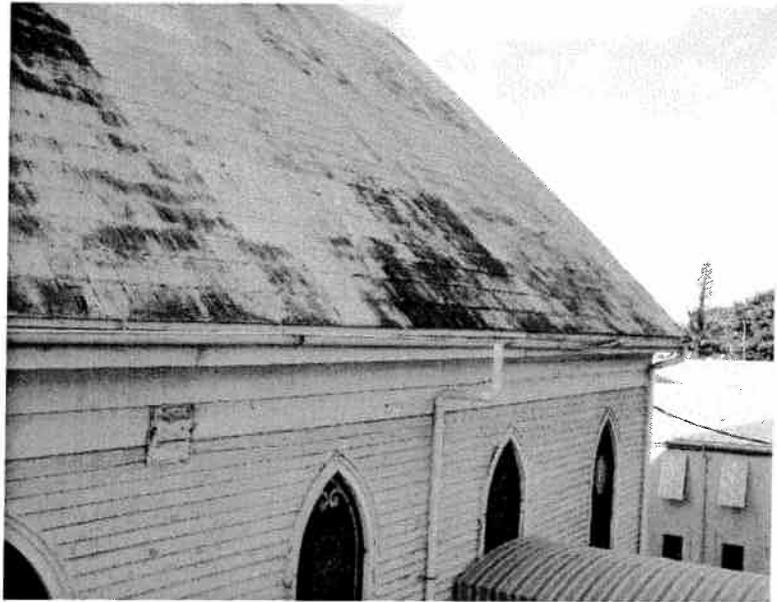
Figure 33 Roof

The roof covering consists of 29 gauge galvanized metal shingles upon rosin paper nailed to the original wood roof sheathing. The shingles are forty to fifty years old and at the end of their useful life. They exhibit extensive rust on the surface and there are many leaks that have damaged the ceiling below. (Figures 33, 34, and 35).

1. Replace the existing roof, gutters, downspouts and flashing.

Repair all rotten and damage areas of the existing roof sheathing.

Replace the existing 29 gauge shingles with 24 gauge shingles.

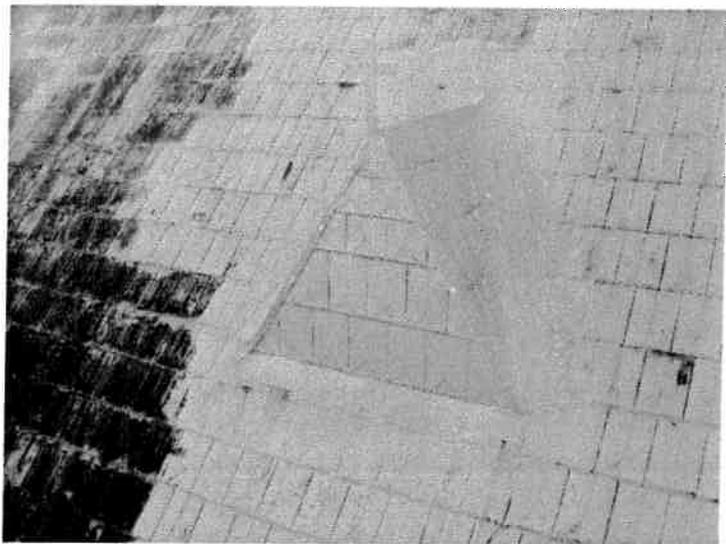
Figure 39 Original Roof Ventilation Dormers (Closed)

The church has four original ventilation dormers high on the roof but they have been closed and covered with roof shingles (Figure 45). The gutters are 6" half-round galvanized steel and the downspouts are 4" diameter galvanized steel round. Some downspouts are missing; others hang loosely from the gutters.

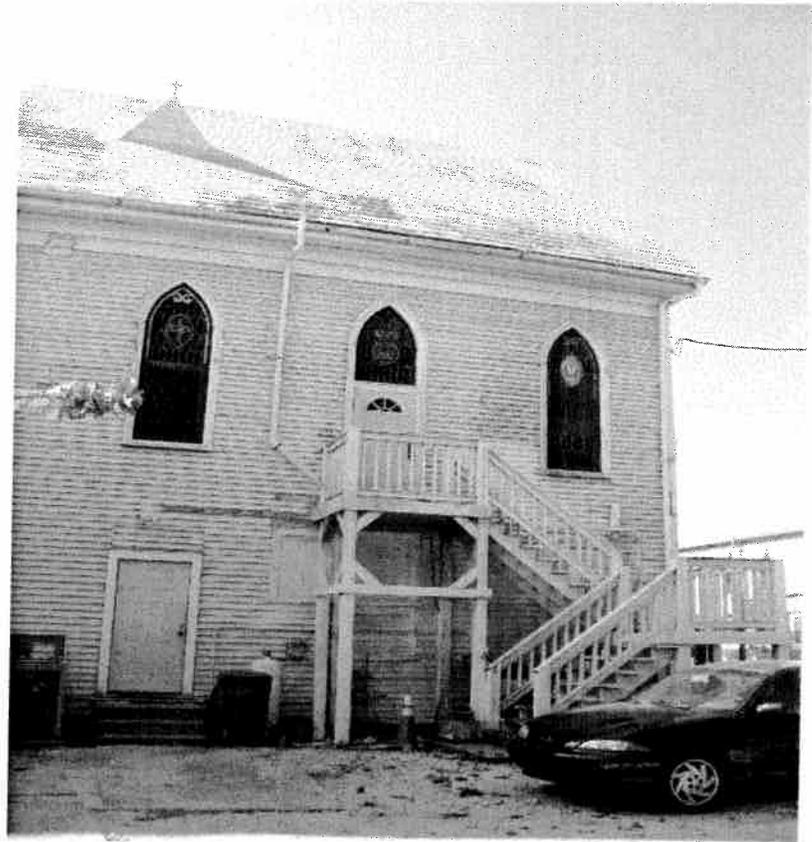
Figure 43 Rear Egress Stair

A wood stair has been constructed at the rear of the church outside the rear egress door to provide emergency egress for the sanctuary. It is approximately twenty years old and shows considerable rot at the ground level where the stringers and supporting posts are in contact with the soil. It is also in violation of the code with respect to tread and riser ratio (Figure 43).

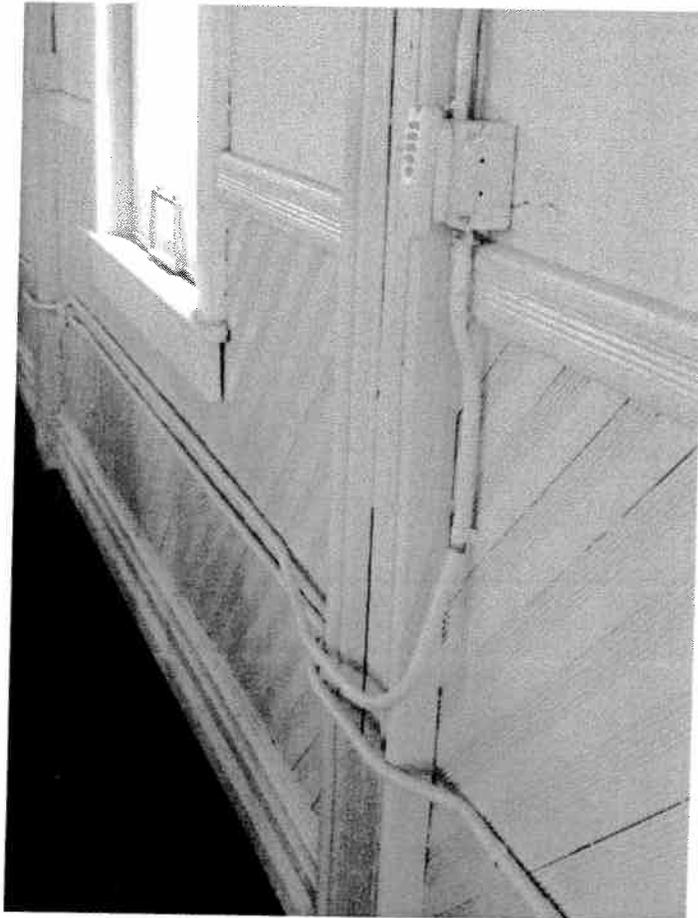
Figure 51 Conduit on Woodwork

Because the church was built before the advent of electricity over time the electrical wiring has been installed on the surface of the walls and ceiling. This has resulted in visible conduit attached to the face of the walls and woodwork (Figure 51), diminishing the woodwork's appearance.

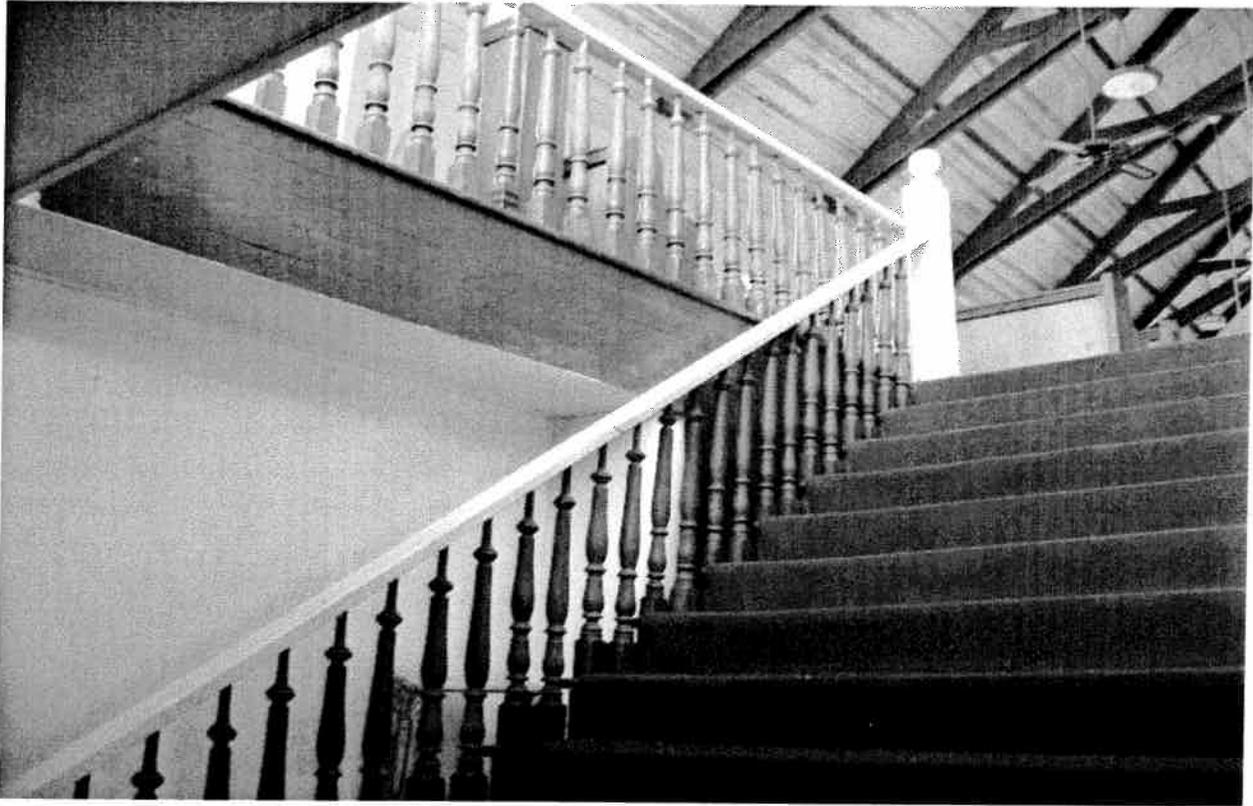
Figure 52 Interior Stair

The interior stair balustrade appears to be partially original, as the turned balusters are Victorian. The banister (the cap) and newel posts, however, are nothing more than painted grade 2x4s and 6x6s (Figure 52). Very likely the original banister and newel posts deteriorated and were thrown out.

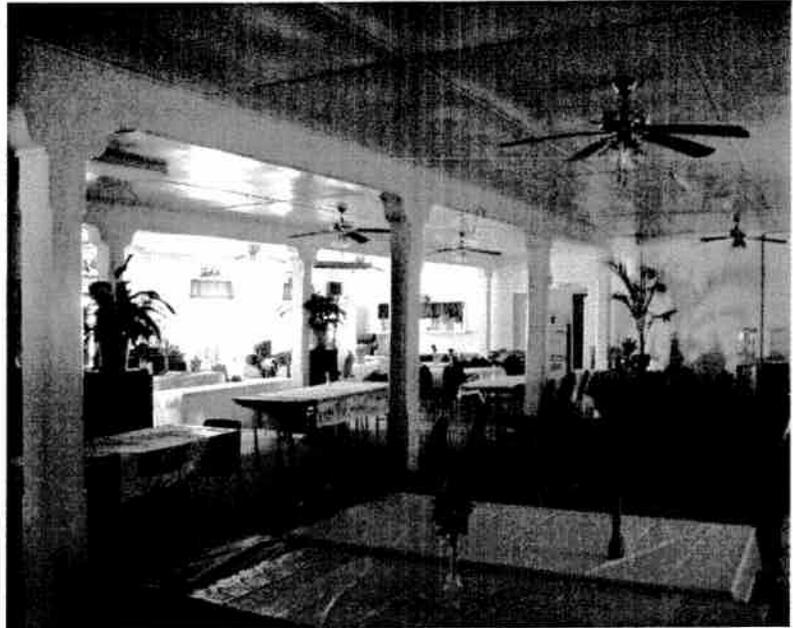
Figure 53 Ground Floor Fellowship Hall

The walls and ceiling framing are covered with a type of "Masonite" wall board and are painted. Considerable sagging was observed. (Figure 53). The columns in the space are 8"x 8" timbers and are painted. They show superficial termite damage.

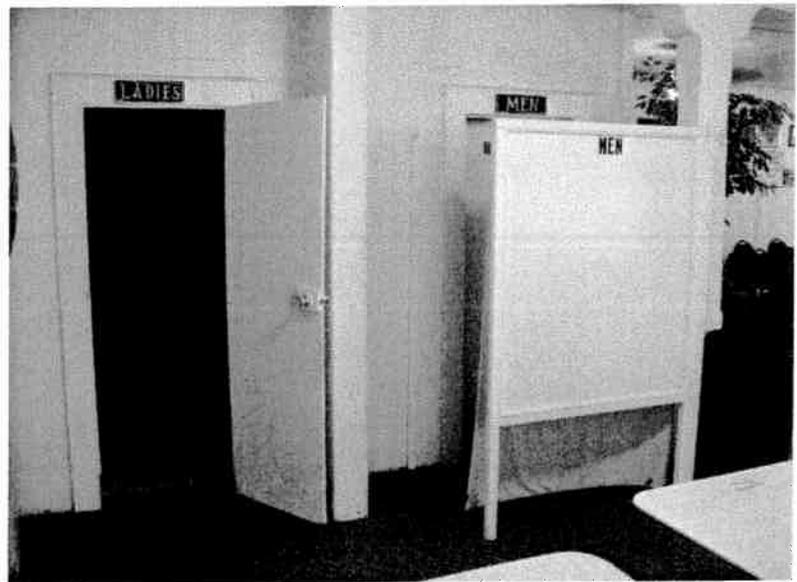
Figure 56 Bathrooms

The bathrooms are located on the ground floor and, while clean, are in aging condition (Figure 56). There are three water closets, one urinal, and three lavatories. They are neither adequate for the occupancy load of the church or are they ADA compliant.

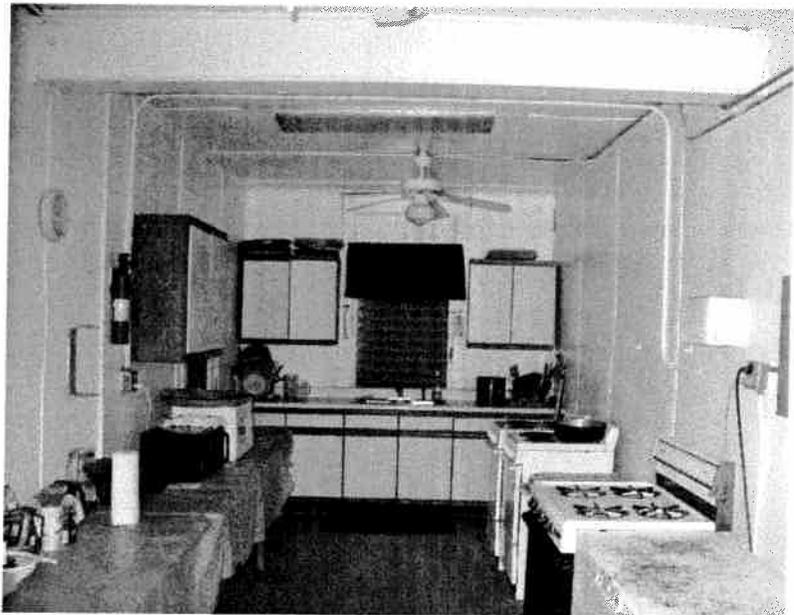
Figure 57 Kitchen

The kitchen is one large room at the back of the ground floor and contains one double sink, two electric stoves, one gas stove, two wall ovens, one microwave oven, one freezer, and two refrigerators. All of the appliances are residential grade in more or less serviceable condition and more or less adequate for volunteers to cater events (Figure 57). It does not meet the state code for its purpose.

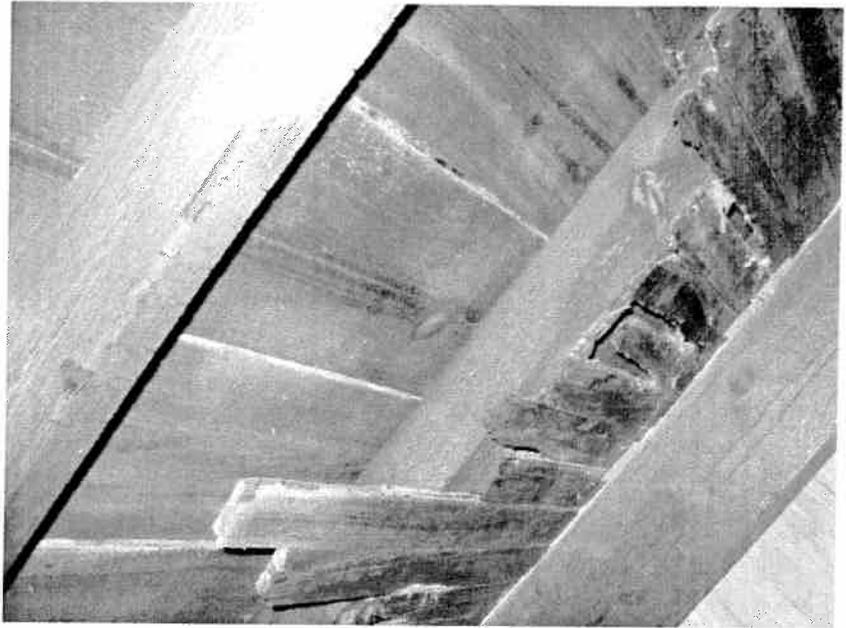
Figure 59 Evidence of 1964 Fire

The church suffered a fire in 1964 in the area of the attic. Part of the roof burned through and some of the exposed structural beams in the attic were charred. The roof was repaired with plywood sheathing—perhaps at the time the current roof was installed—but the charred beams were left intact. These remain to view today (Figure 59).

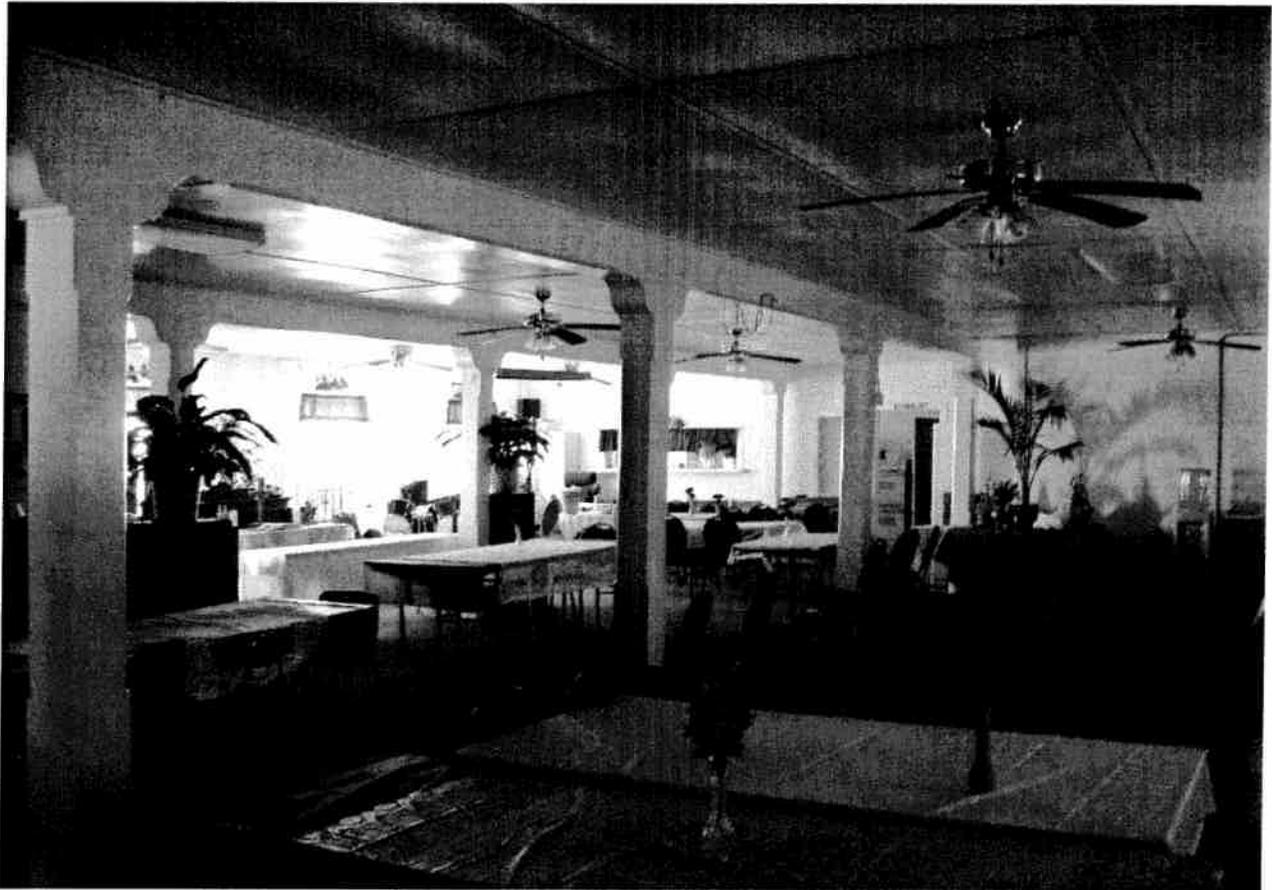
Figure 62 First Floor Interior Lights

First Floor Interior: Lighting on the interior of the ground floor consists of a combination of economy-grade residential ceiling fans with light kits and florescent ceiling fixtures (Figure 62) in the fellowship hall. They are in poor working order.

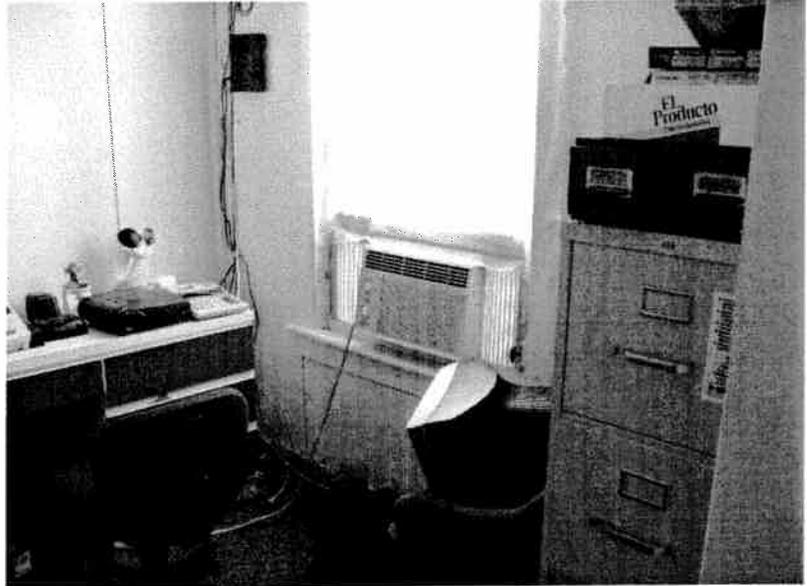
Figure 70 Window Unit

Ground Floor: There are five window units, of 3/4 to 1-1/2 tons (Figure 70). Four are serviceable, the others in varying stages of life. They are used frequently, as the Fellowship Hall is used during the week by different religious groups. They are no doubt inefficient by today's standards and contribute to high energy costs.

3. Replace the window units on the First Floor with high SEER ductless split system air conditioners.

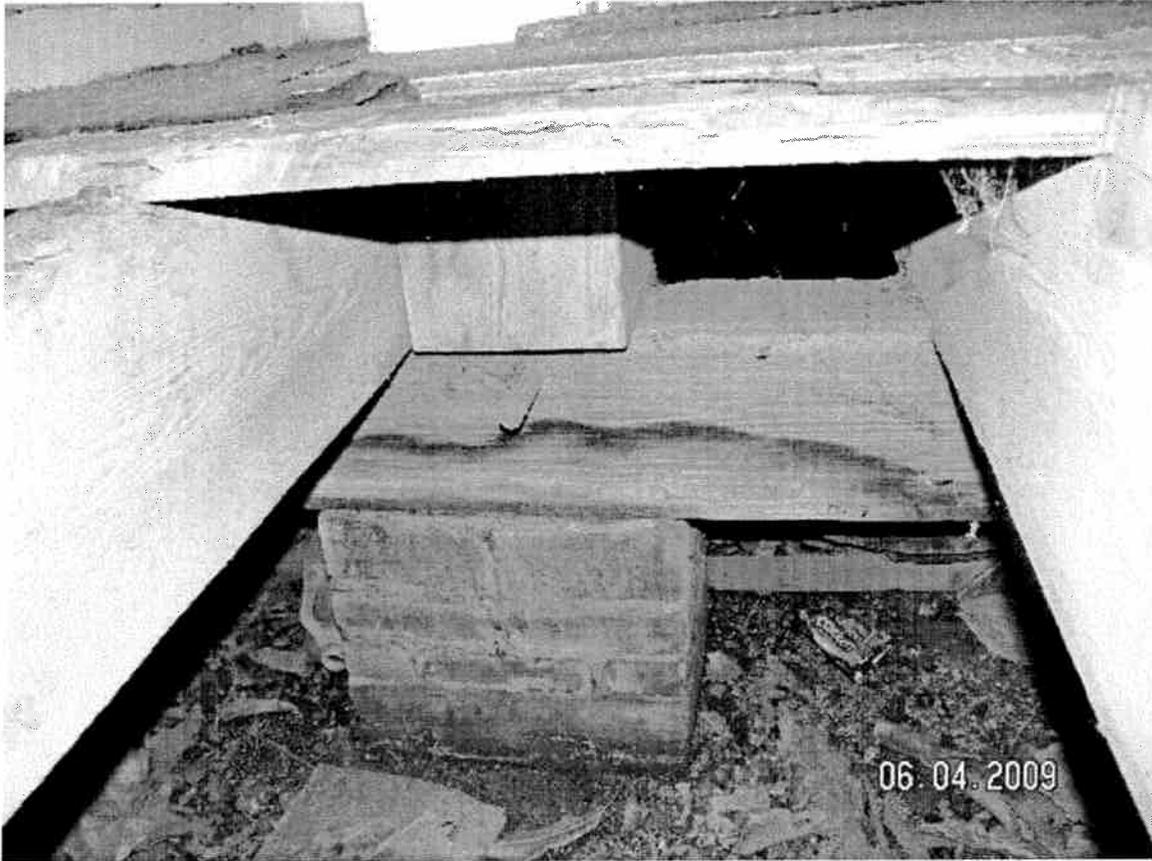
The columns are connected to the floor beam (6x8) by a mortise and tenon joint. This consists of a wood pin through a "tongue" of the column and a "groove" cut into the beam. This type of connection is common in buildings of this age. Due to the load from the Nave floor, the columns have rotated slightly at this connection causing the columns to fall out of plumb. The columns remain in good condition but realigning the columns and a stronger connection should be investigated. See photo on next page.

Note the brick pier with the 6x8 floor beam running over and the column attached by mortise and tenon joint with a wooden dowel. The 4x10 joists are shown on each side. It would appear that there is no positive connection from the pier to the beam to the joist. The South wall of the building exhibits some differential footing settlement. The Ground Floor appears level along the North wall and at the center but has a 6" fall to the Southwest and 1 1/2" fall to the Southeast. Many historical buildings in Key West have piers that have settled differentially.
