**LIMITED ASBESTOS
INSPECTION SURVEY REPORT**

**GLYNN ARCHER ELEMENTARY SCHOOL COMPLEX
CITY HALL PLANNING PROJECT
1302 WHITE STREET
KEY WEST, FLORIDA 33040**

August 29, 2012
EE&G Project No. 2012-2373

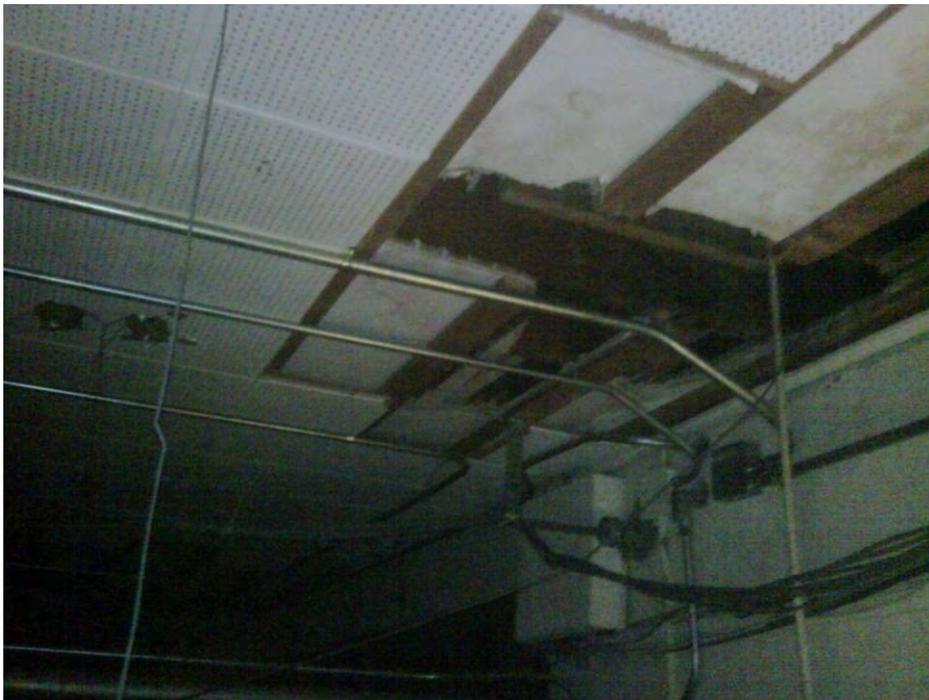
Photo 2: Typical nonACM 1'x1' ceiling tile on upper plaster ceilings

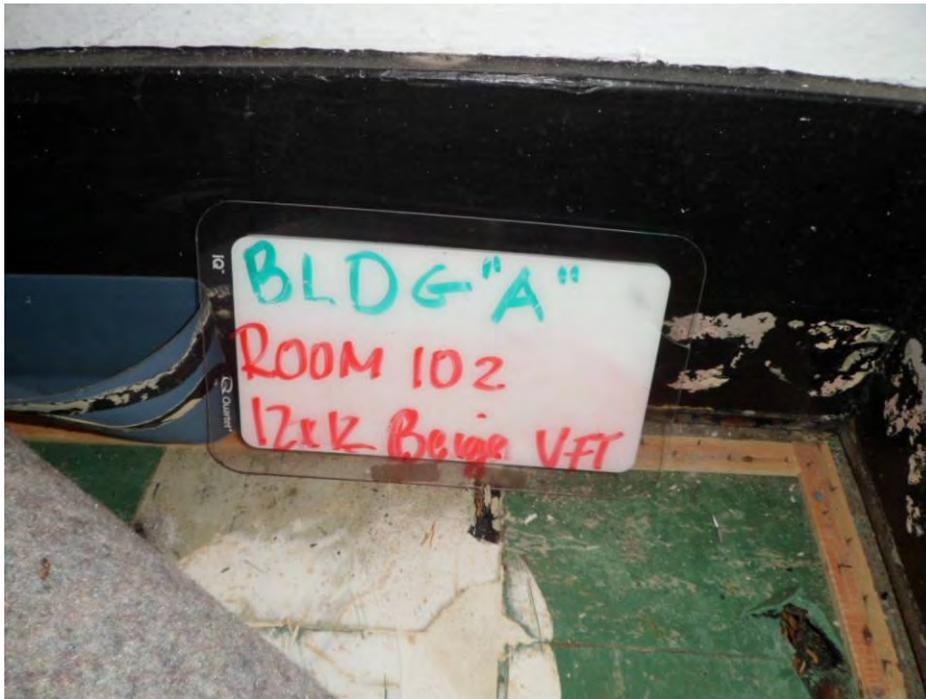
Photo 3: Typical nonACM 12"x12" beige VFT over Green ACM VFT/mastic

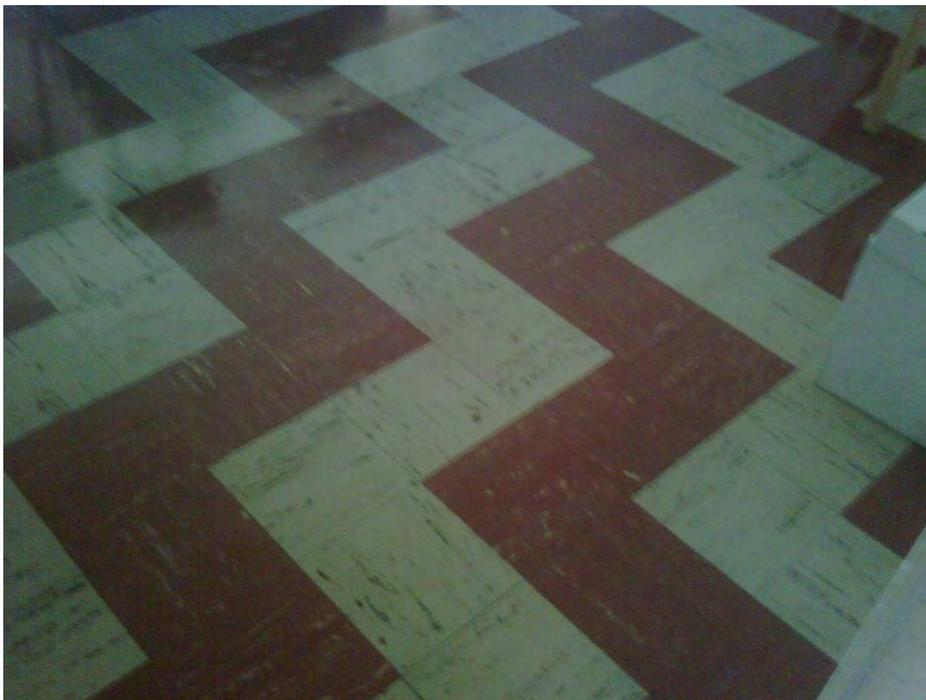
Photo 4: Typical 9" Red/white VFTs with ACM black mastic

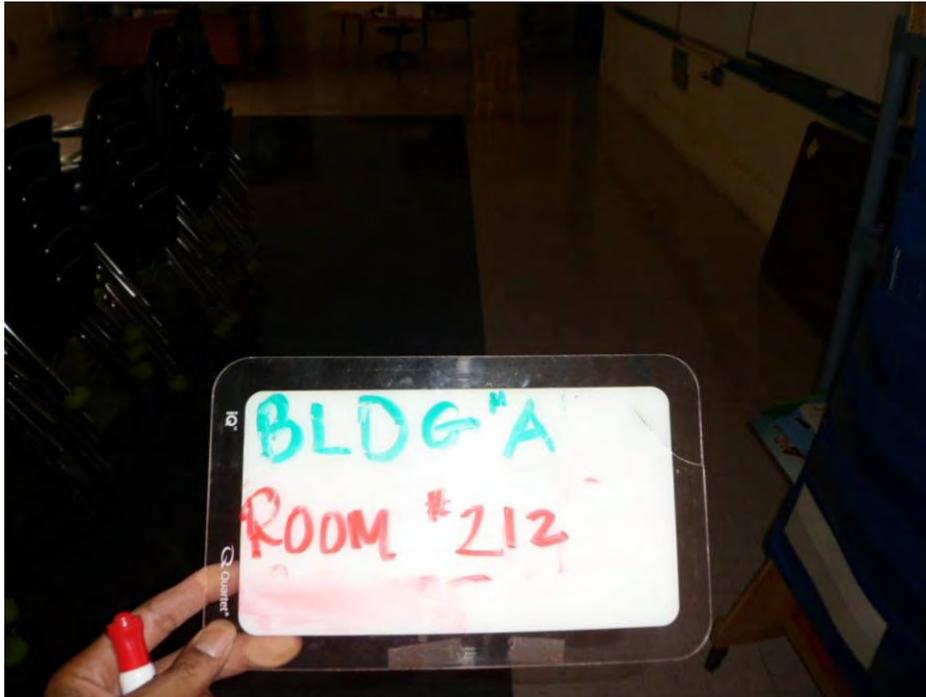
Photo 5: Typical ACM 9"x9" VFT

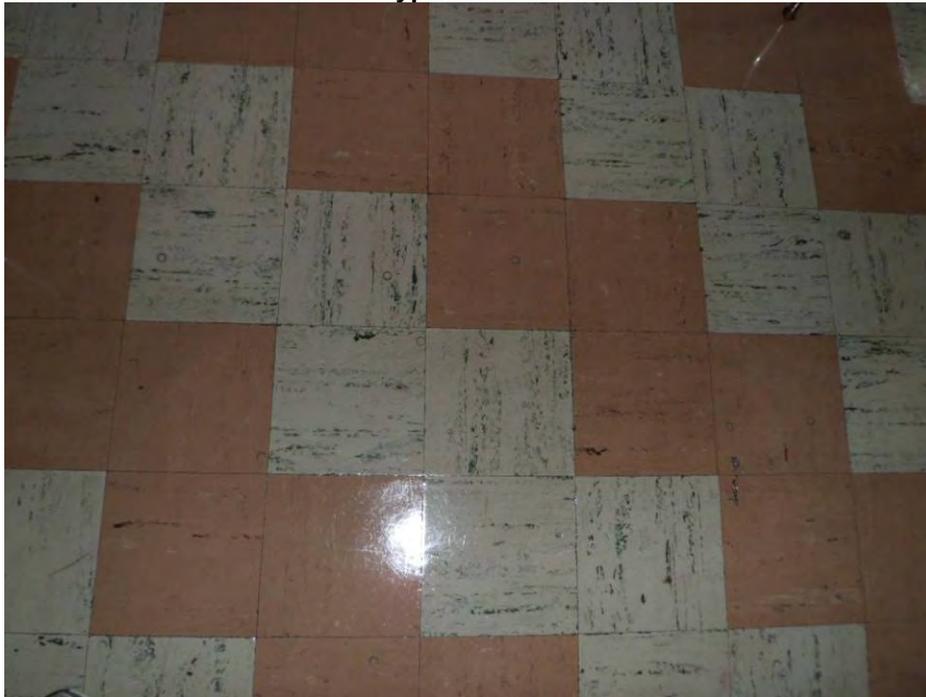
Photo 6: Typical ACM 9"x9" Pink VFT

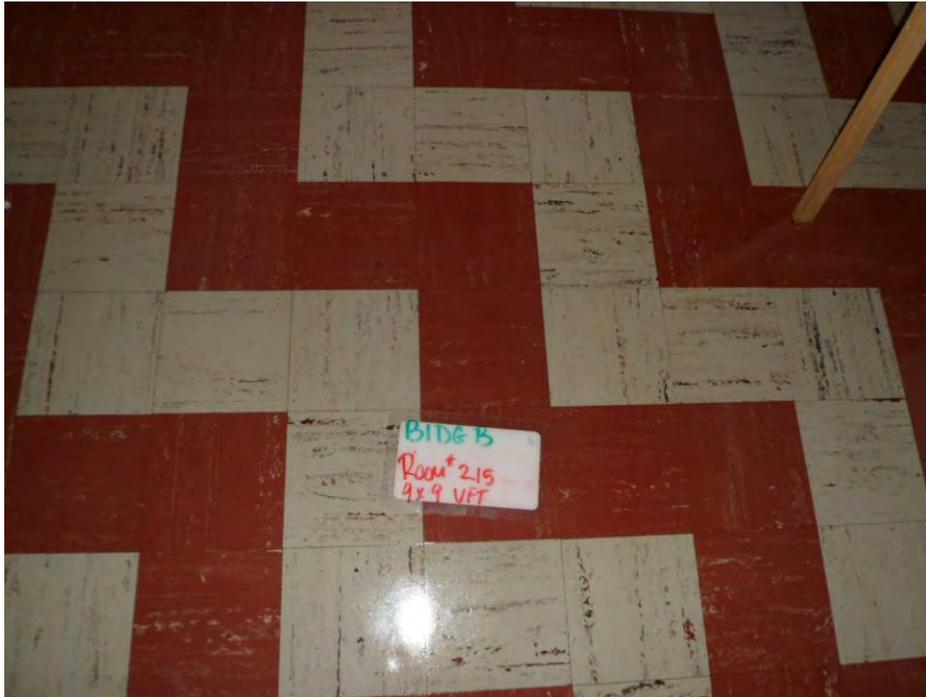
Photo 7: Typical ACM 9"x9" red and white VFTs in B215

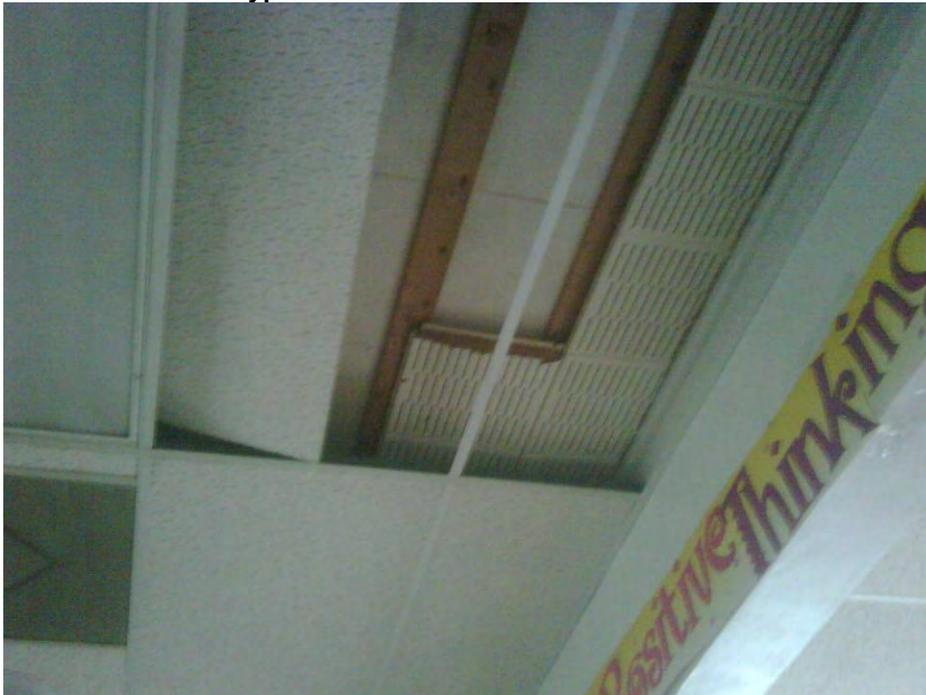
Photo 8: Typical nonACM 2'x4' white ceiling tiles below nonACM 1x1' upper ceilings

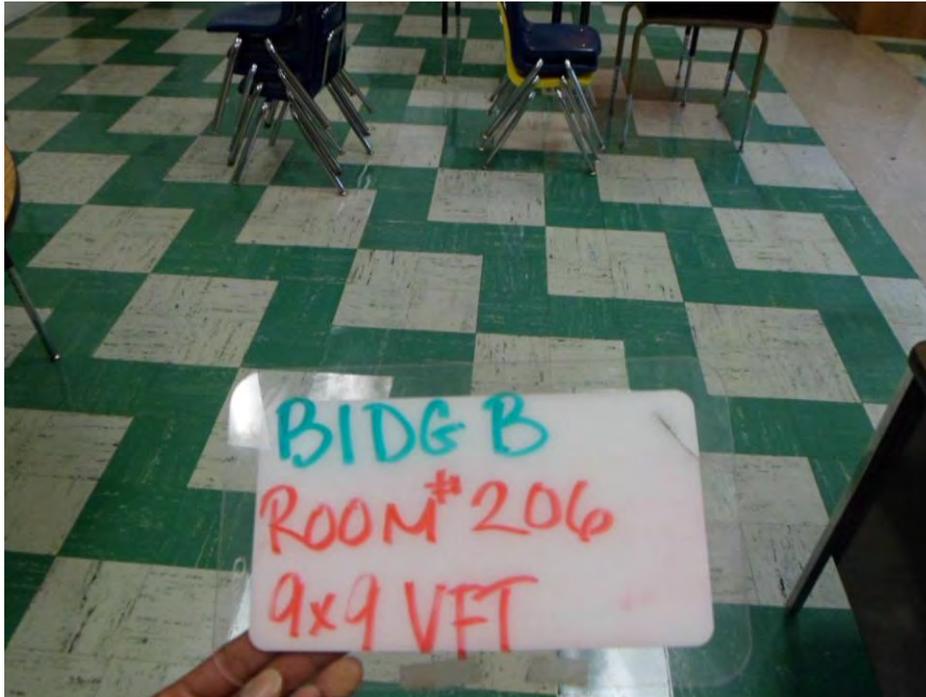
Photo 9: Typical ACM 9"x9" white and green VFTs in B206

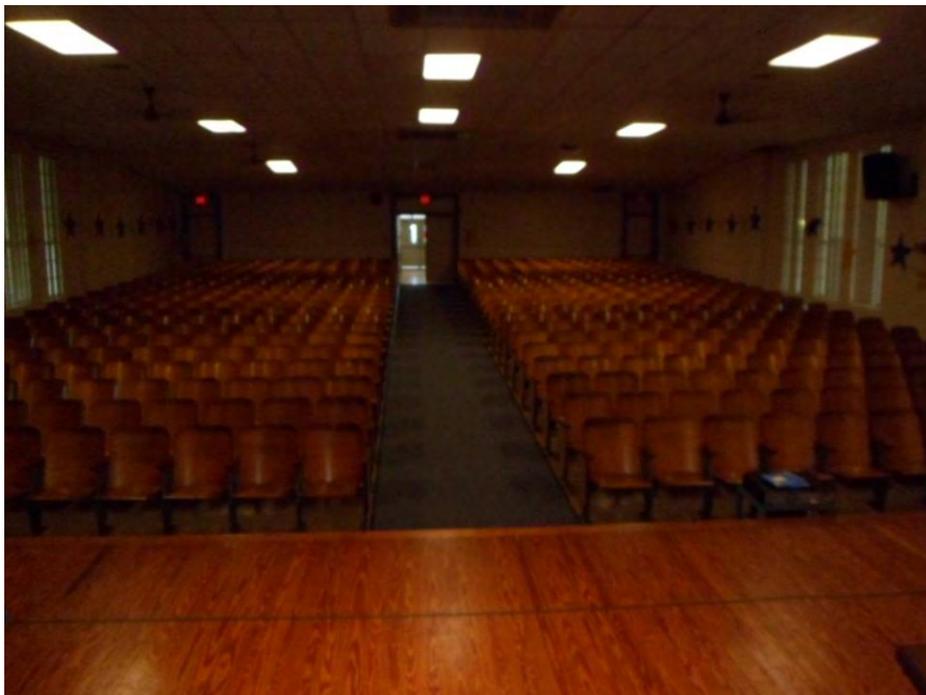
Photo 10: Auditorium – ACM linoleum over ACM maroon VFT under seats

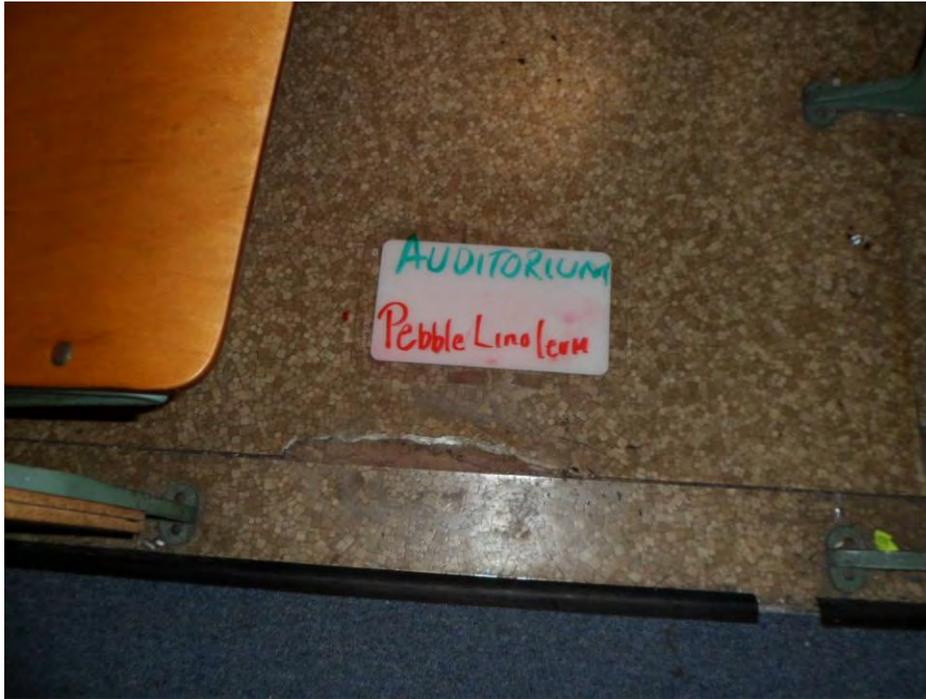
Photo 11: Typical ACM pebble linoleum (top layer)

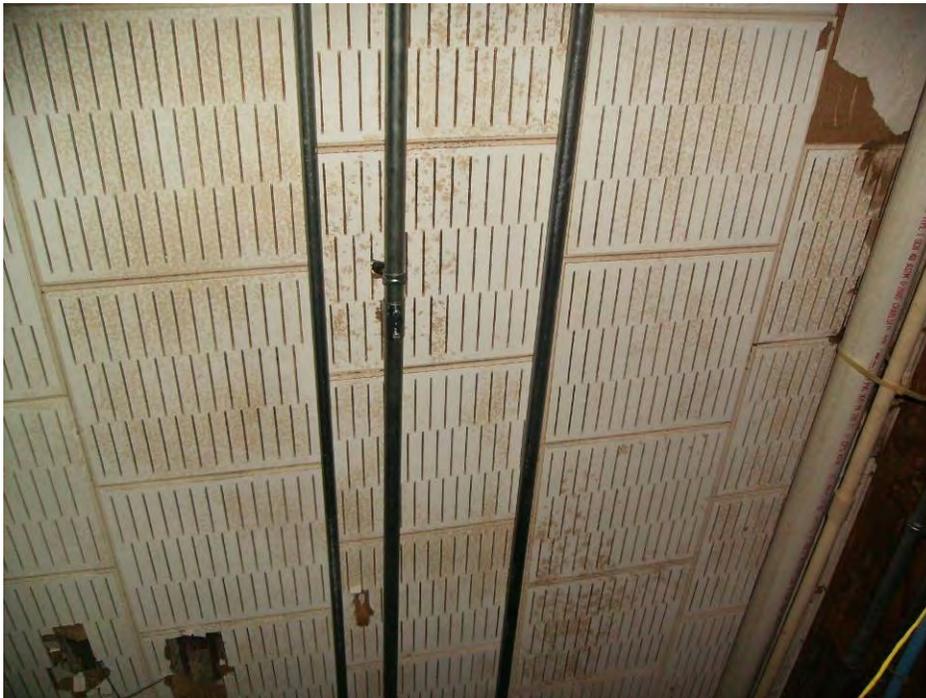
Photo 12: Typical nonACM 1'x1' brown ceiling tiles on Auditorium upper ceilings

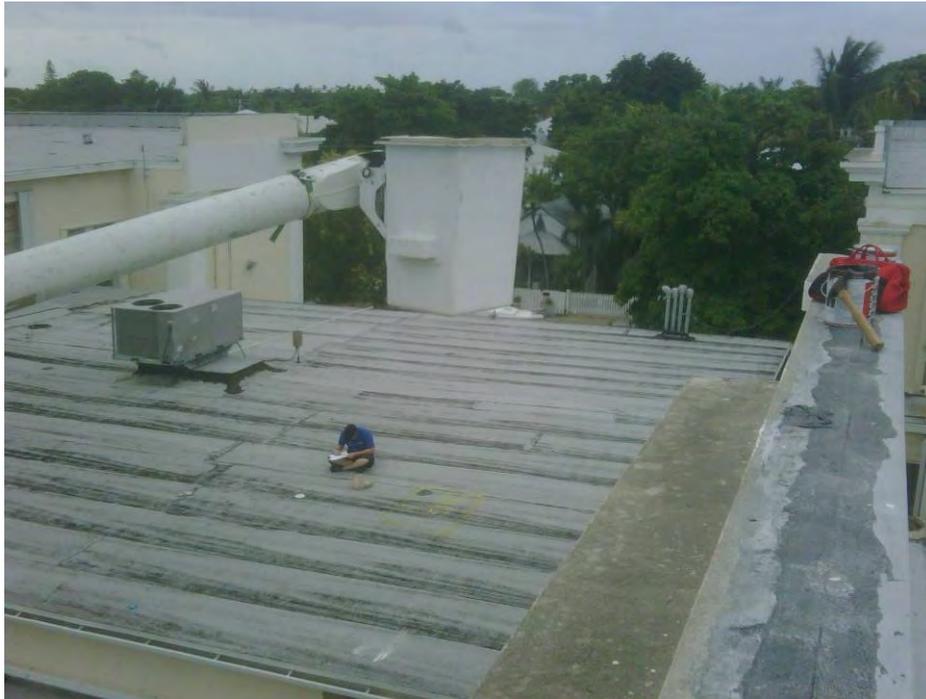
Photo 13: Typical nonACM roof field membrane on Bldgs A, B, Aud, C

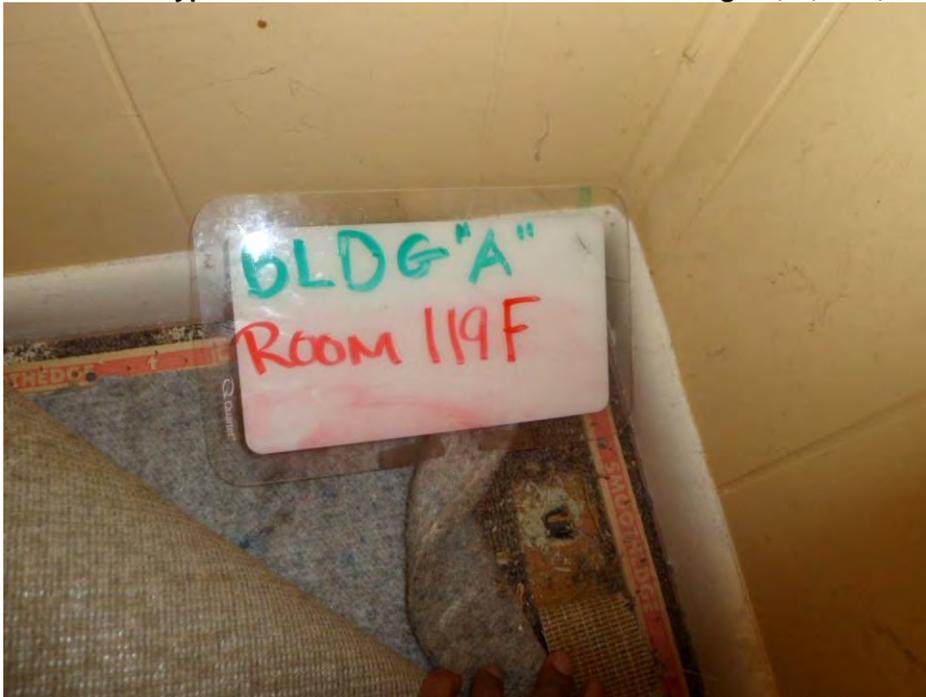
Photo 14: ACM VFT/mastic under carpet in office 119F

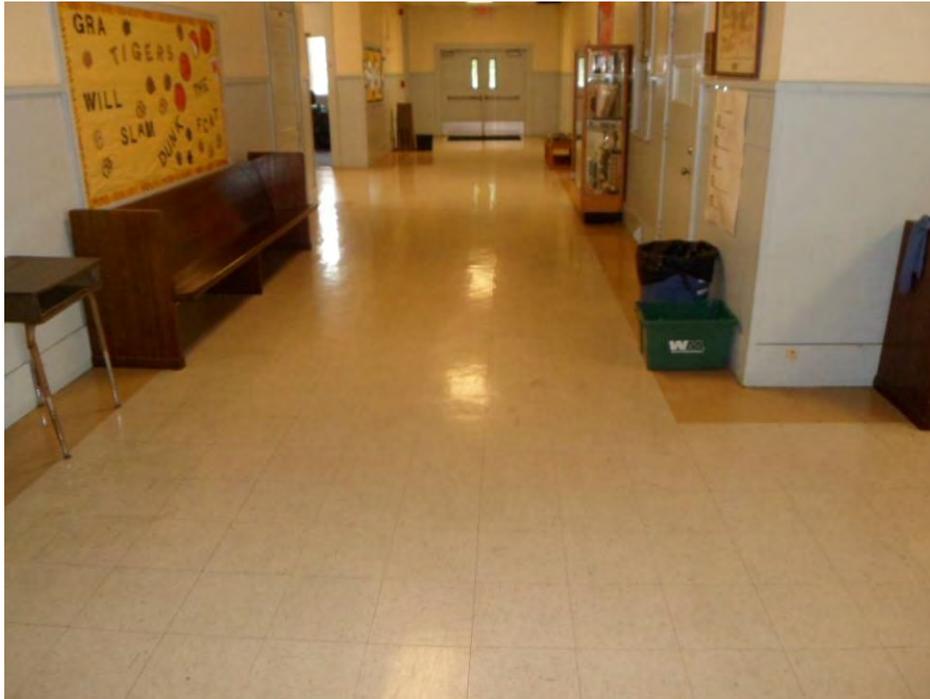
Photo 15: ACM VFT under newer VFTs in Bldg A main corridors

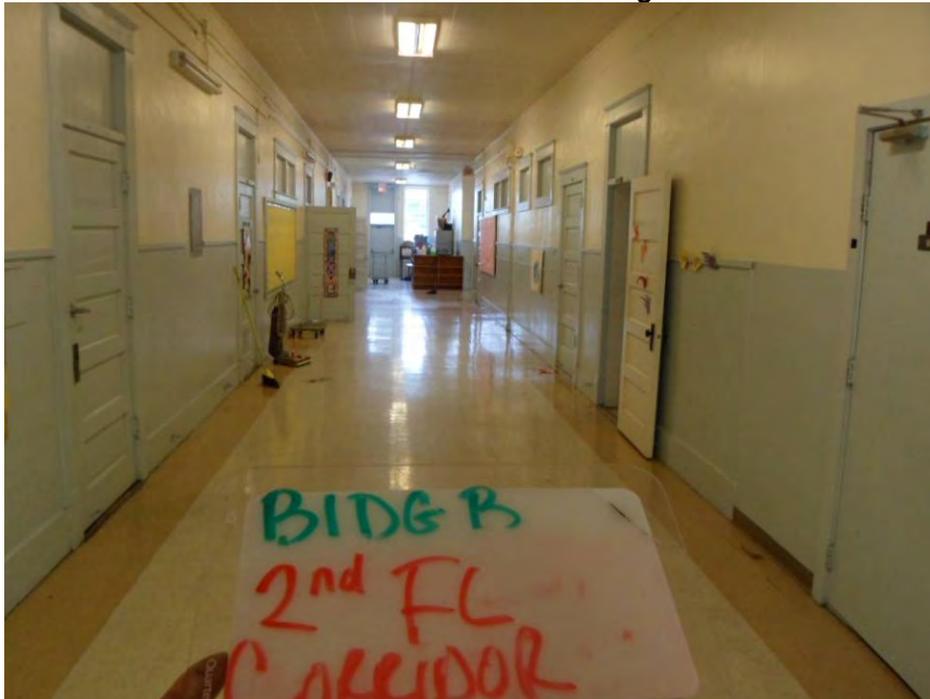
Photo 16: ACM VFT under newer VFTs in Bldg B main corridors

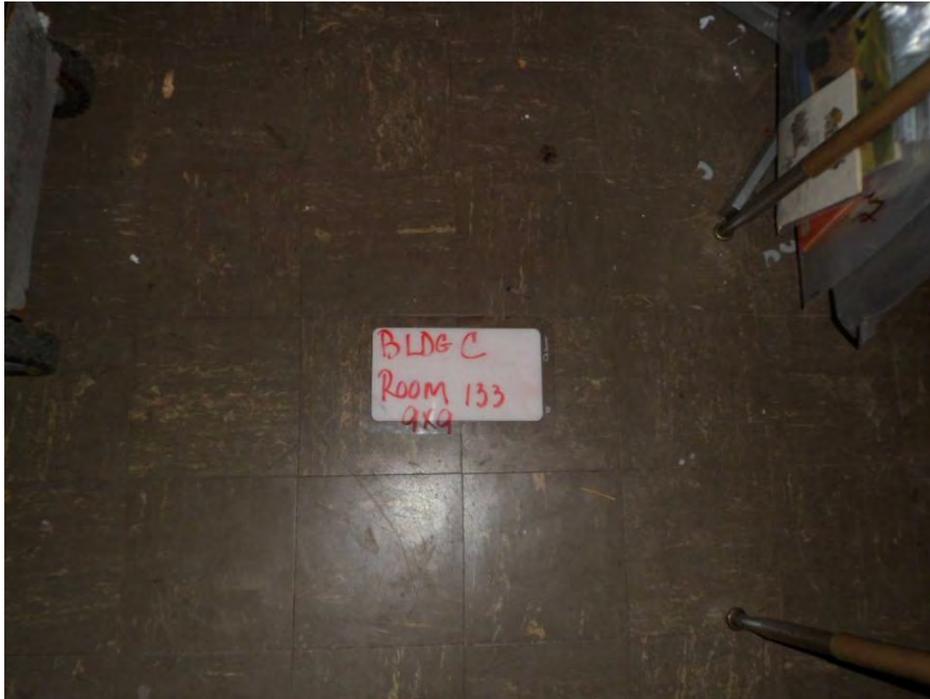
Photo 17: ACM VFT/mastic in C-133

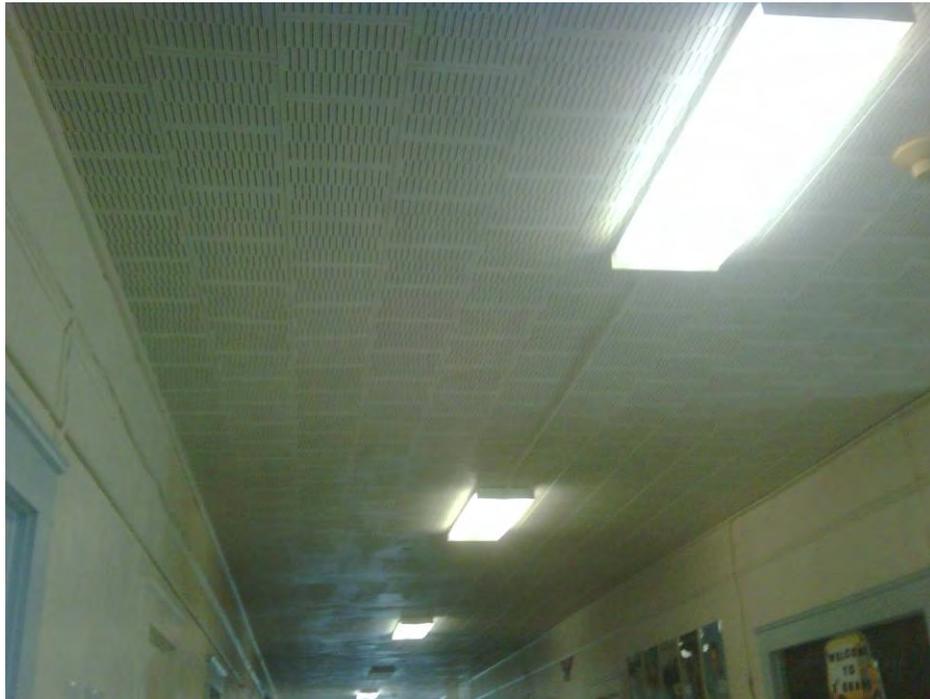
Photo 18: Typical nonACM ceiling tiles in Bldg C corridors

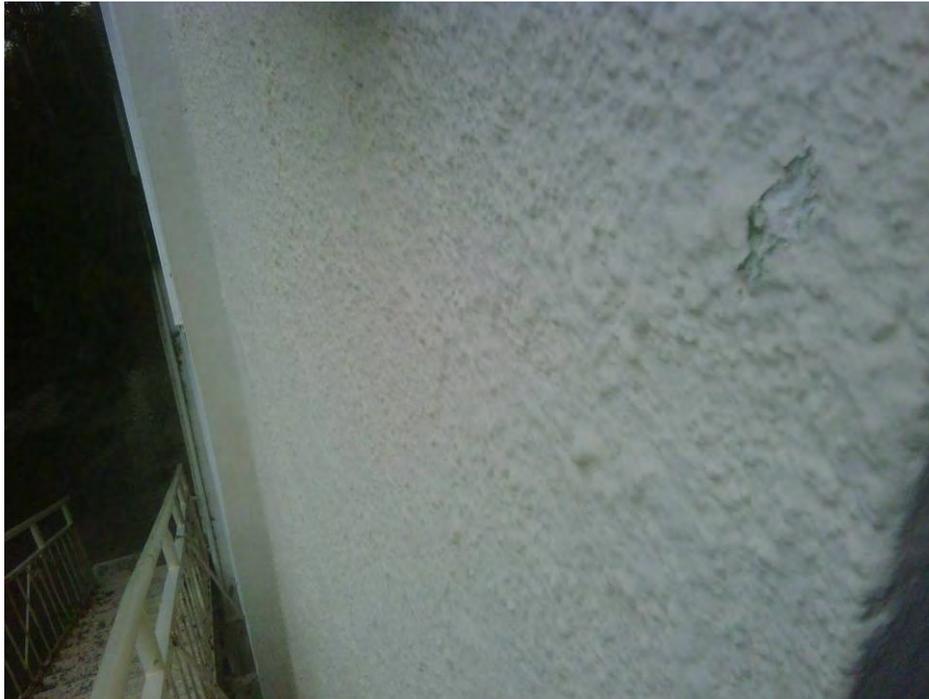
Photo 19: Typical nonACM stucco finish on Aud building.

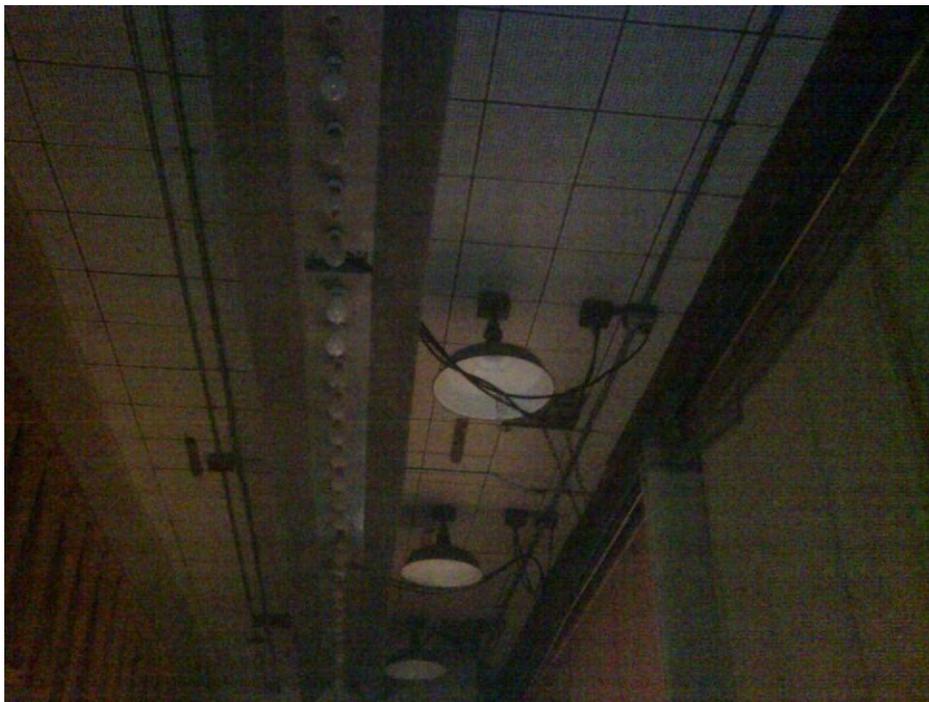
Photo 20: Typical nonACM 1x1' ceiling tiles and plaster above stage in Aud.

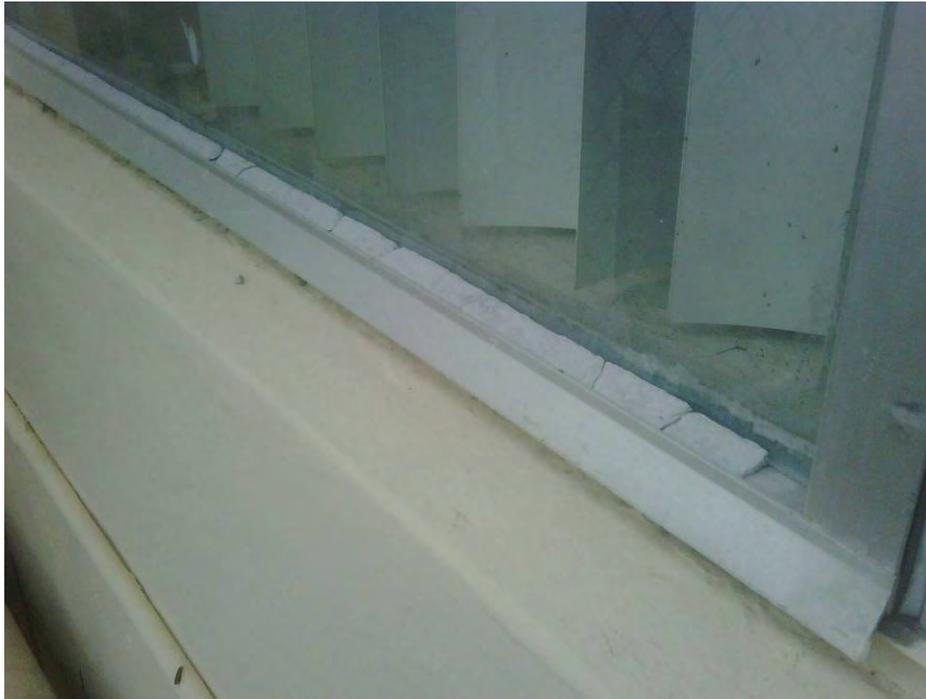
Photo 21: Typical nonACM window glazing on Building C

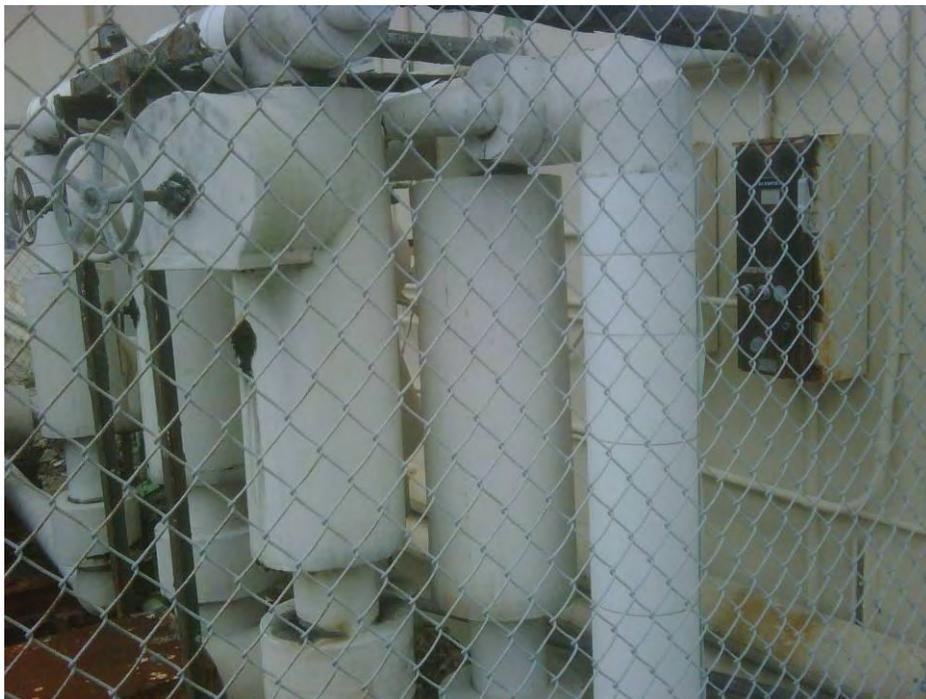
Photo 22: Typical nonACM TSI on Northside mech complex on Bldg C

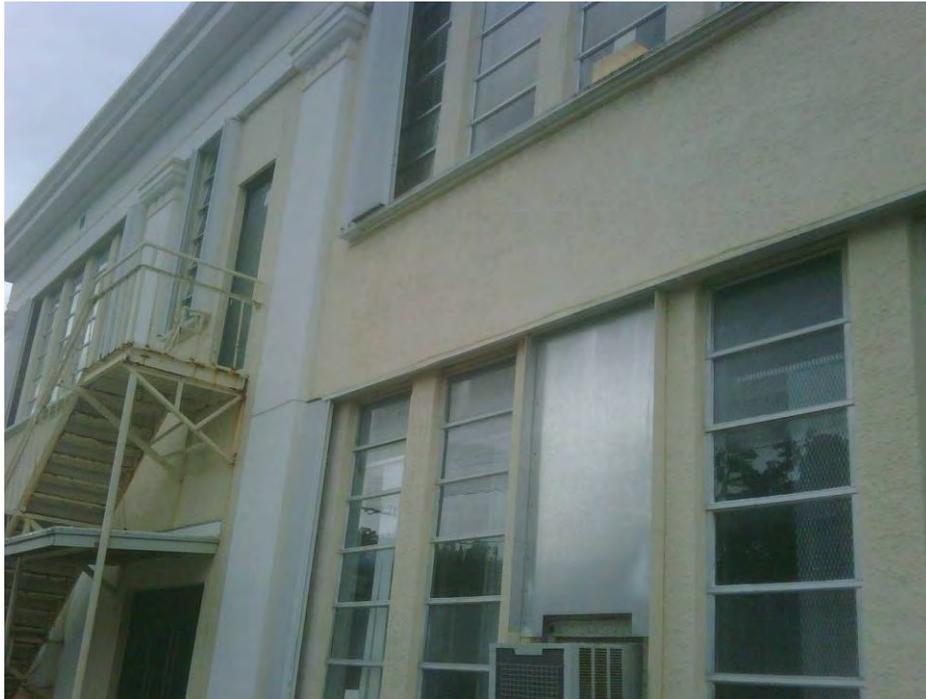
Photo 23: Typical nonACM exterior stucco finishes on Bldg A

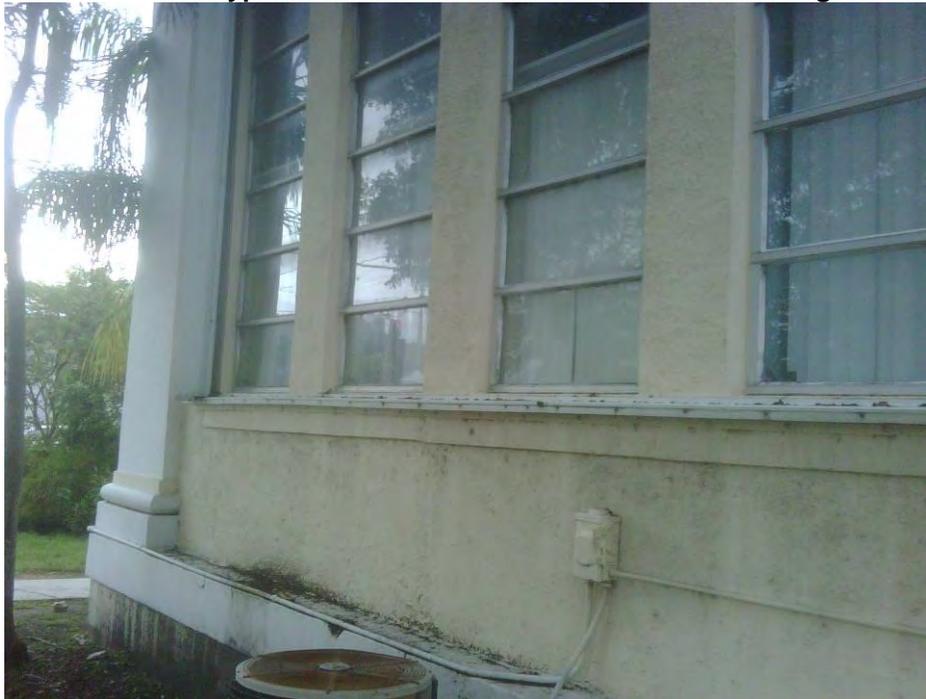
Photo 24: Typical nonACM exterior stucco finishes on Bldg A

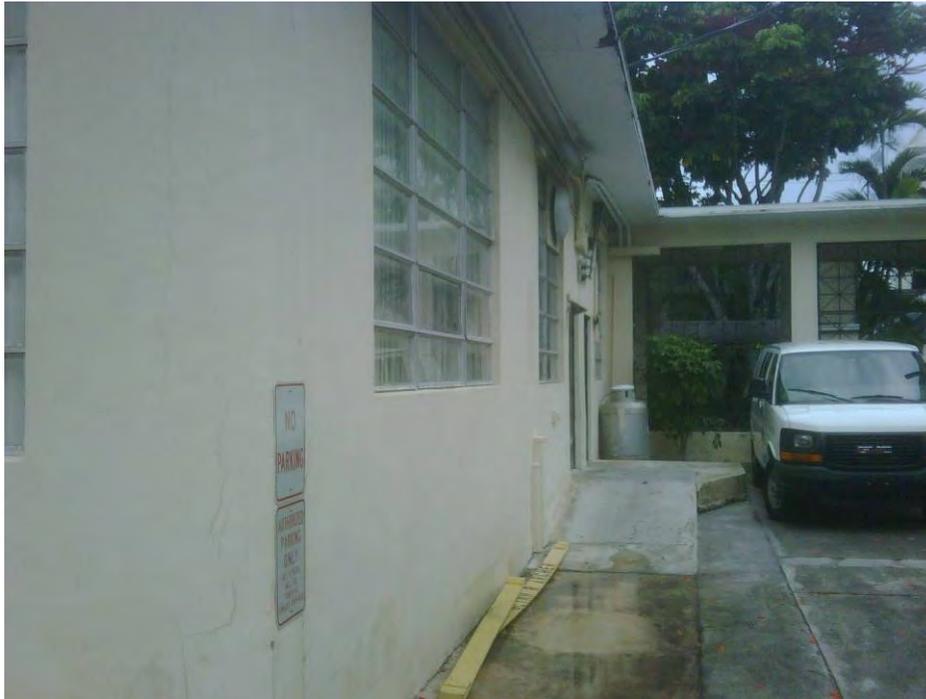
Photo 25: Typical nonACM exterior stucco on Bldg C

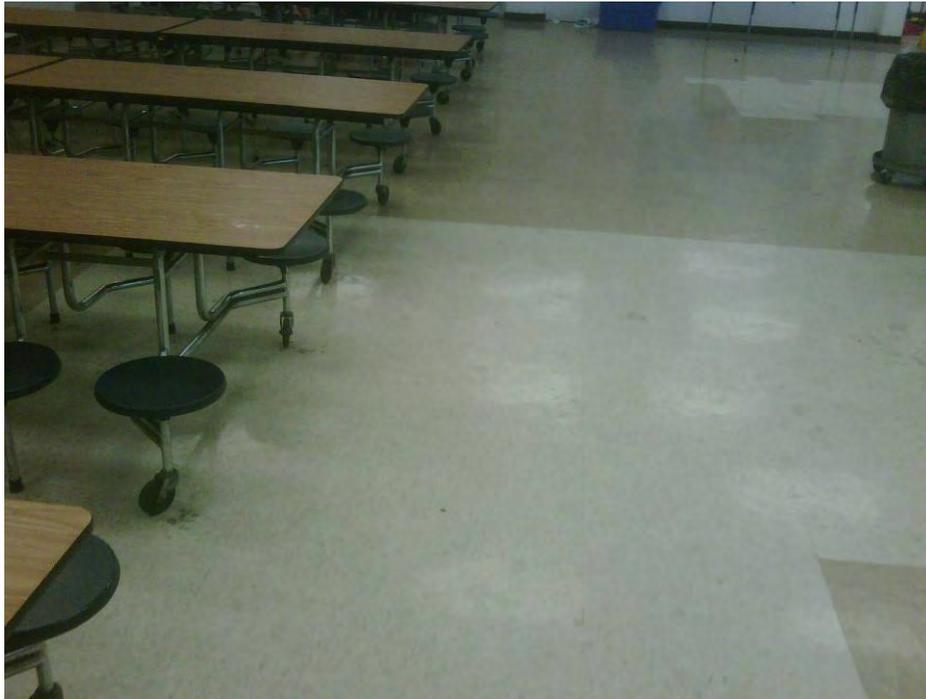
Photo 27: Typical ACM mastic under VFT in Cafeteria 135

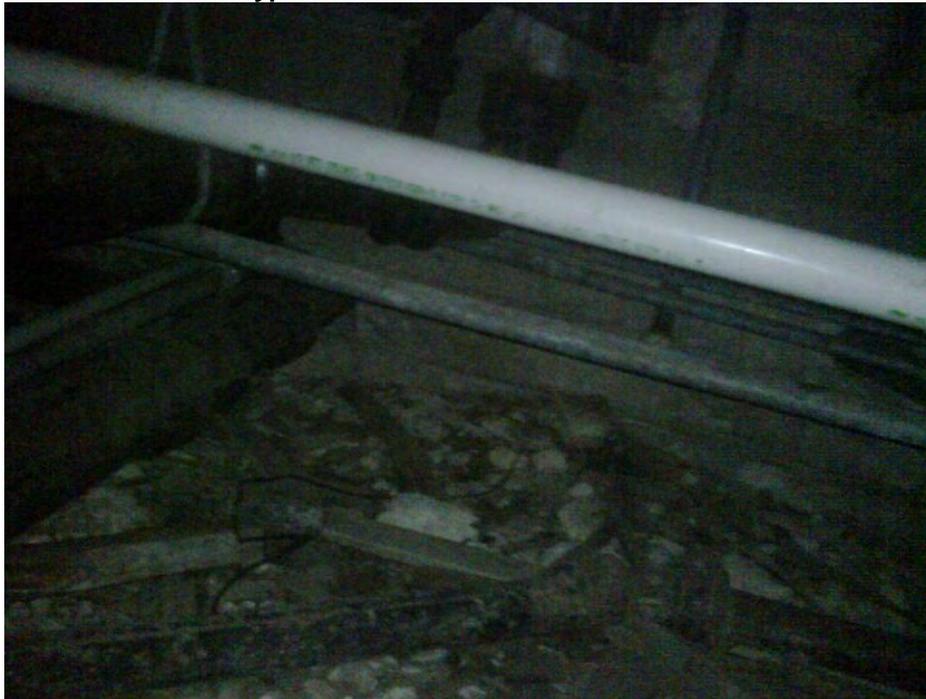
Photo 28: Typical crawlspace view of Bldg B, no suspect ACMs observed

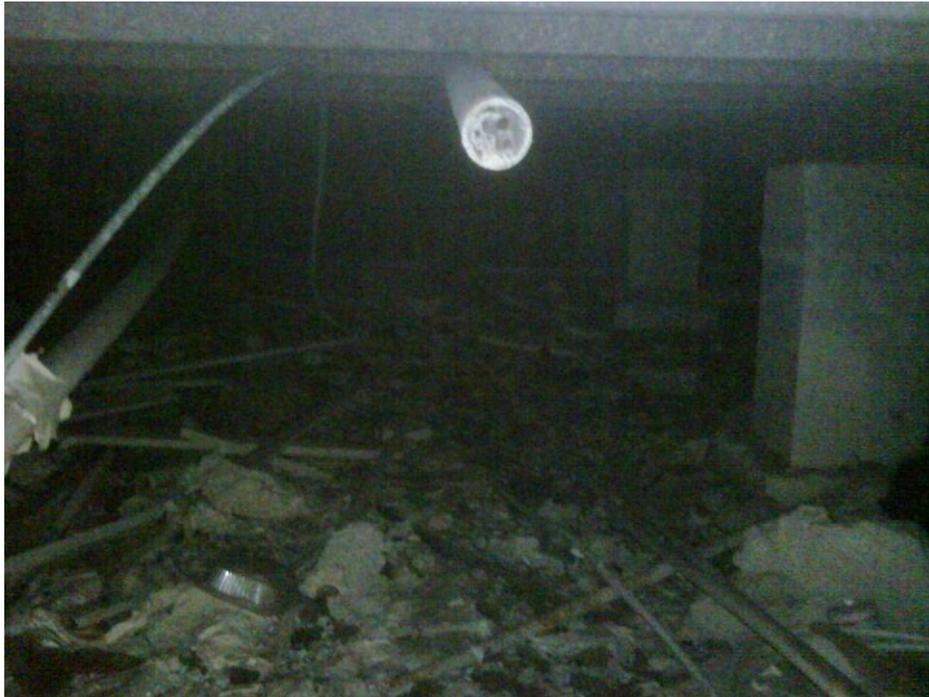
Photo 29: Typical crawlspace view of Bldg A, no suspect ACMs observed

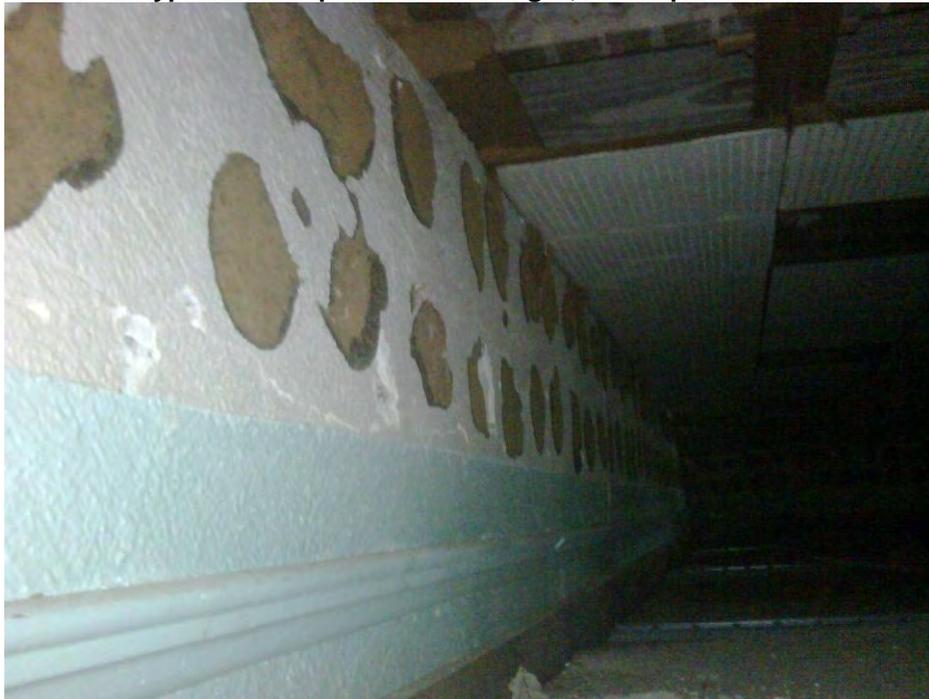
Photo 30: Typical nonACM glue on 1x1' ceiling tiles

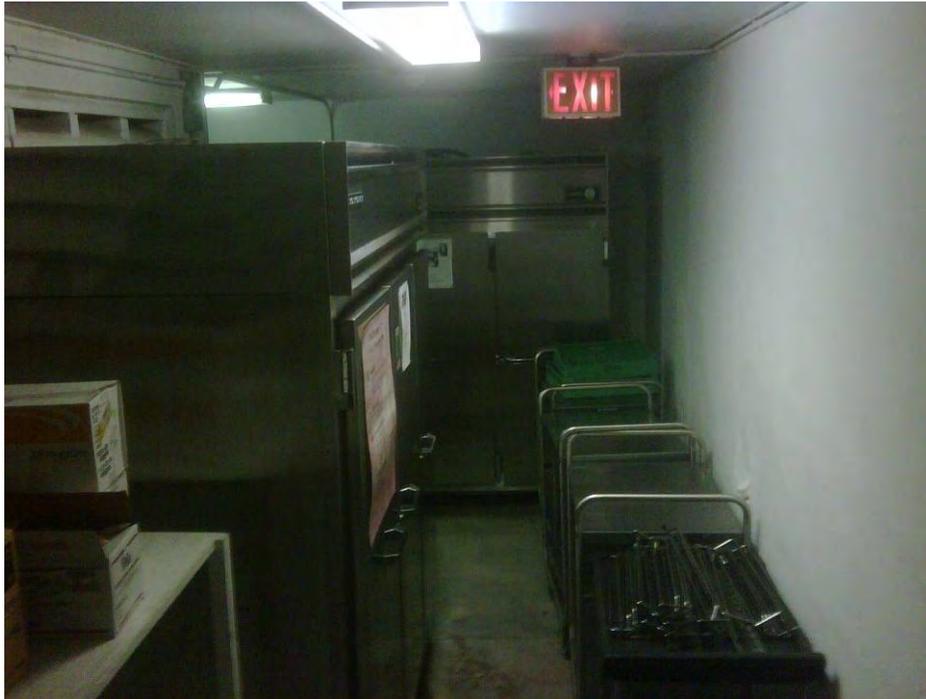
Photo 31: No suspect ACM in kitchen stores

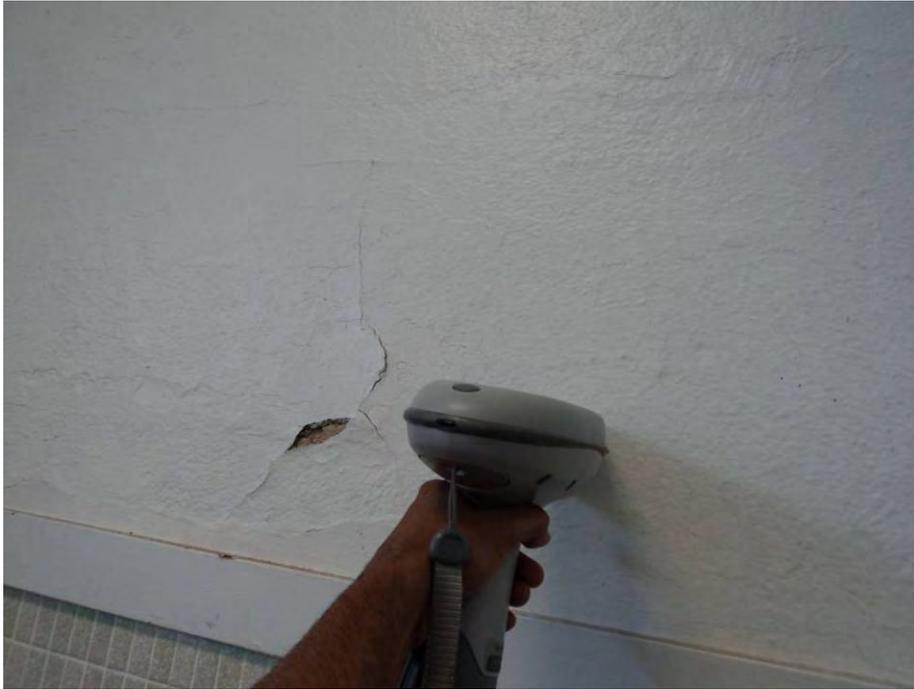
Photograph #1: Wall paint identified with LBP (XRF #15).

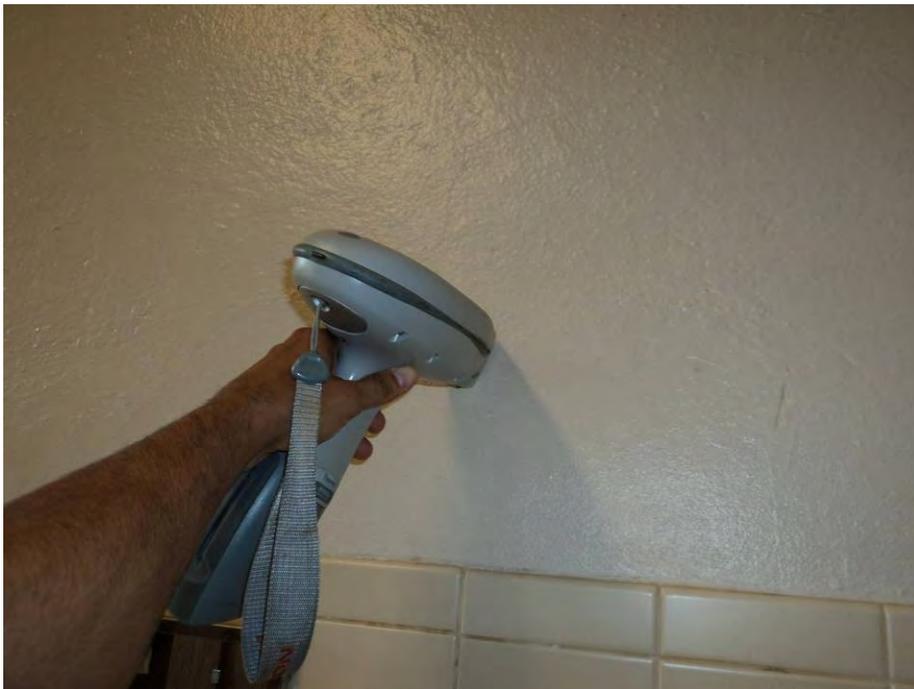
Photograph #2: Wall paint identified with LBP (XRF #25).

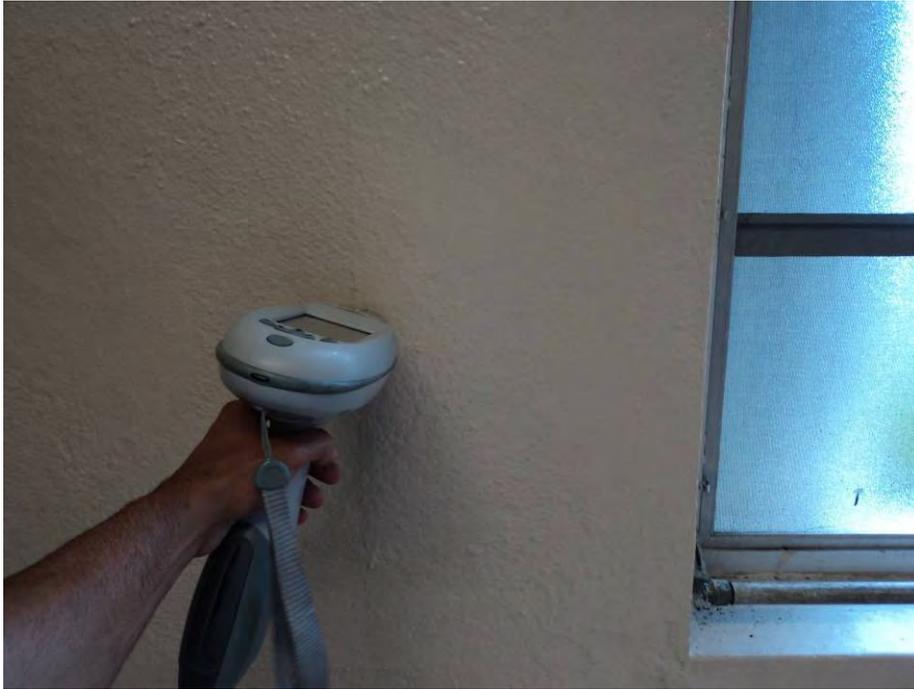
Photograph #3: Wall paint identified with LBP (XRF #28).

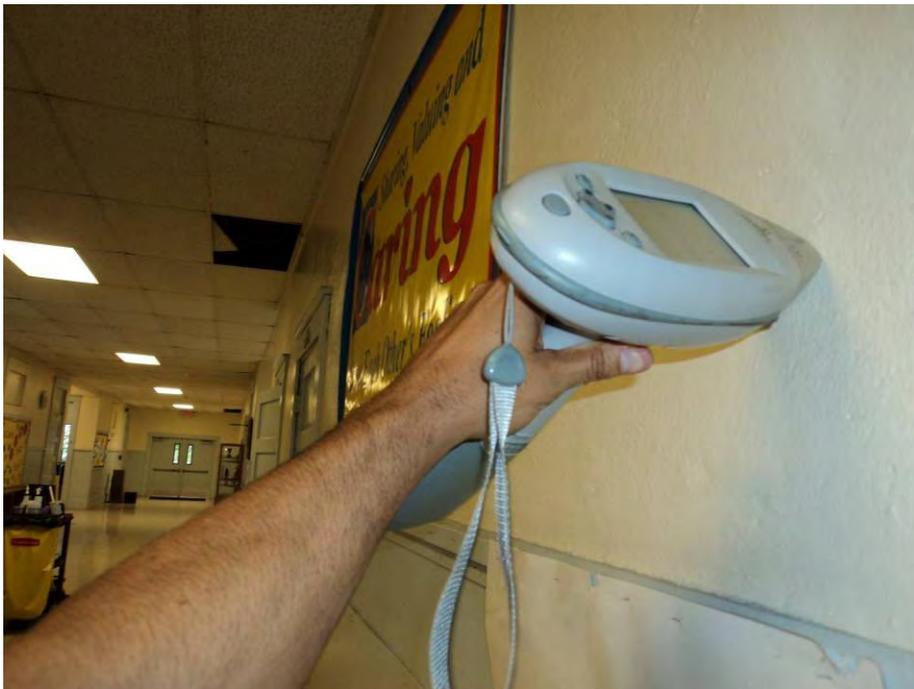
Photograph #4: Wall paint identified with LBP (XRF #43).

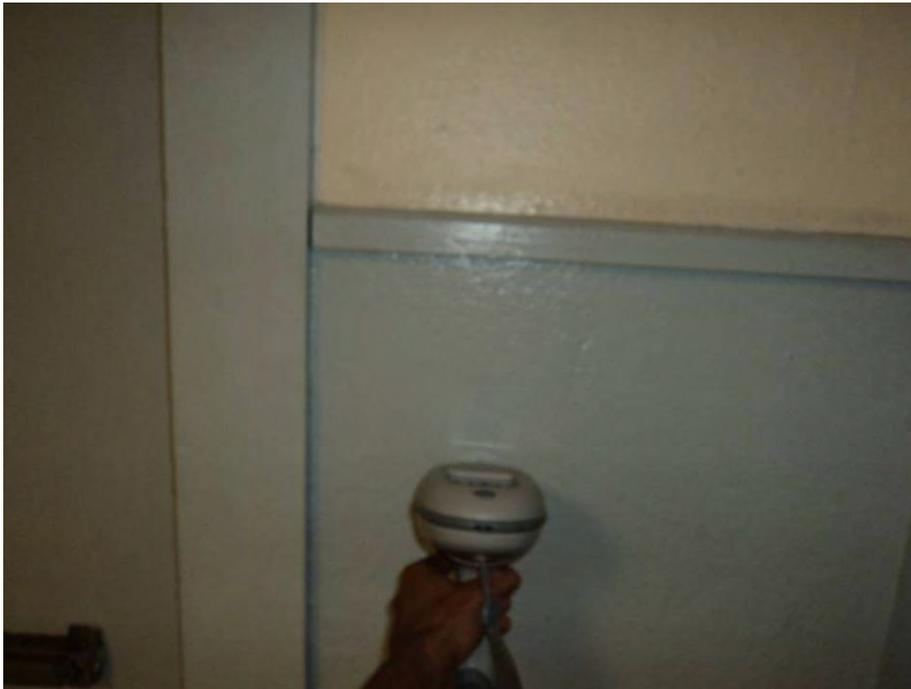
Photograph #5: Wall paint identified with LBP (XRF #39).

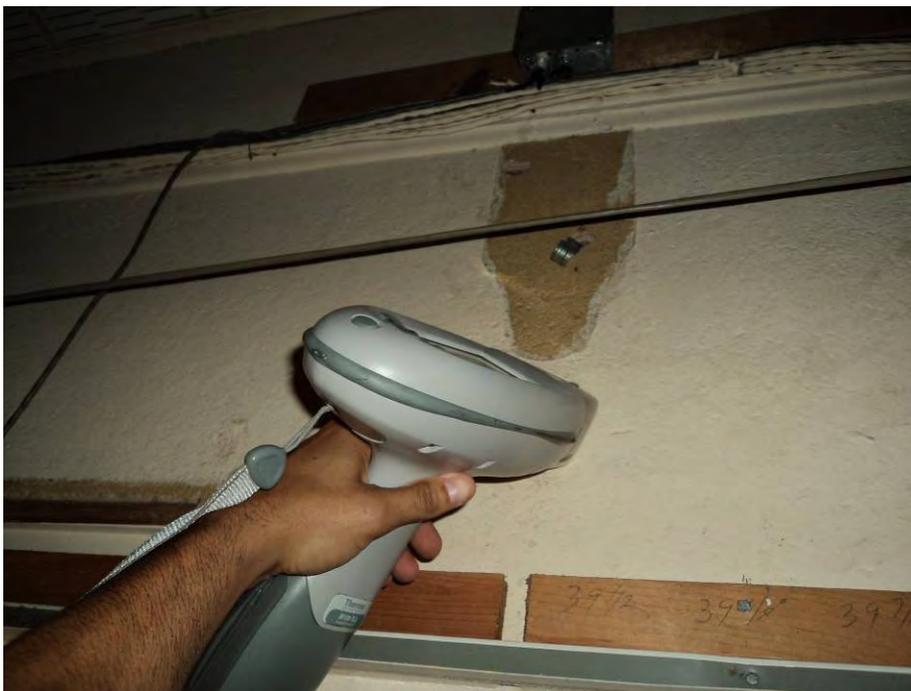
Photograph #6: Wall paint identified with LBP (XRF #113).
