**LIMITED ASBESTOS
INSPECTION SURVEY REPORT**

**GLYNN ARCHER ELEMENTARY SCHOOL COMPLEX
CITY HALL PLANNING PROJECT
1302 WHITE STREET
KEY WEST, FLORIDA 33040**

August 29, 2012
EE&G Project No. 2012-2373

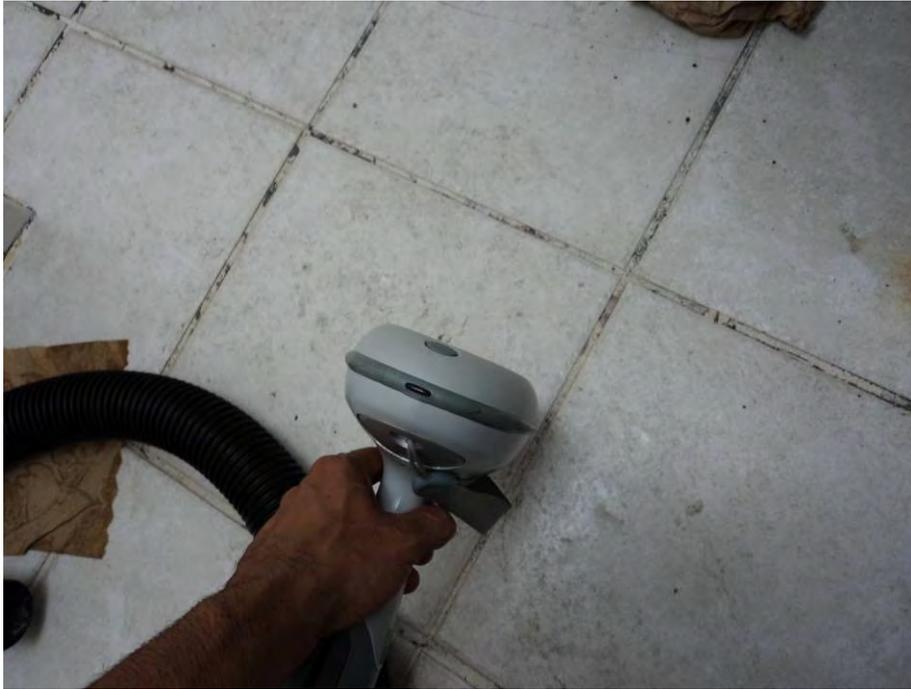
Photograph #7: Ceramic tile identified with lead during this inspection (XRF#212).

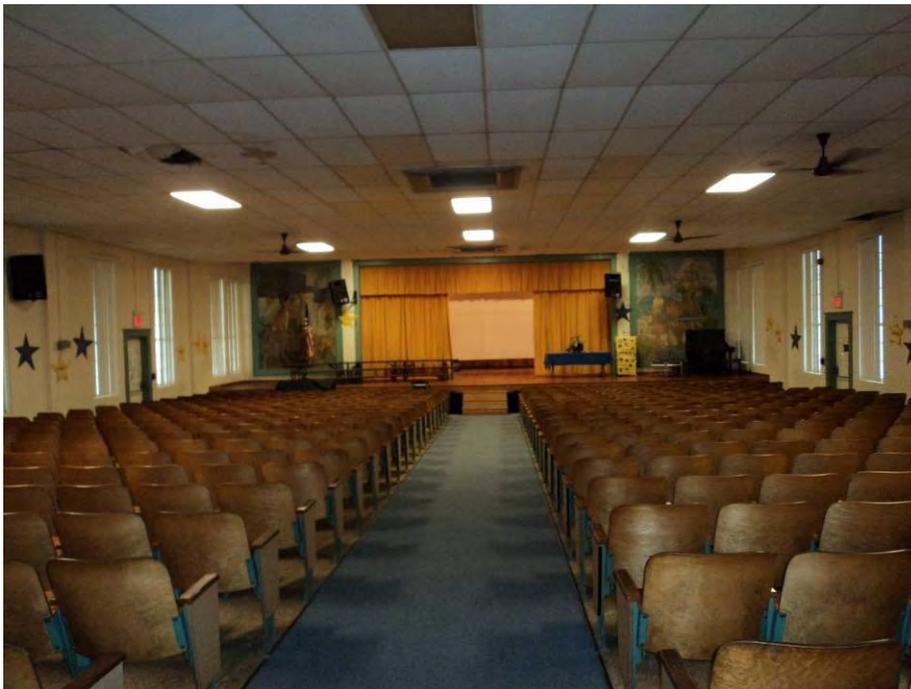
Photograph #8: Auditorium walls and columns identified with LBP during this inspection.

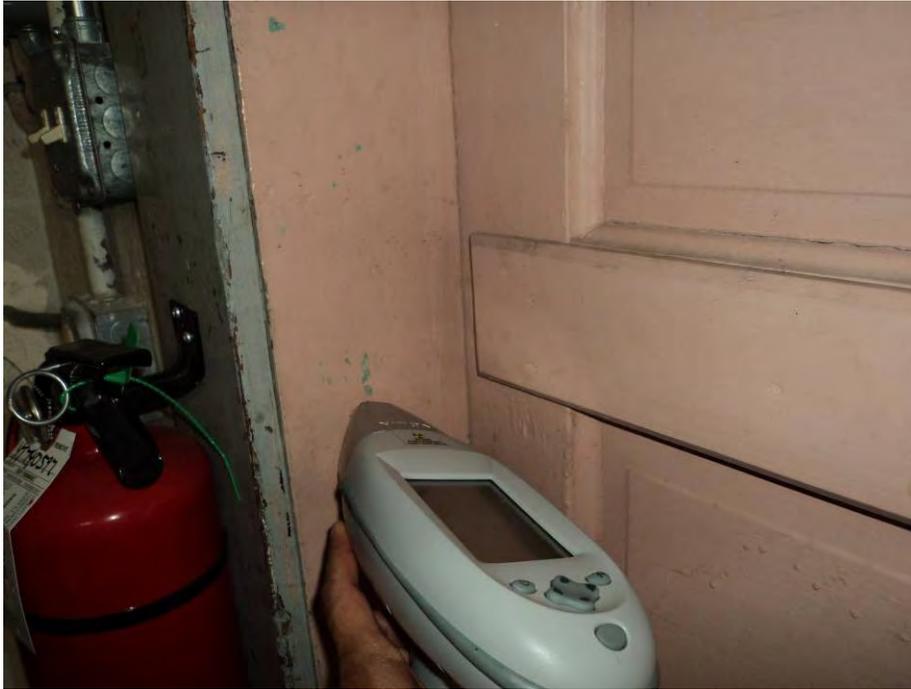
Photograph #9: Door and door casing identified with LBP during this inspection (XRF #182-183).

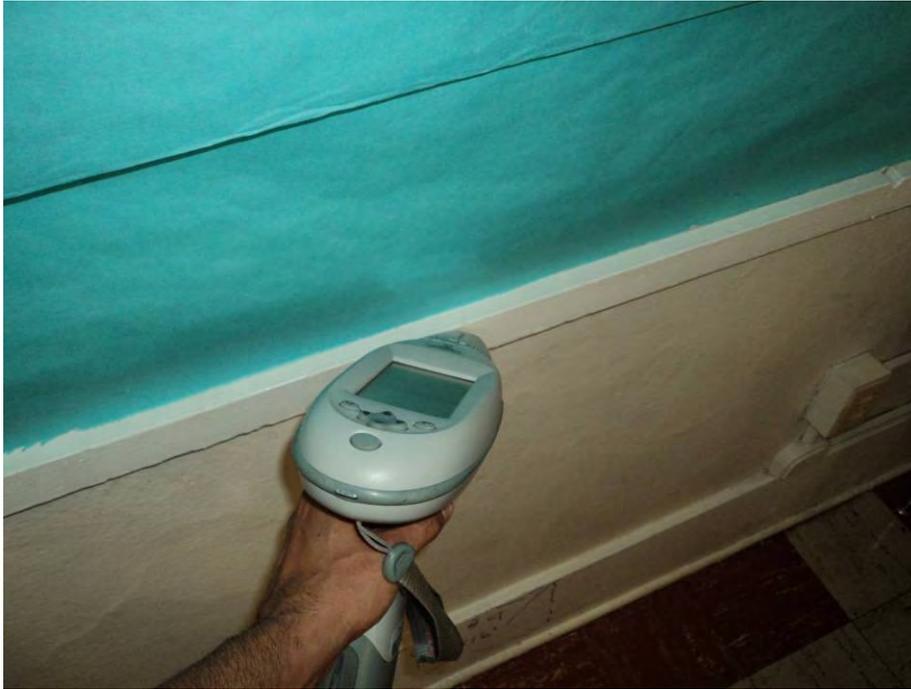
Photograph #11: LBP identified on wood trim during this inspection (XRF #256-257).

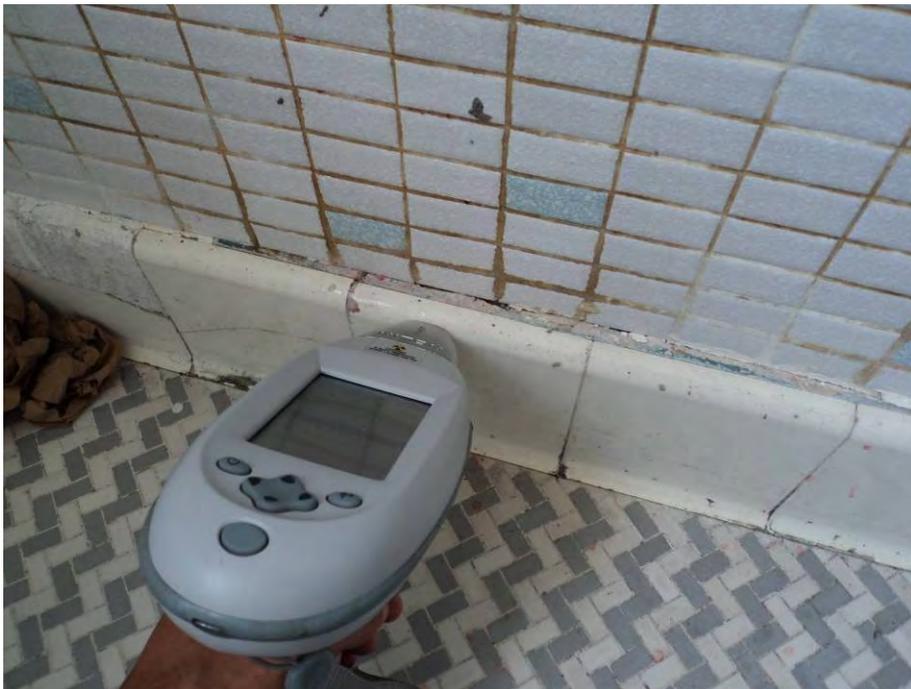
Photograph #12: Lead identified on ceramic baseboard (XRF # 272).

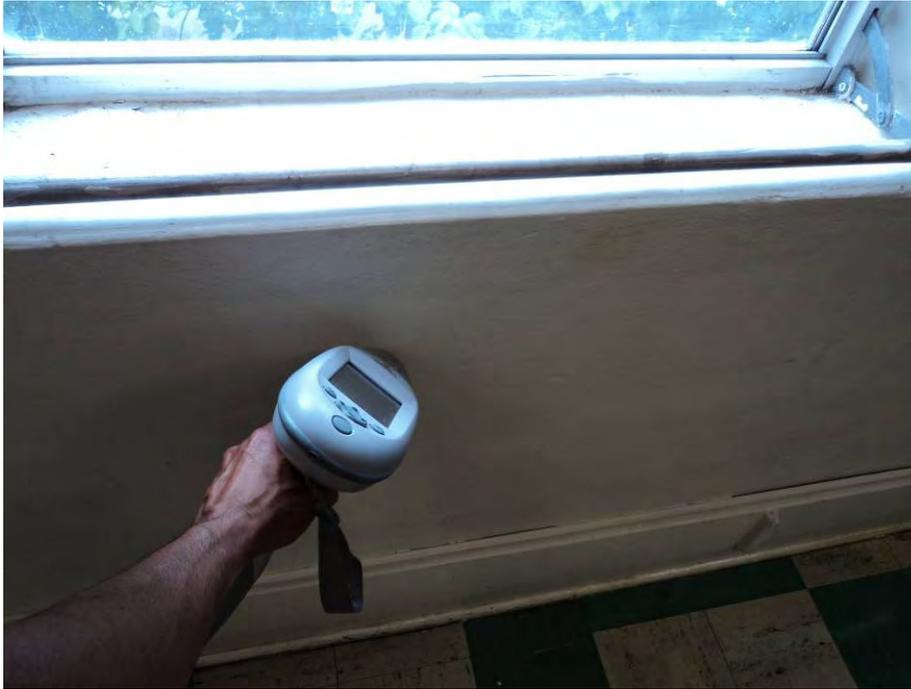
Photograph #13: LBP identified on wall during this inspection (XRF #287-288).

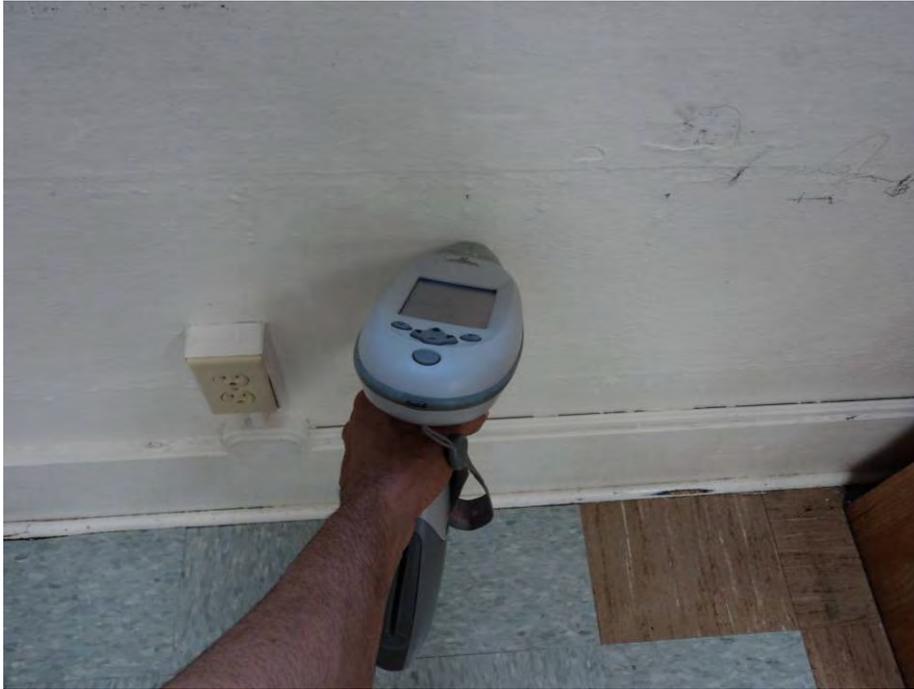
Photograph #15: LBP identified on classroom wall (XRF #368).

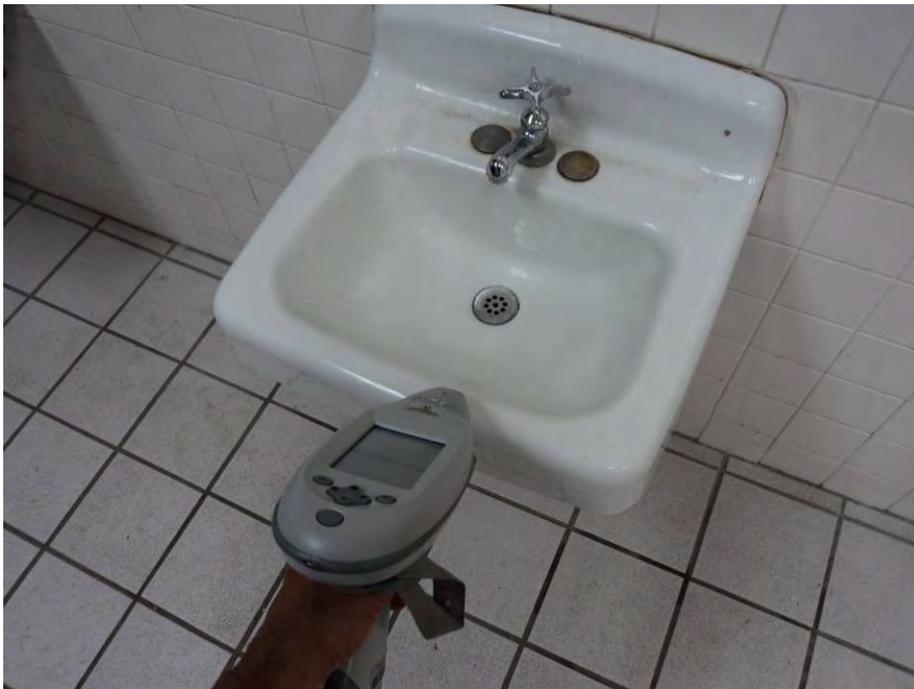
Photograph #16: Lead identified on metal sink.

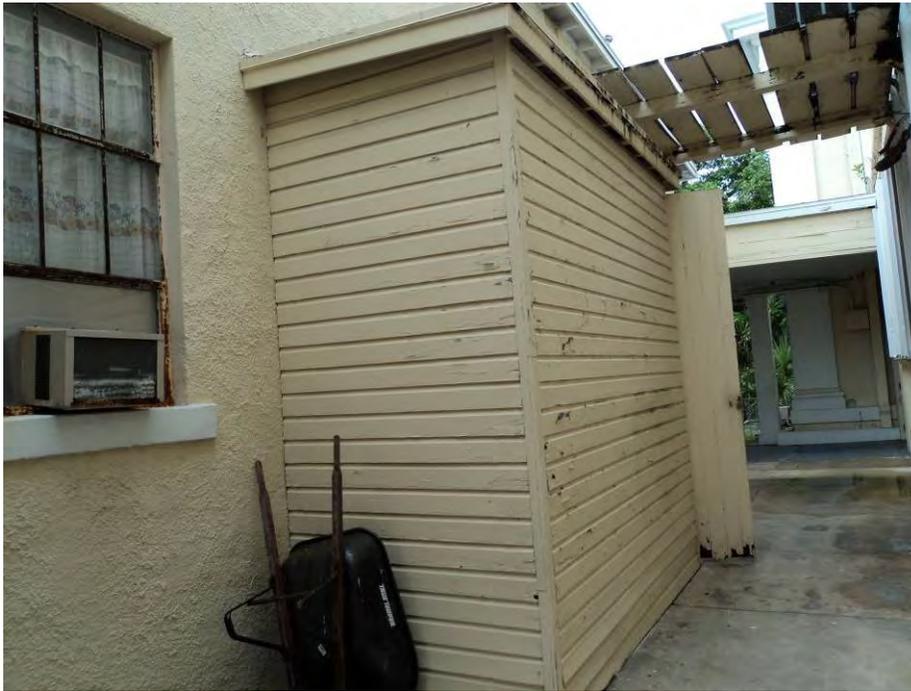
Photograph #19: LBP in poor condition identified on exterior wood shed attached to the Auditorium building (XRF #512)

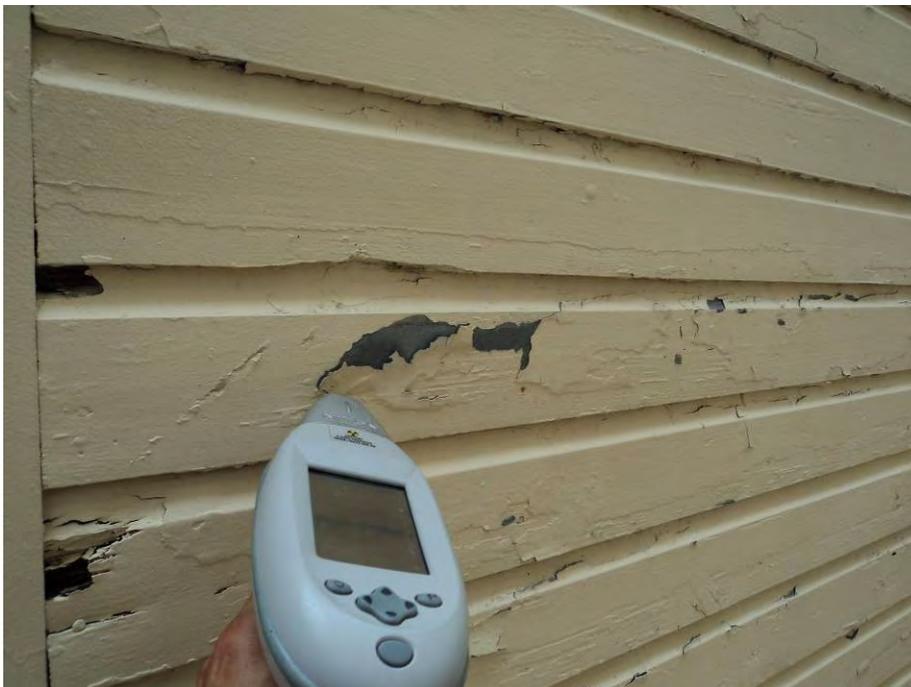
Photograph #20: LBP in poor condition identified on exterior wood shed attached to the Auditorium building (XRF #512)

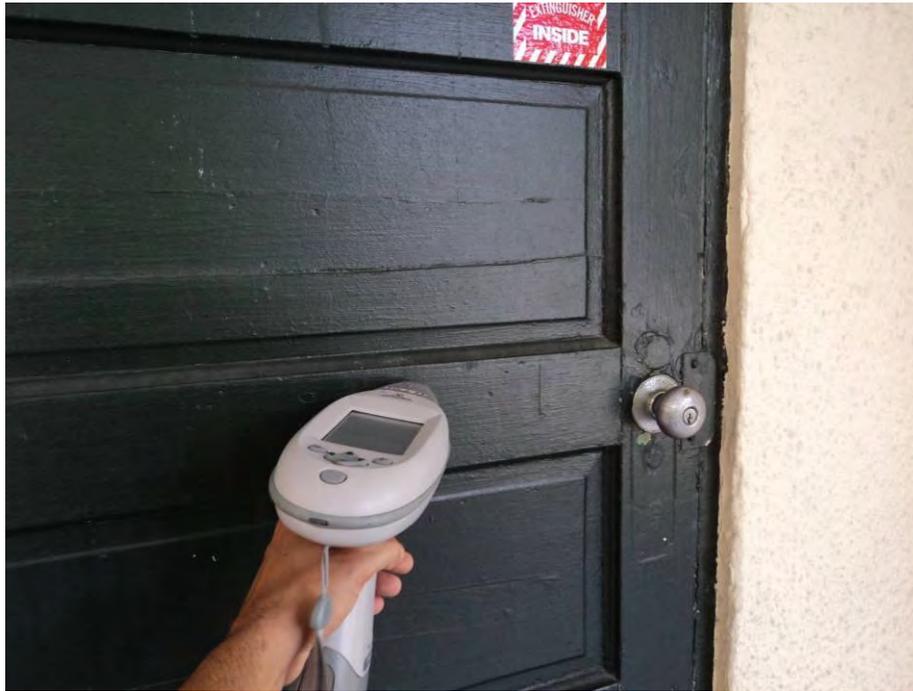
Photograph #21: Exterior door paint identified with LBP during this (XRF #504)

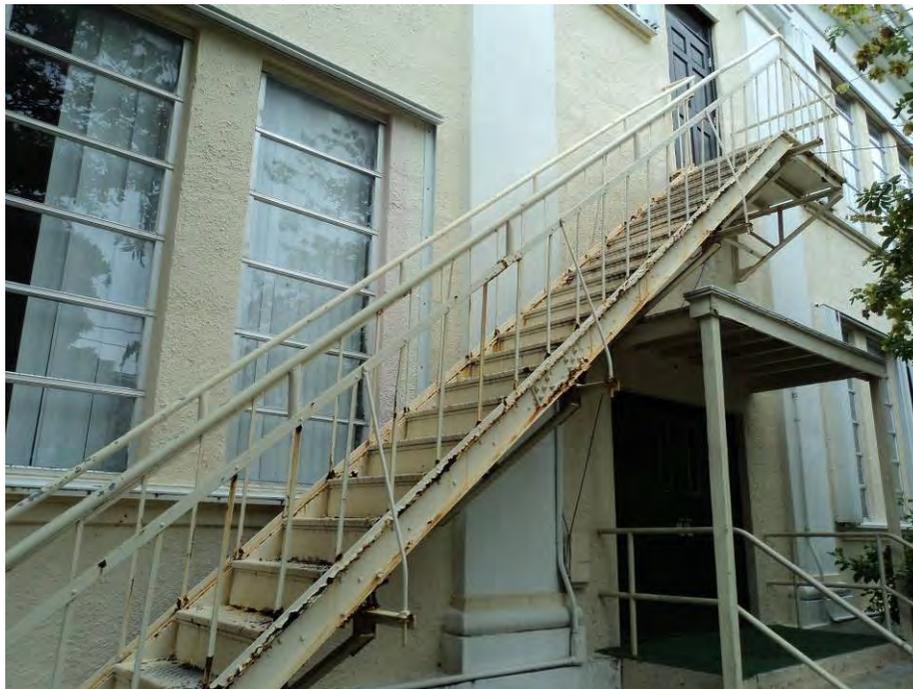
Photograph #22: Typical exterior stairwell identified with LBP during this inspection.

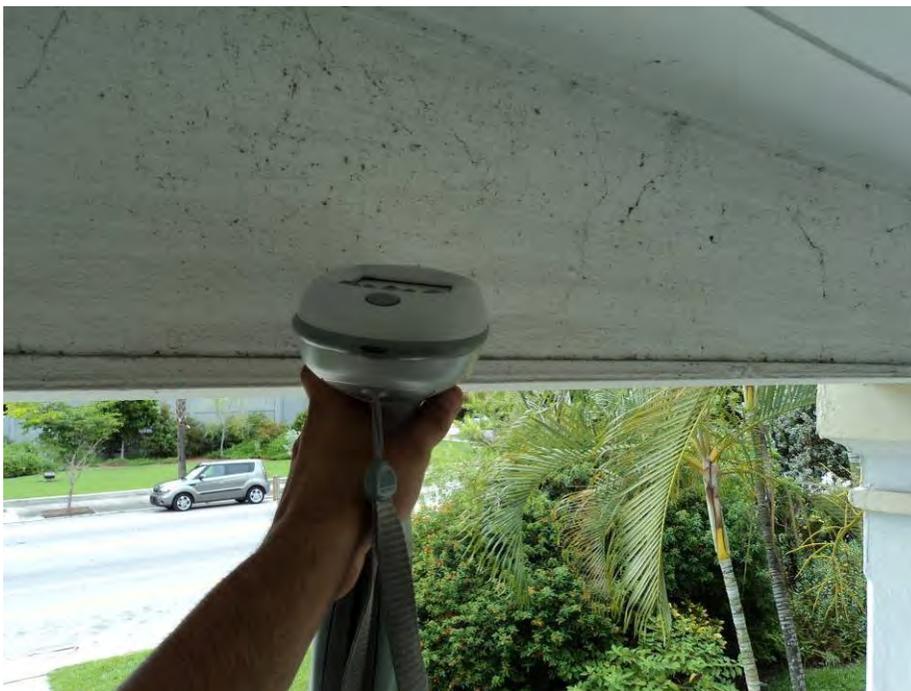
Photograph #24: Exterior wood beam paint identified with LBP during this inspection (XRF #548).
