Appendix E
I&E (Radiographic Testing)

**Re: Concrete Radiographic Examination &
Ground Penetrating Radar Investigation
Glynn Archer School
1300 White Street
Key West, FL**

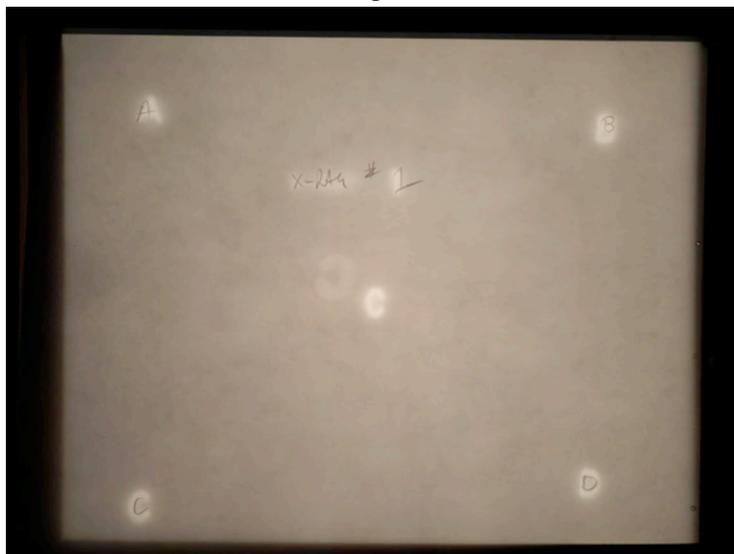
W 100 – Auditorium, First Floor, South Side

A 24” wide x 48” high area was scanned on the southeast side of column 100. The GPR scans showed no steel. A 14” x 17” radiograph was taken in the middle of the area at a height of 38.5” from the floor to the top of the film. No steel was found in the radiograph.

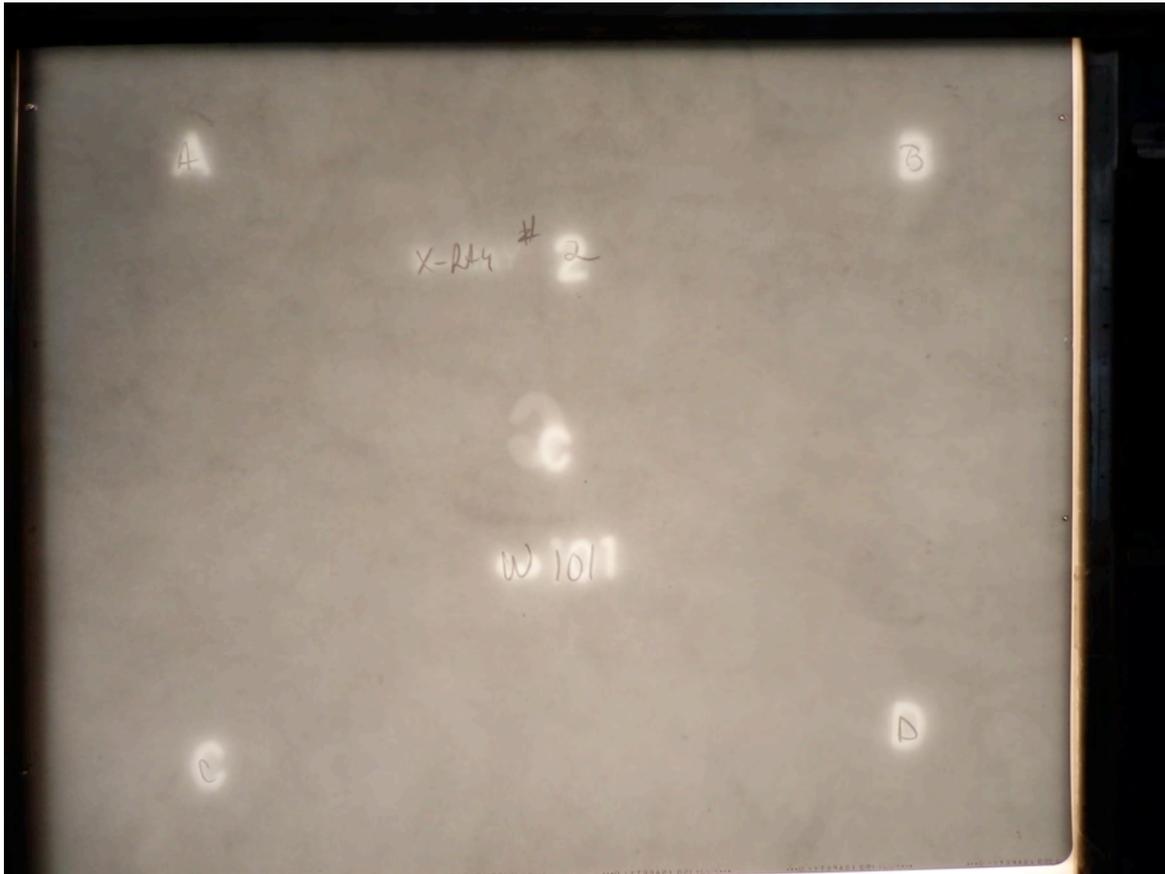
W101 – Auditorium, First Floor, South Side – X-Ray # 2

A 24” wide x 48” high area was scanned on the southwest side of column 100. The GPR scans showed no steel. A 14” x 17” radiograph was taken in the middle of the area at a height of 47” from the floor to the top of the film. No steel was found in the radiograph.

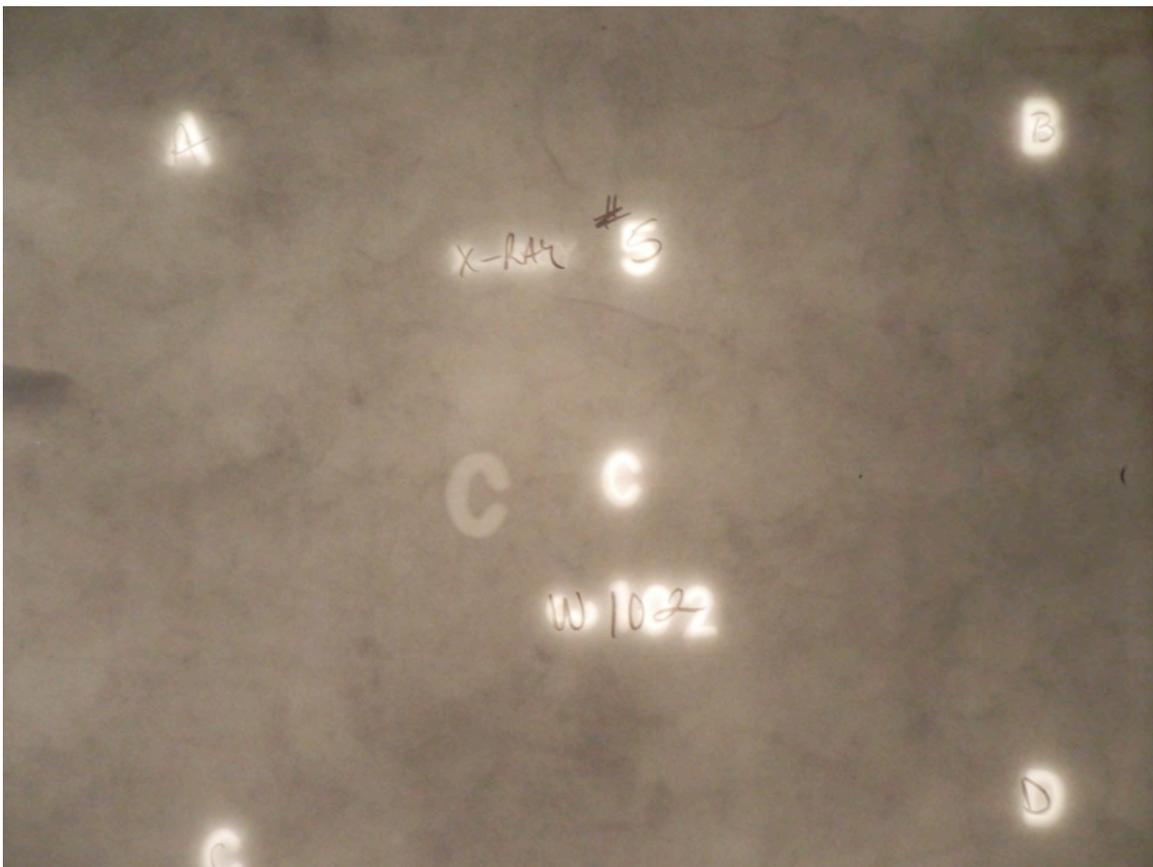
W 102 – Auditorium – First Floor – North Side – X-Ray # 5

A 24” wide x 48” high area was scanned on the west side of column 101. The GPR scans showed indications both vertical and horizontal. A 14” x 17” radiograph was taken at the intersecting points of the GPR indications at a height of 32” from the floor to the top of the film. No steel was found in the radiograph.

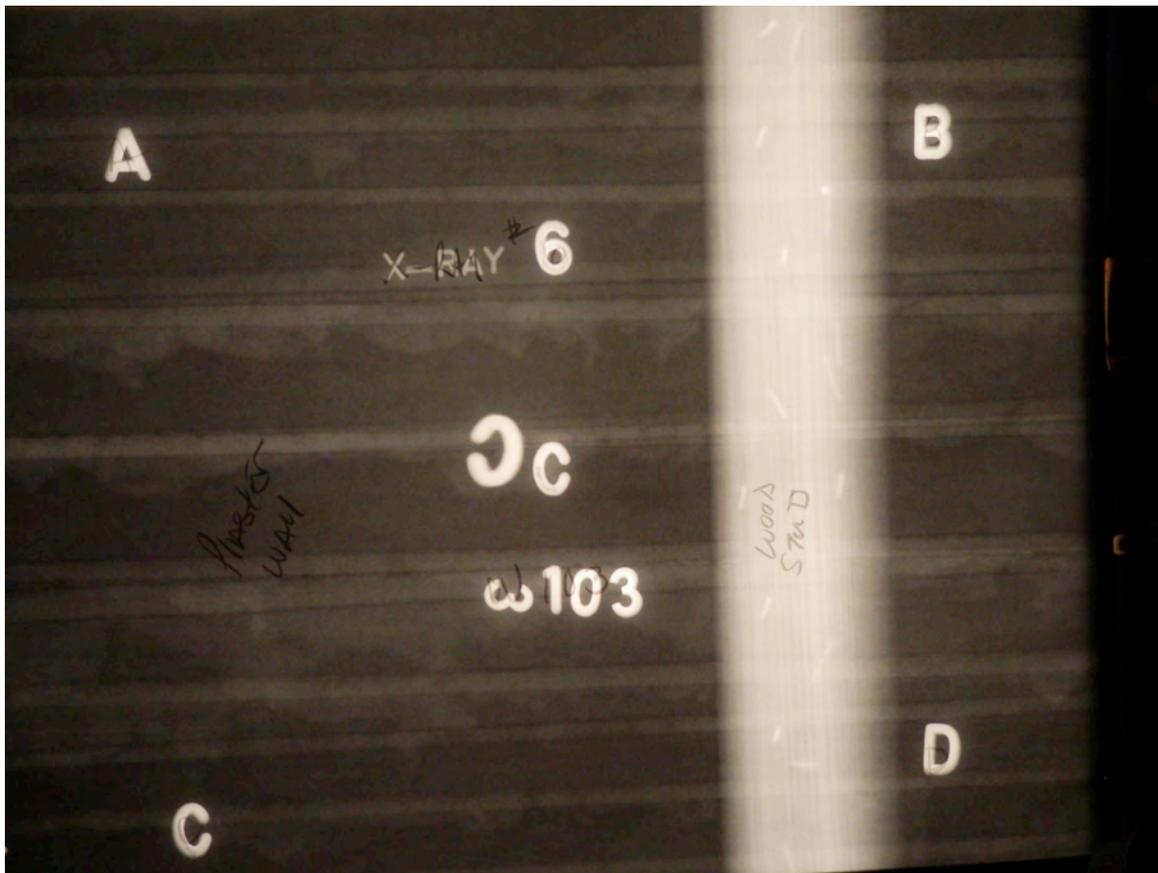
W 103 – Auditorium, First Floor – North Side – East Side Column 101 X-Ray # 6

A 24" wide x 48" high area was scanned on the east side of column 101. The GPR scans showed indications both vertical and horizontal. A 14" x 17" radiograph was taken at the intersecting points of the GPR indications at a height of 44" from the floor to the top of the film. The radiograph showed the wall to be made of wood lathing and plaster. The radiograph confirmed that the GPR indications were a pattern of nail heads.

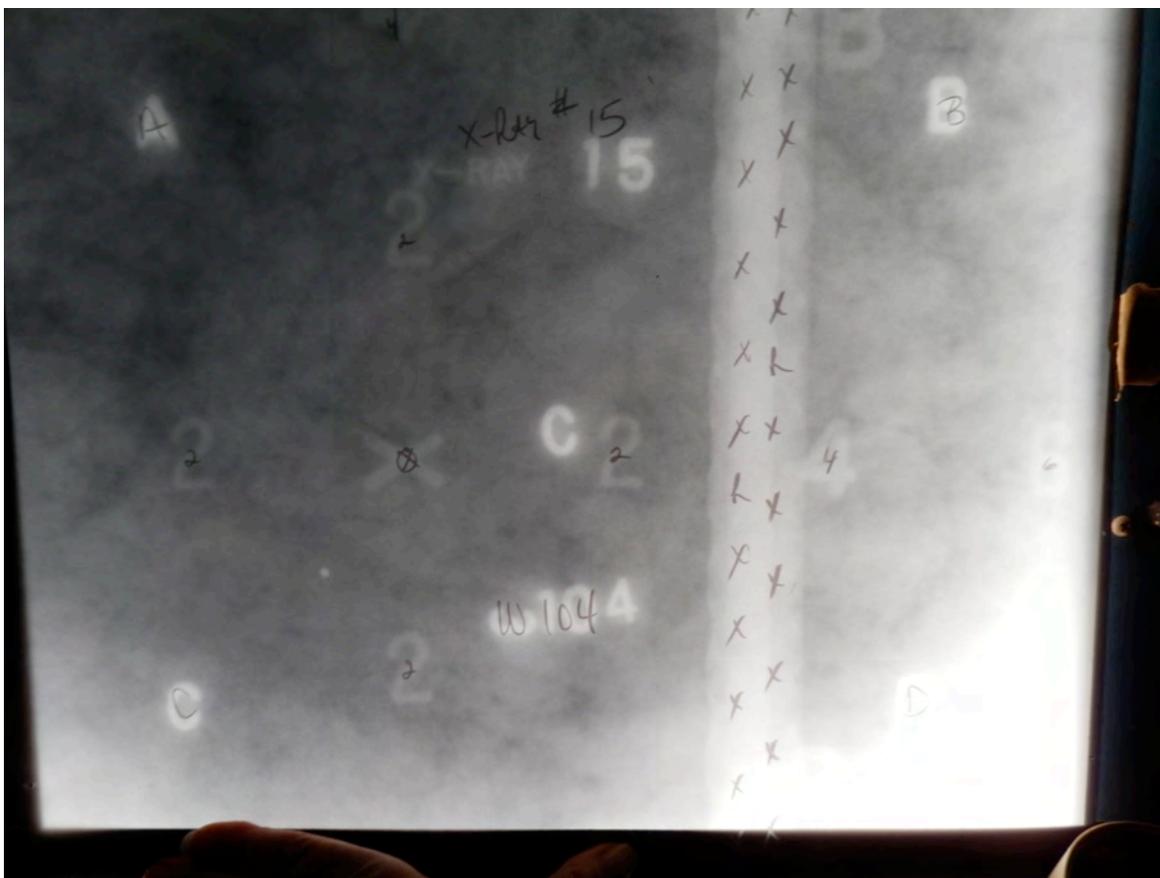
W 104 R – A - Wing, First Floor, Northeast Corner – X-Ray # 15

This area was shifted to the opposite corner due to obstructions.
A 2' high x 3' wide area was scanned southeast wall. The GPR scans showed two overlapping vertical bars at an approximate depth of 6". A 14" x 17" radiograph was taken at a height of 40" from the floor to the top of the film. The bars are deformed rebar and are estimated at 15/16" in diameter.

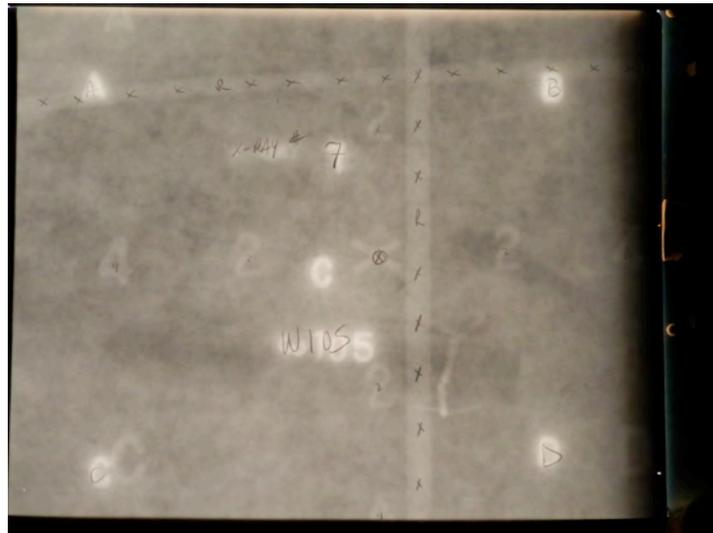
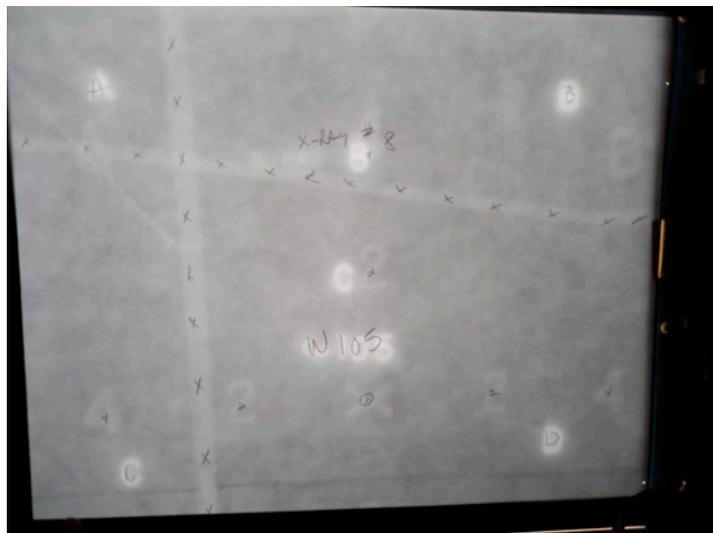
W 105 – B - Wing, First Floor, Southeast Corner

A L-shaped area of 17" high x 4' wide x 38" high was scanned. The GPR scans showed two vertical bars spaced at 26" and one horizontal bar bisecting the bar closest to the corner. These bars were at an approximate depth of 6" to 8". A 14" x 17" radiograph was taken at the bisect. The bars are deformed rebar. The vertical bar is estimated 1/4" in diameter. The horizontal bar is estimated at 1/2" in diameter.

A 2' wide x 4' high area was scanned. The GPR scans showed one vertical and one horizontal bar at an approximate depth of 6" to 8". A 14" x 17" radiograph was taken at the bisect. The bars are deformed rebar. The vertical bar is estimated 1/4" in diameter. The horizontal bar is estimated at 1/2" in diameter.

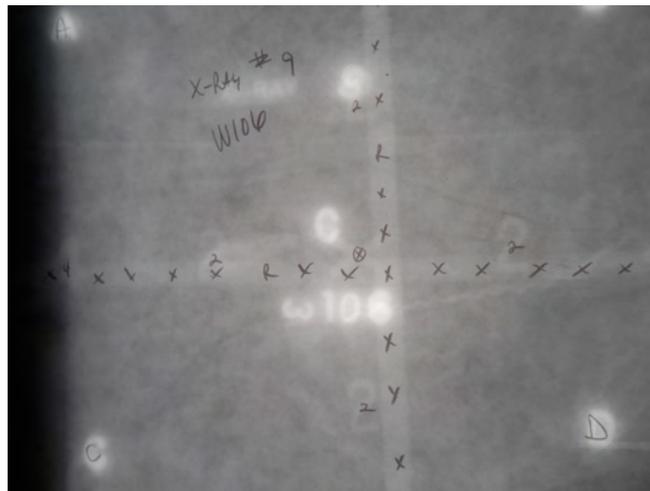
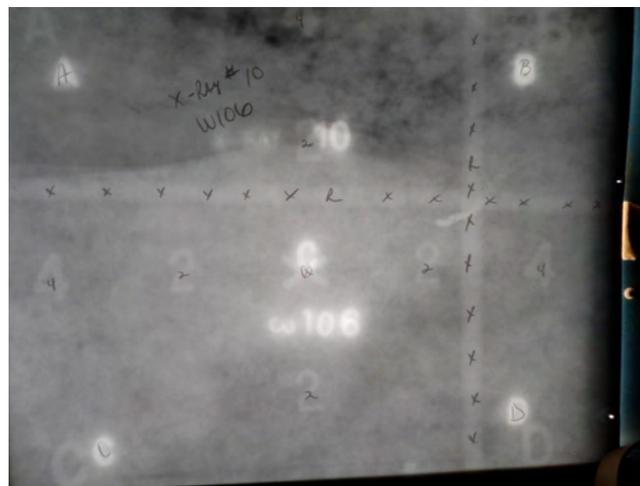
W 106 R – B - Wing, First Floor, Southeast Corner – X-Rays # 8 & # 10

This area was shifted from room 104 to room 109 due to obstructions.

A area of 36" high x 30" wide was scanned on the southeast wall of the corner. The GPR scans showed one vertical and one horizontal bar. These bars were at an approximate depth of 4" to 8". A 14" x 17" radiograph was taken at the bisect. The bars are deformed rebar. The vertical bar is estimated $\frac{1}{2}$ " in diameter. The horizontal bar is estimated at $\frac{5}{16}$ " in diameter.

A 2' wide x 4' high area was scanned on the northwest wall of the corner. The GPR scans showed one vertical and one horizontal bar at an approximate depth of 8" to 9". A 14" x 17" radiograph was taken at the bisect. The bars are deformed rebar. The vertical bar is estimated at $\frac{1}{2}$ " in diameter. The horizontal bar is estimated $\frac{5}{16}$ " diameter.

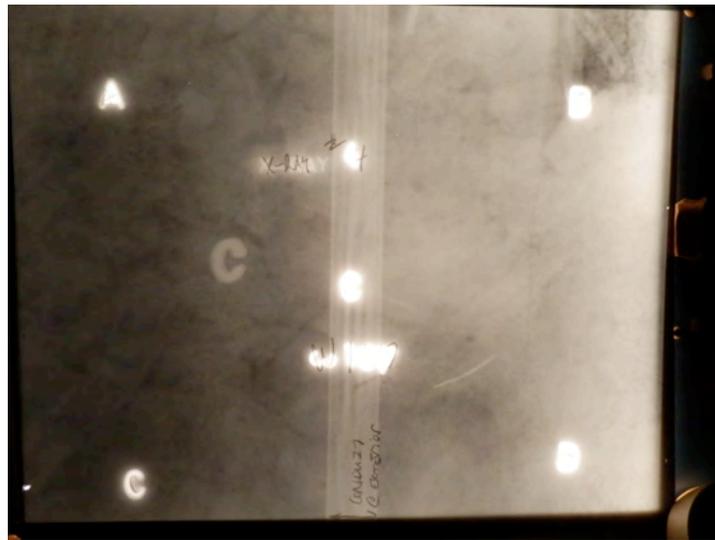
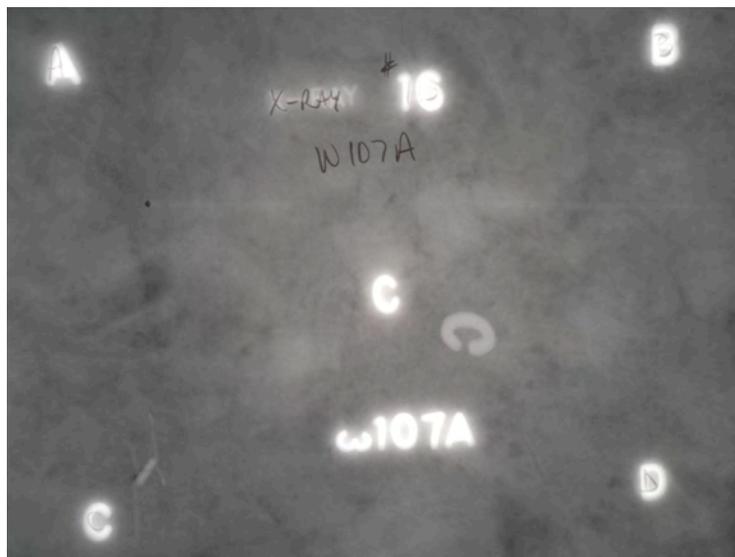
107 Auditorium, First Floor, West Side, Backstage – X-Rays # 4 & # 16

A 5' high x 9' wide area was scanned. The GPR scans showed indications. Two 14" x 17" radiographs were taken at a height of 70" and 65" from the floor to the top of the film. The radiographs showed no steel bars, one radiograph shows exterior conduit.

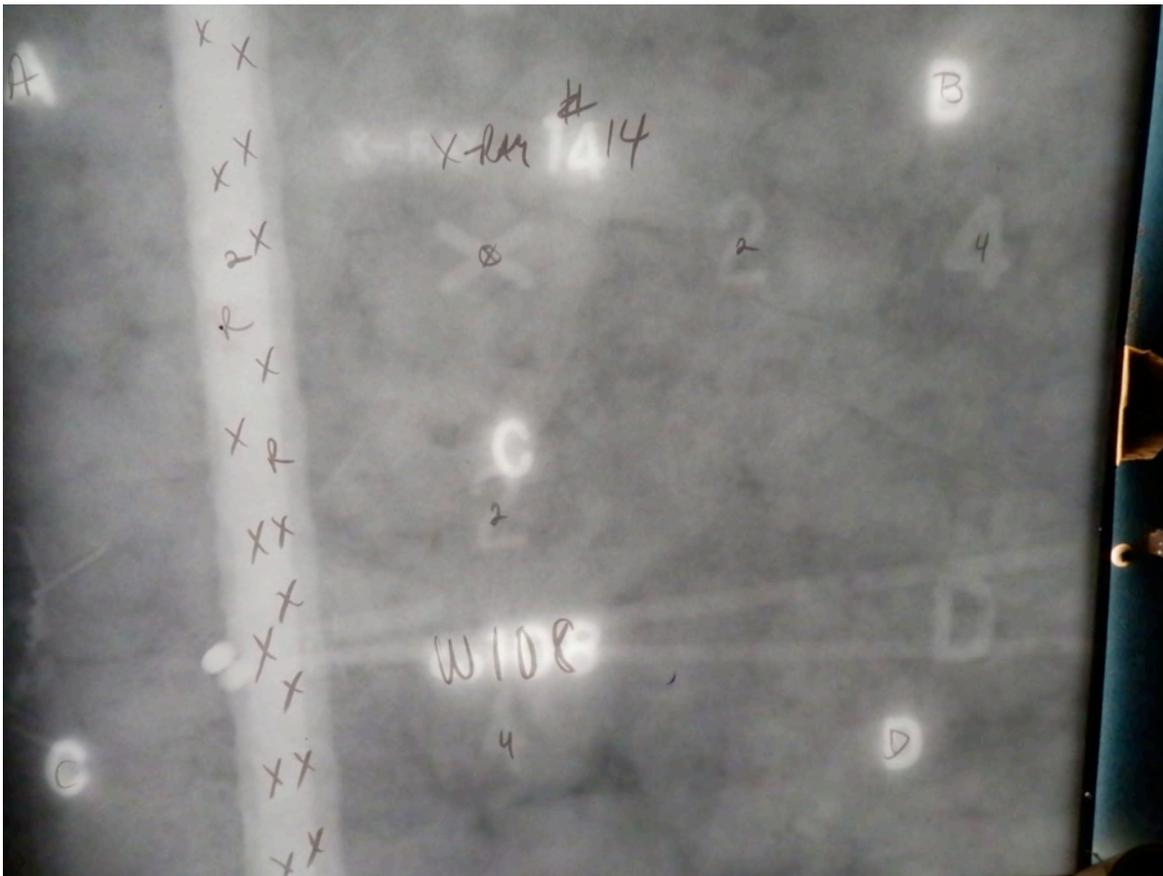
W 108 A - Wing, First Floor, Northwest Corner – X-Ray # 14

A L-shaped area 6' wide x 18" high and 4' high x 3' wide were scanned on the southwest wall. The GPR scans showed three vertical indications at an approximate depth of 6" and spacing at 7". A 14" x 17" radiograph was taken at a height of 34" from the floor to the top of the film. The radiograph shows two overlapping deformed rebar, estimated at 3/4" in diameter.

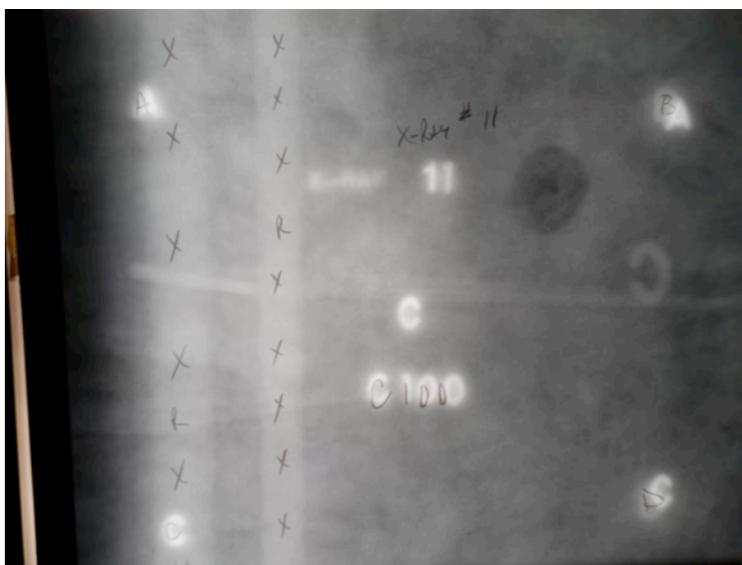
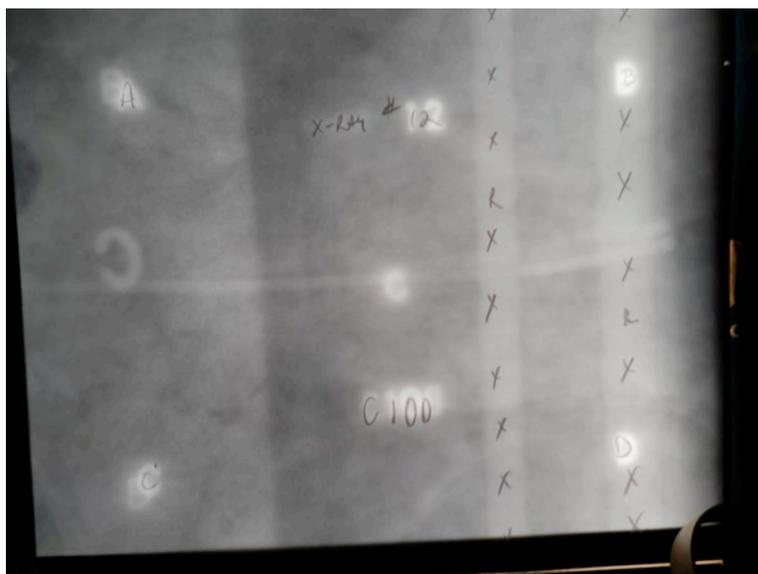
C 100 Auditorium, First Floor, South Side – X-Rays # 11 & 12

A 4' high x 2'-1" wide area was scanned. The GPR scans showed vertical and horizontal indications. Two 14" x 17" radiographs were taken across the width of the column, at a height of 66.5" from the floor to the top of the film. The radiographs show two vertical, deformed rebar, at an approximate 6" depth and approximately 5" in from each side of the column. The diameter of the rebar is estimated at 1" in diameter.

The one horizontal indication is at a depth of approximately 6" at a height of 17" from the floor.

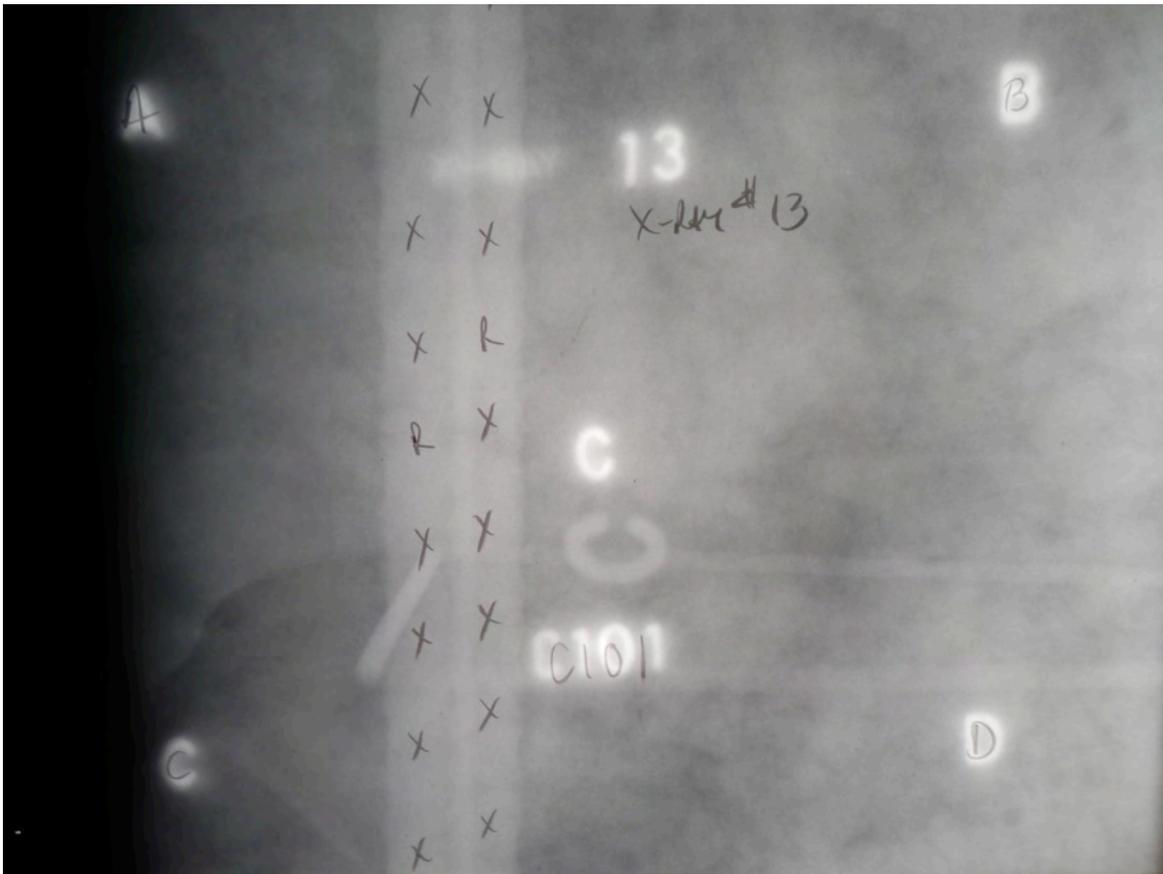
C 101 Auditorium, First Floor, North Side – X-Ray # 13

A 4' high x 2' wide area was scanned. The GPR scans showed a vertical indication. Two 14" x 17" radiographs were taken across the width of the column, at a height of 48" from the floor to the top of the film. The radiographs show two vertical, deformed rebar, at an approximate 6" depth. These rebar are side by side and approximately 5" in from the west side of the column. The diameter of the rebar is estimated at 1" in diameter.

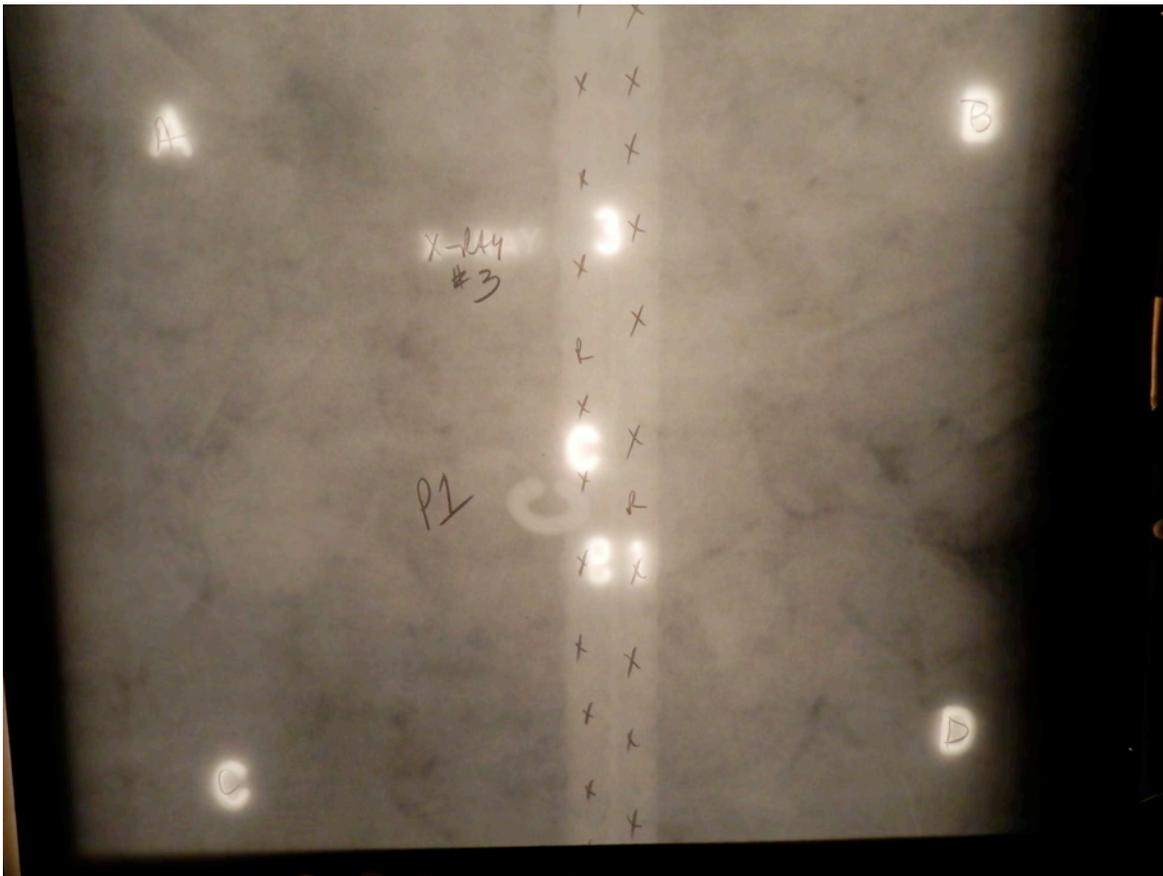
P 1 Auditorium, First Floor, South Side, Between Windows – X-Ray # 3

A 4' high x 2' wide area was scanned. The GPR scans showed two vertical indications. Two 14" x 17" radiographs were taken across the width of the column, at a height of 58" from the floor to the top of the film. The radiographs show two vertical, deformed rebar, at an approximate 3" depth. These rebar are side by side and are on center. The diameter of the rebar is estimated at 1/2" in diameter.

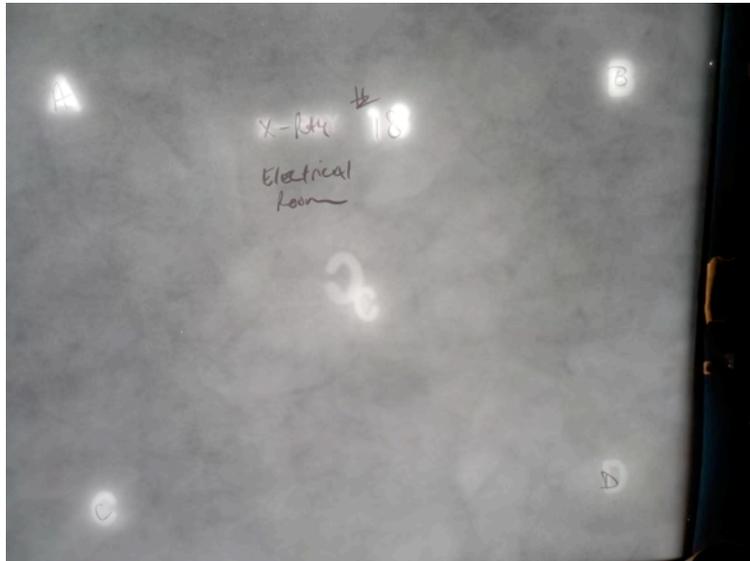
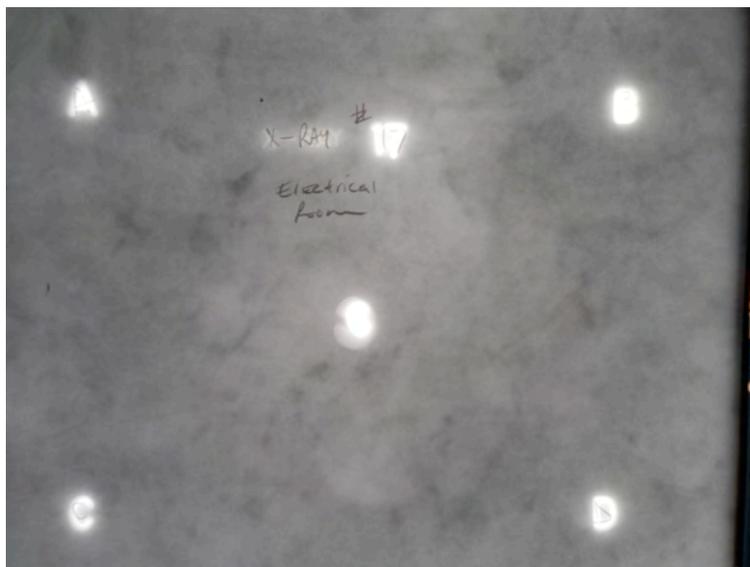
Electrical Room, West Side of Stage, West Corner – X-Ray # 17 & 18

No GPR Scans were performed in the electrical room. As directed by Andy Chan, P.E., two radiographs were taken in the west corner on either wall spaced 12" apart in height. The radiographs showed no steel.
