**PRE-DEMOLITION
REMOVAL OF NONFRIABLE
ASBESTOS-CONTAINING
FLOORING AND ROOFING MATERIALS**

**GLYNN ARCHER ELEMENTARY SCHOOL COMPLEX
(CITY HALL PLANNING PROJECT)
1302 WHITE STREET
KEY WEST, FLORIDA 33040**

September 24, 2013
EE&G Project Number 2012-2373

**GLYNN ARCHER ELEMENTARY SCHOOL
PRE-DEMOLITION ABATEMENT
SCOPE OF WORK**

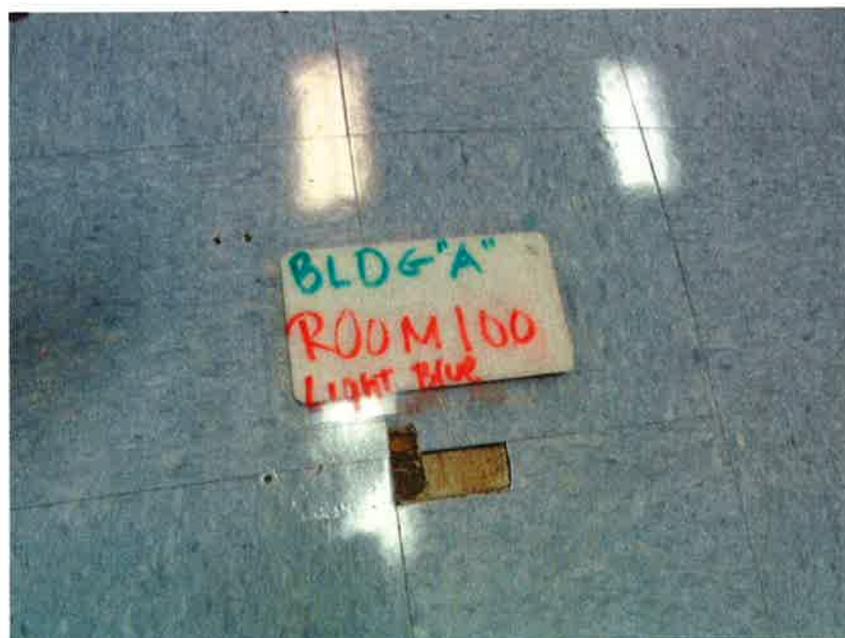
Photo 2: ACM VFT under nonACM VFT in A-100

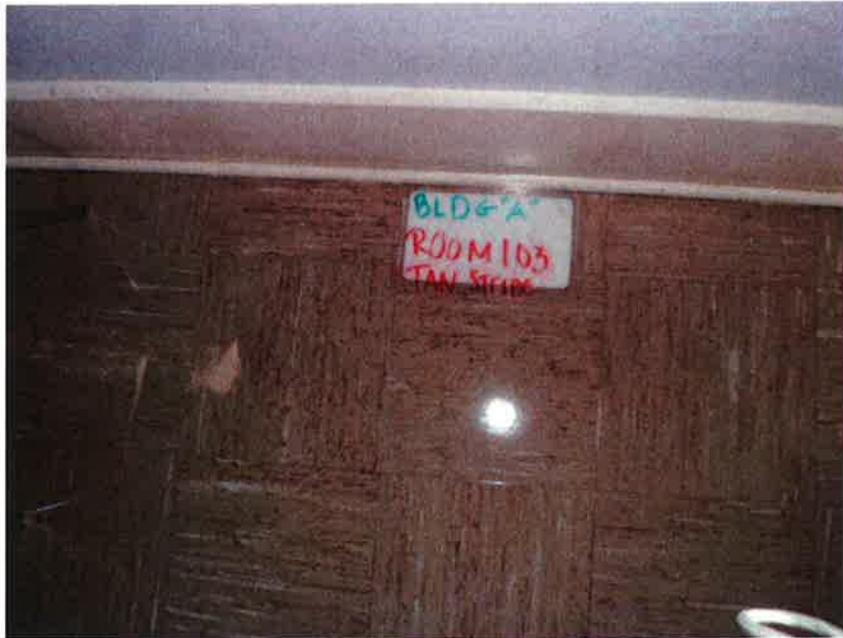
Photo 3: ACM VFT under VFT in A-103

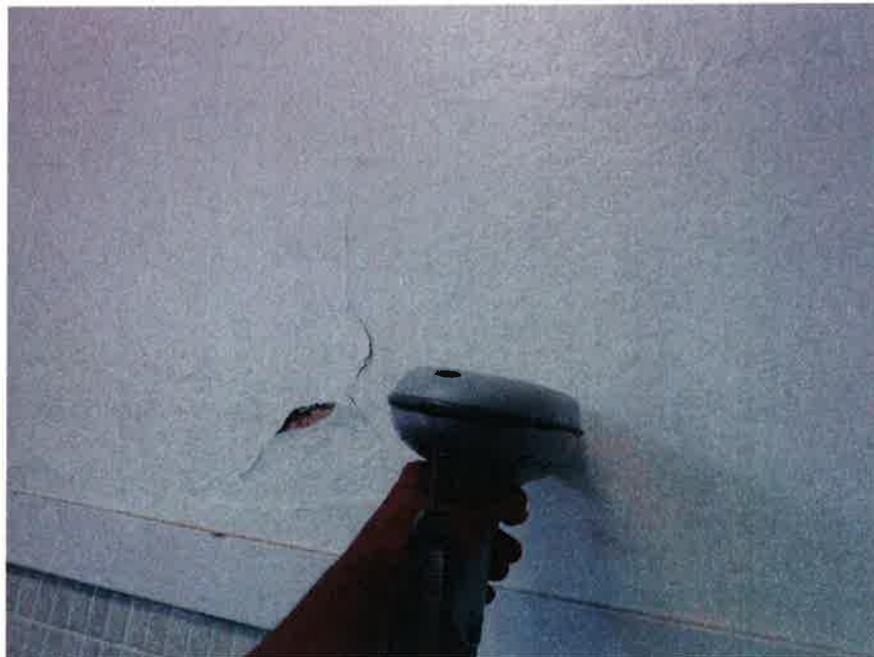
DESCRIPTION: **Wall paint**
LOCATION: **Bathroom room 122, 124**
COLOR: **Beige top layer**
XRF NUMBER: **Page #1, XRF #15-17, 25-28**
CONDITION: **Intact – Not intact**

Photograph #1: Wall paint identified with LBP (XRF #15).

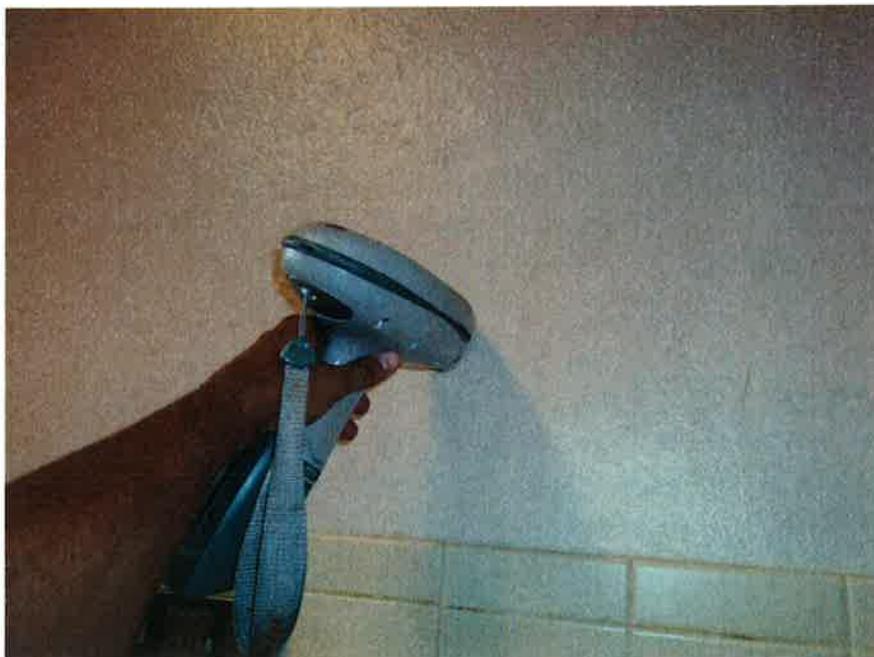
Photograph #2: Wall paint identified with LBP (XRF #25).

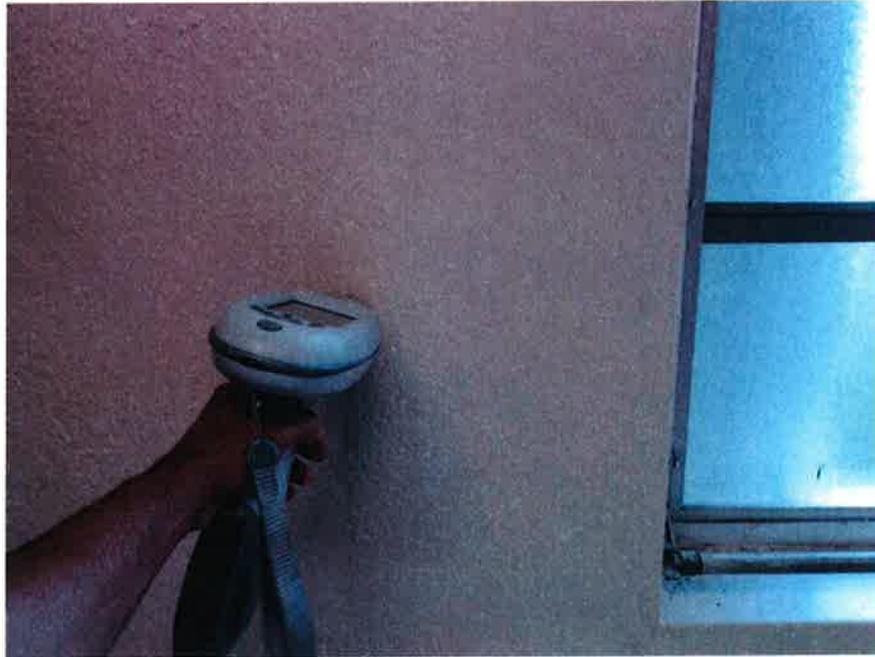
Photograph #3: Wall paint identified with LBP (XRF #28).

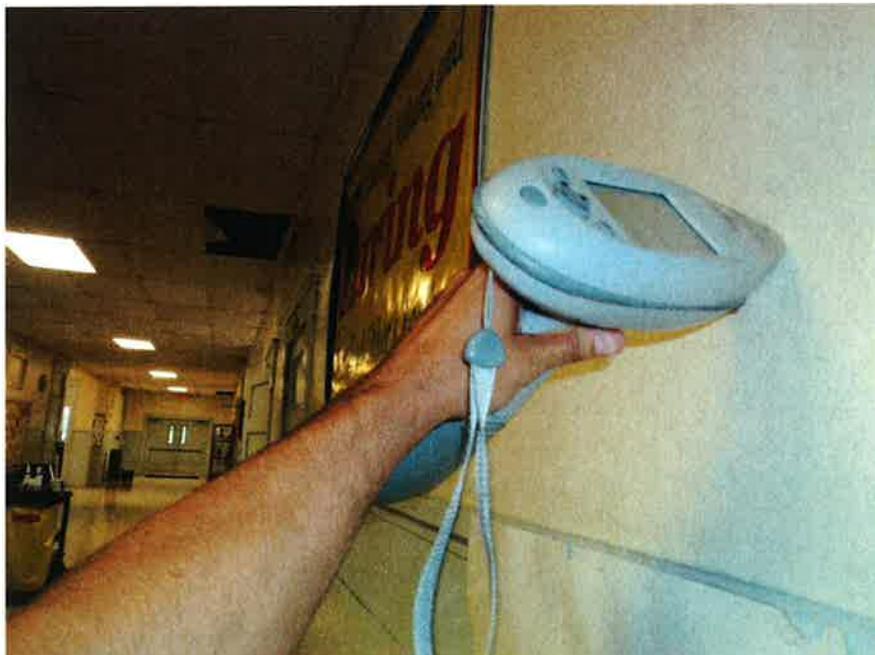
DESCRIPTION: **Wall paint**
LOCATION: **Corridor floor 1**
COLOR: **Blue & beige top layer**
XRF NUMBER: **Page #2, XRF #39-40, 43-45, 50-51**
CONDITION: **Intact**

Photograph #4: Wall paint identified with LBP (XRF #43).

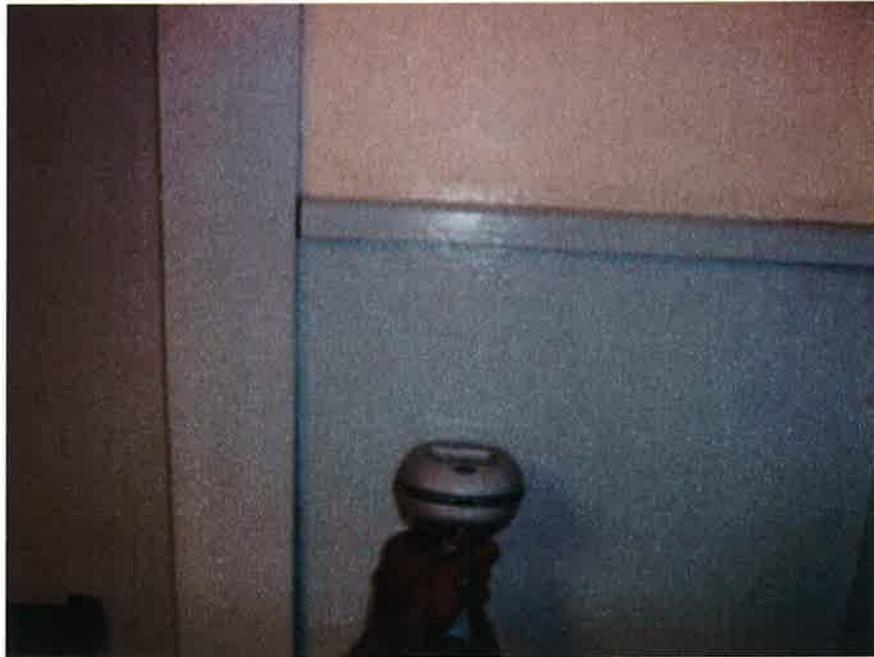
Photograph #5: Wall paint identified with LBP (XRF #39).

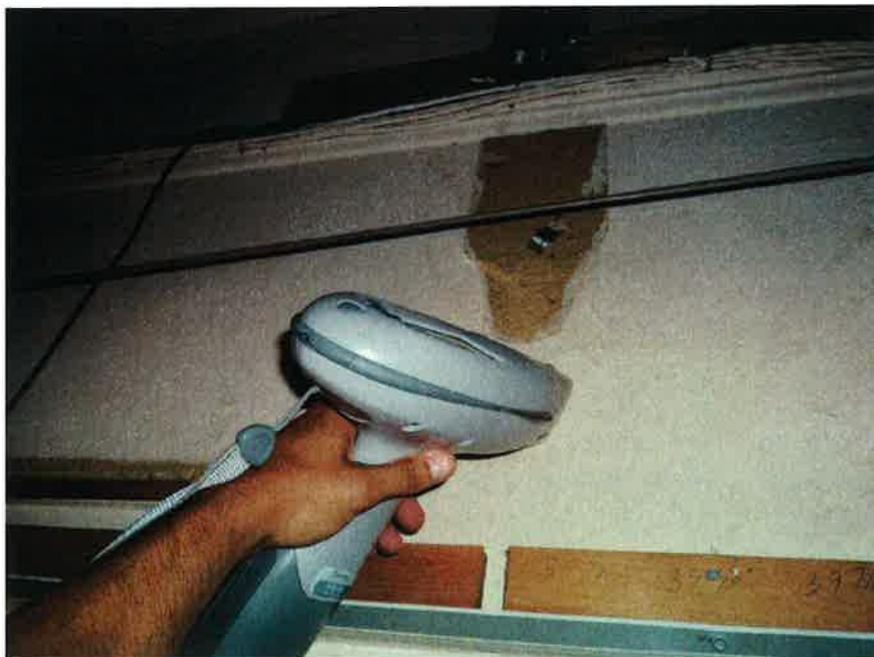
DESCRIPTION: **Wall paint**
LOCATION: **Class room 203**
COLOR: **Beige top layer**
XRF NUMBER: **Page #4, XRF# 113-114**
CONDITION: **Intact**

Photograph #6: Wall paint identified with LBP (XRF #113).

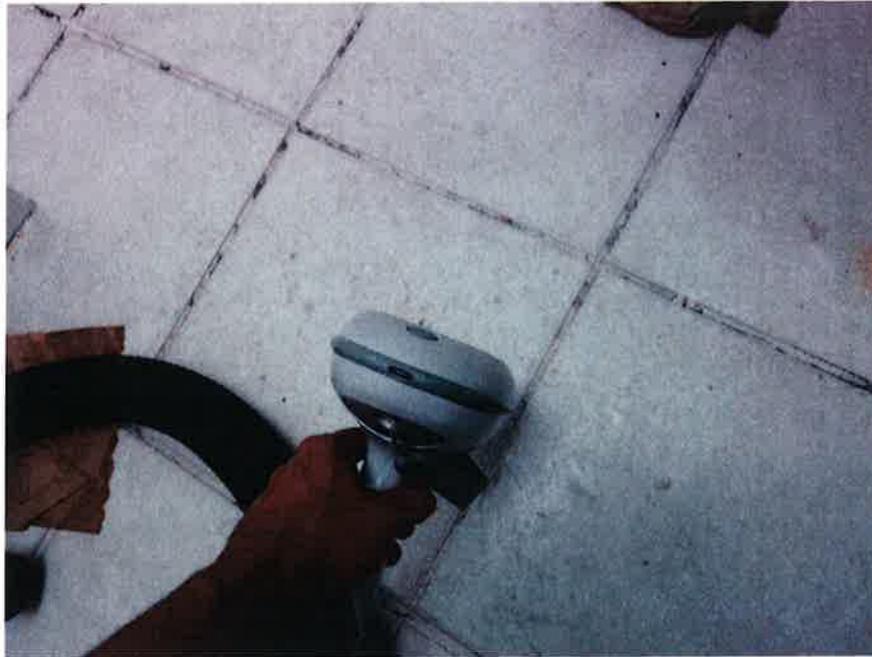
Photograph #7: Ceramic tile identified with lead during this inspection (XRF#212).

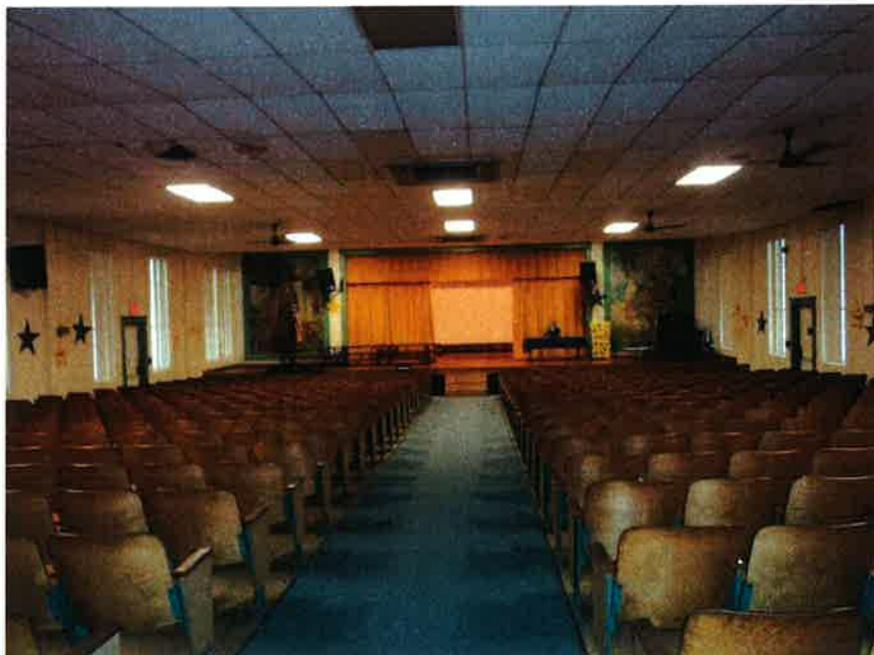
DESCRIPTION: Wall paint
LOCATION: Auditorium 117
COLOR: Beige top layer
XRF NUMBER: Page #5 & 6, XRF# 162, 164-165, 174
CONDITION: Intact- Not intact

Photograph #8: Auditorium walls and columns identified with LBP during this inspection.

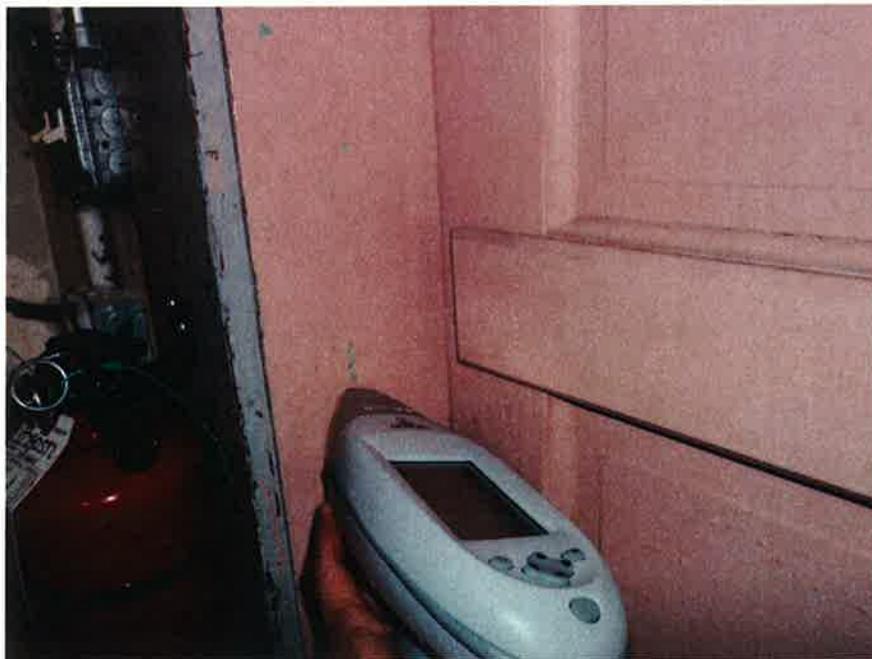
DESCRIPTION: Door paint
LOCATION: Auditorium 117
COLOR: Pink top layer
XRF NUMBER: Page #6, XRF# 182-183
CONDITION: Intact- Not intact

Photograph #9: Door and door casing identified with LBP during this inspection (XRF #182-183).

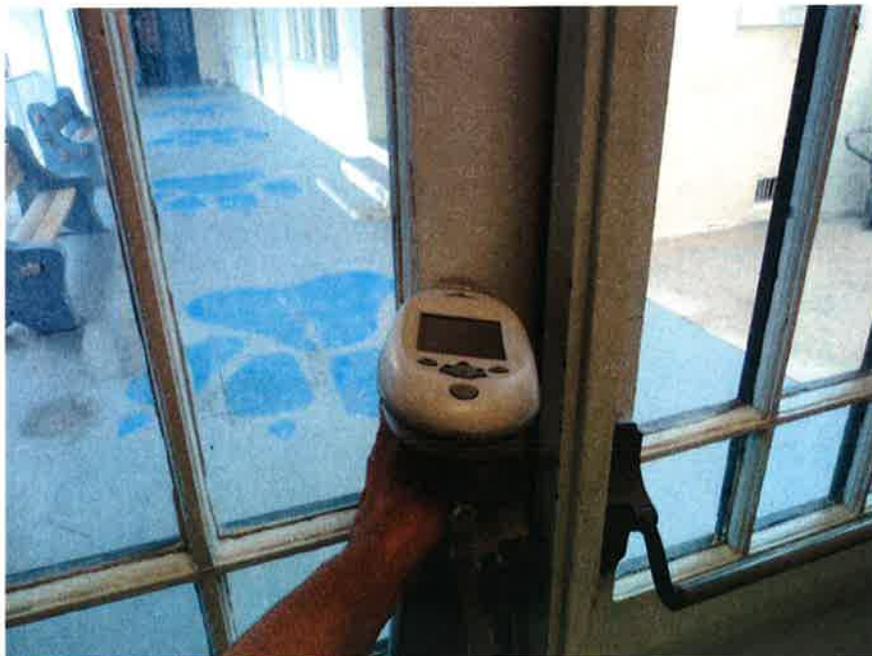
DESCRIPTION: Door paint
LOCATION: Corridor floor 1
COLOR: Blue top layer
XRF NUMBER: Page #7, XRF# 219-220
CONDITION: Intact- Not intact

Photograph #10: Typical wood door identified with LBP during this inspection (XRF #196, 219, 220).

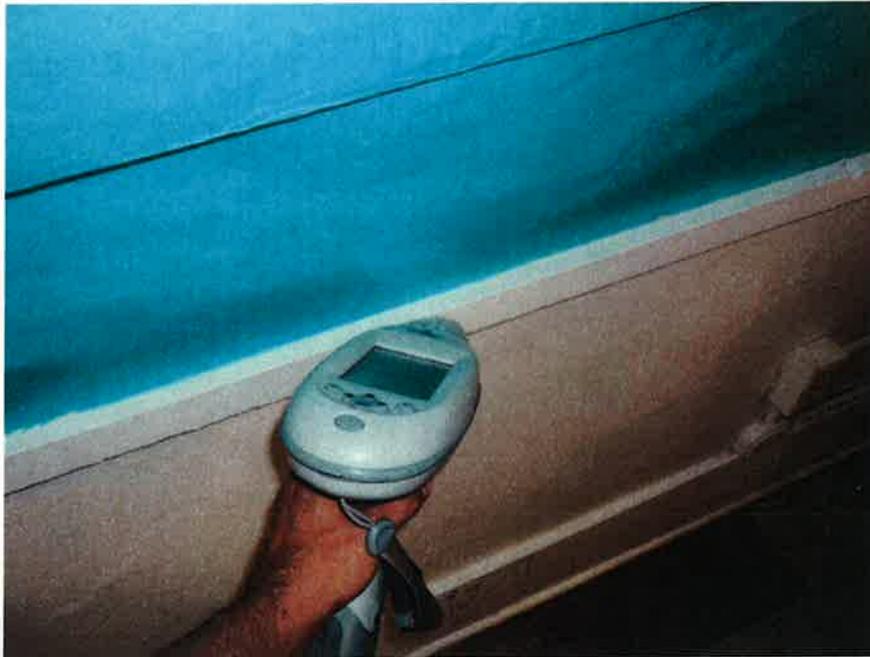
Photograph #11: LBP identified on wood trim during this inspection (XRF #256-257).

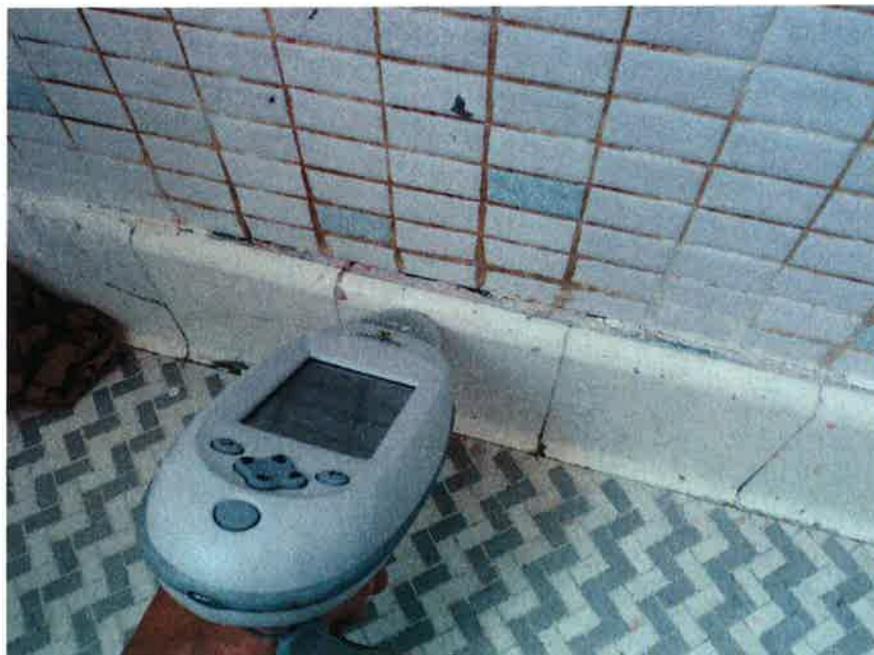
Photograph #12: Lead identified on ceramic baseboard (XRF # 272).

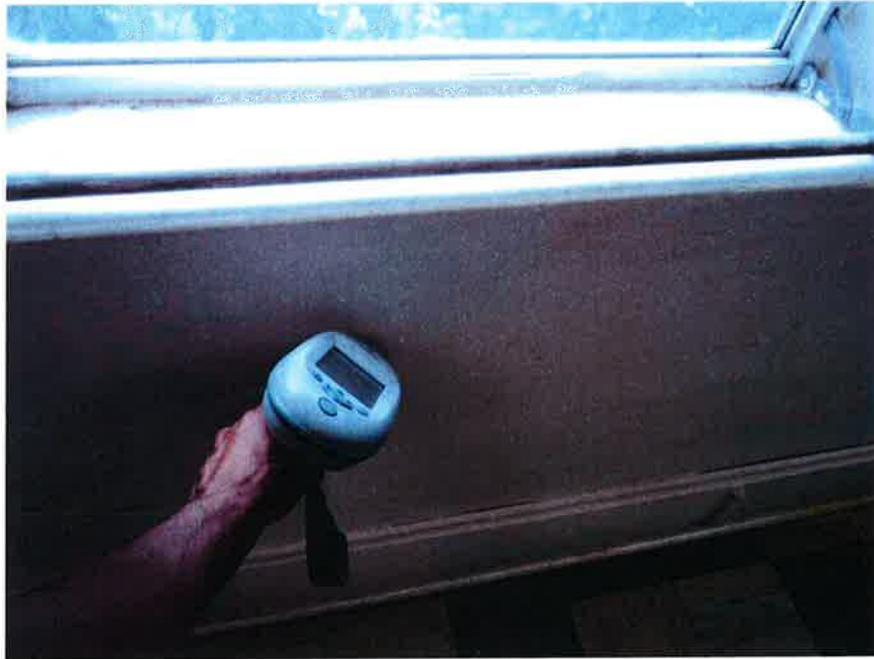
Photograph #13: LBP identified on wall during this inspection (XRF #287-288).

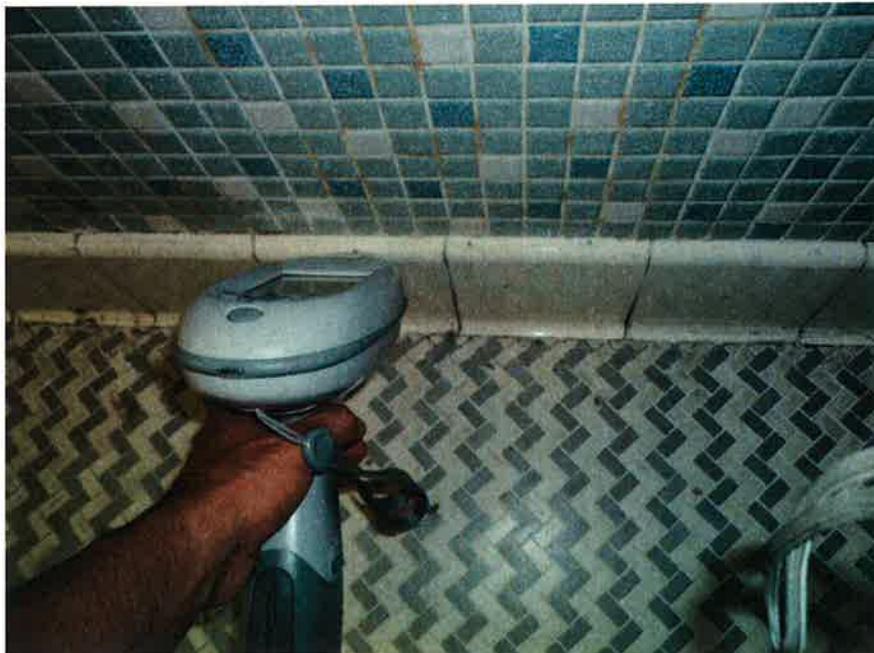
Photograph #14: Lead identified on beige ceramic tile (XRF #360).

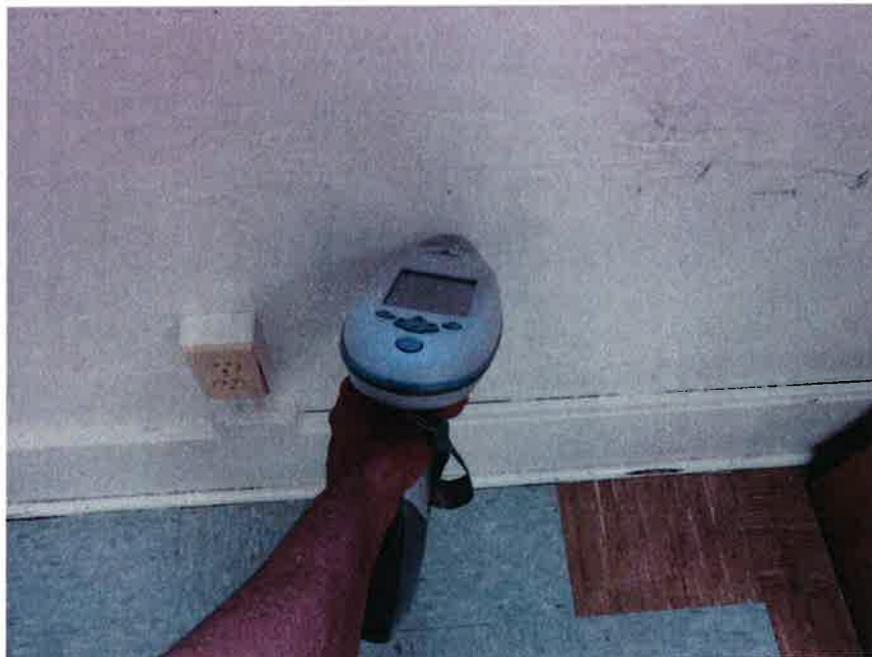
LOCATION:	Class room 109B
COLOR:	Beige top layer
XRF NUMBER:	Page #11, XRF# 368-370
CONDITION:	Not intact

Photograph #15: LBP identified on classroom wall (XRF #368).

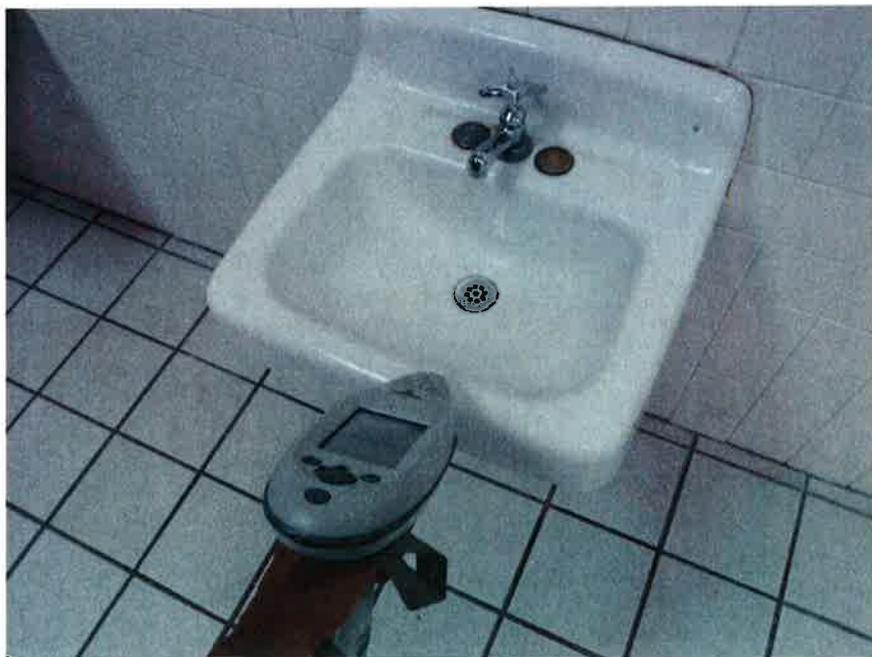
Photograph #16: Lead identified on metal sink.

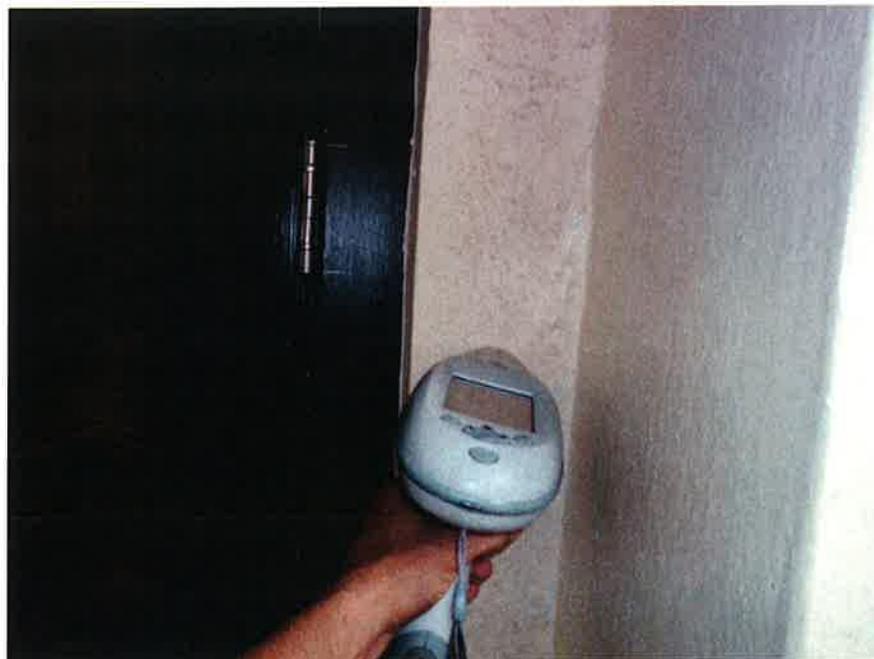
Photograph #17: LBP identified on exterior stucco

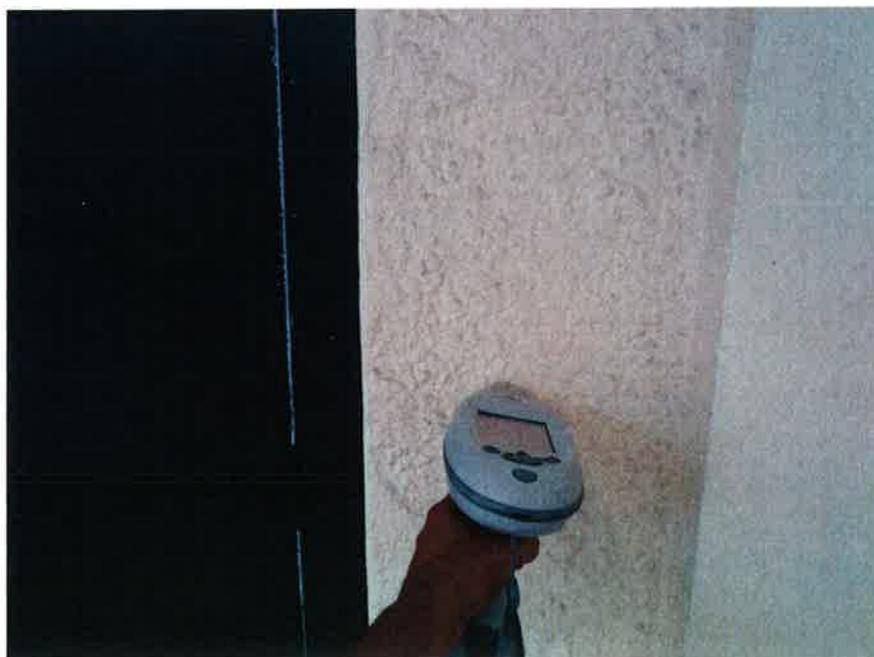
Photograph #18: LBP identified on exterior stucco

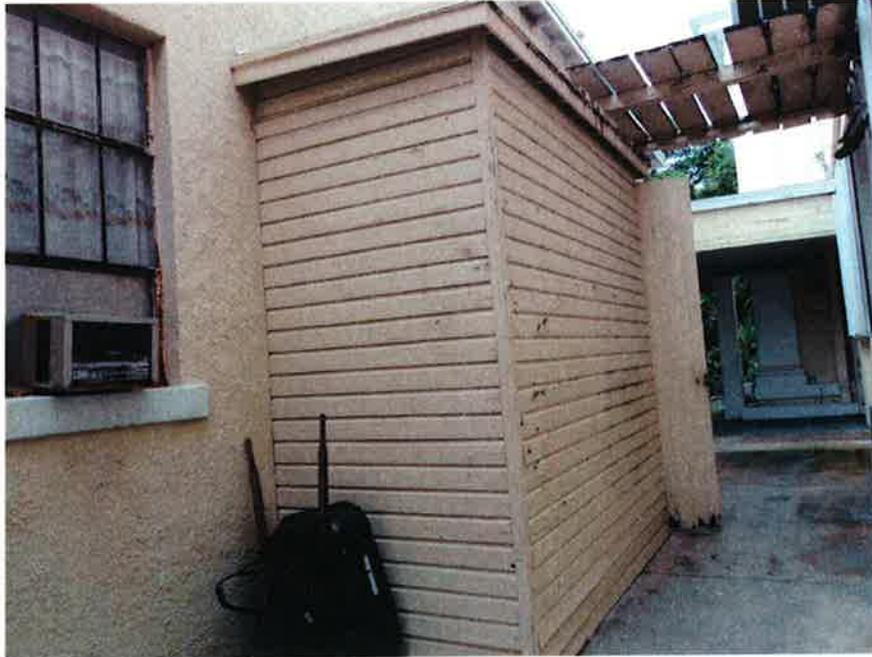
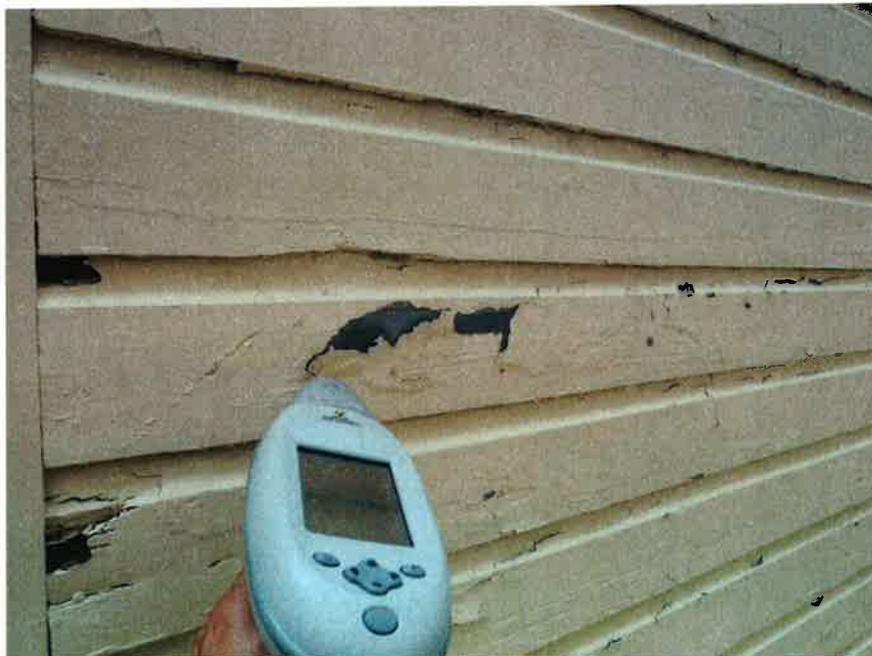
DESCRIPTION: Exterior wall paint
LOCATION: Exterior wood shed attached to the Auditorium
COLOR: Green top layer
XRF NUMBER: Page #15, XRF# 512
CONDITION: Poor condition

Photograph #19: LBP in poor condition identified on exterior wood shed attached to the Auditorium building (XRF #512)

Photograph #20: LBP in poor condition identified on exterior wood shed attached to the Auditorium building (XRF #512)

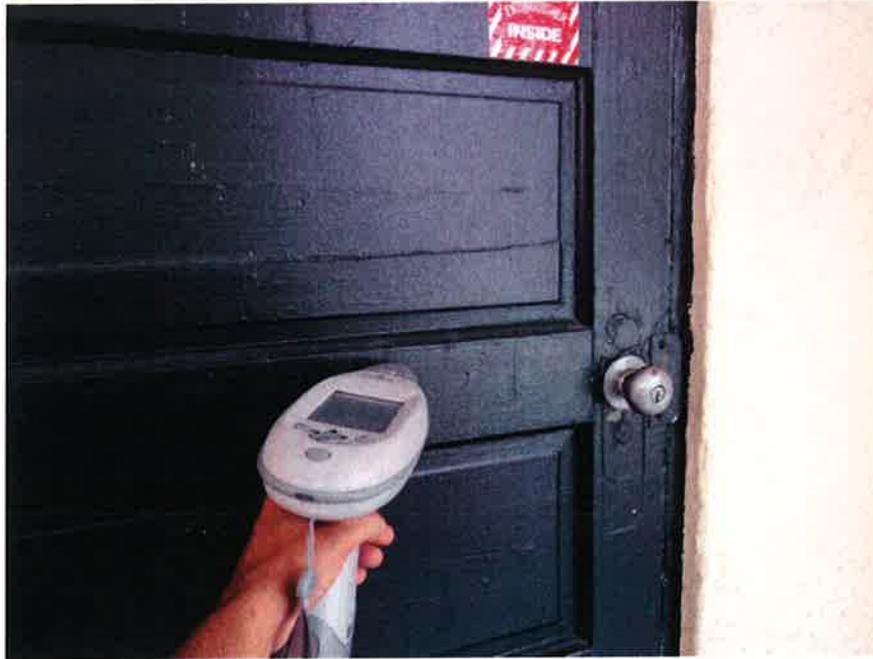
DESCRIPTION: Door and door casing paint
LOCATION: Exterior doors of the Auditorium
COLOR: Green top layer
XRF NUMBER: Page #15, XRF# 504-505
CONDITION: Not intact

Photograph #21: Exterior door paint identified with LBP during this (XRF #504)

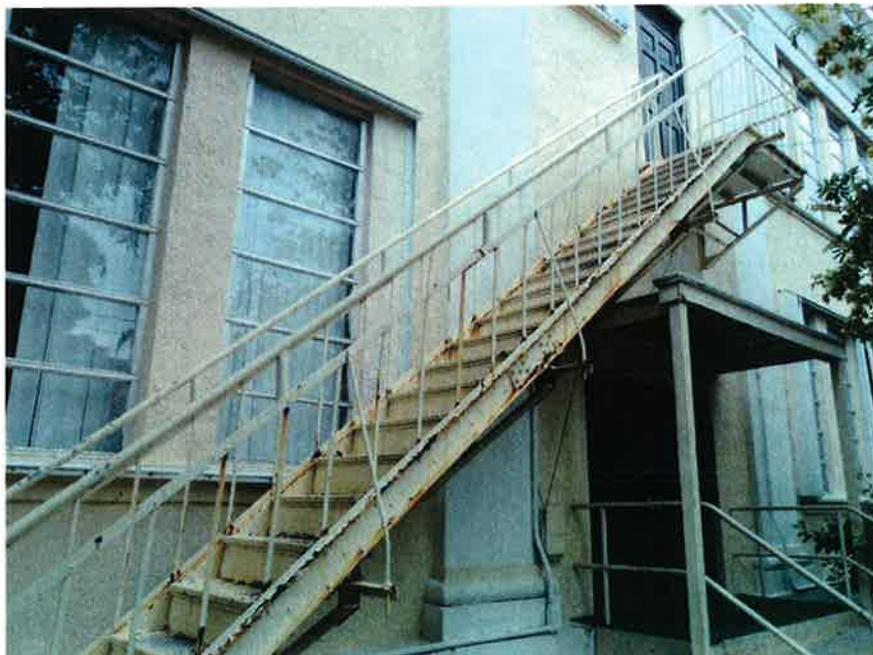
DESCRIPTION: Exterior metal stair-well paint
LOCATION: Building A exterior
COLOR: Beige top layer
XRF NUMBER: Page #16 & 17, XRF# 532, 552
CONDITION: Not intact

Photograph #22: Typical exterior stairwell identified with LBP during this inspection.

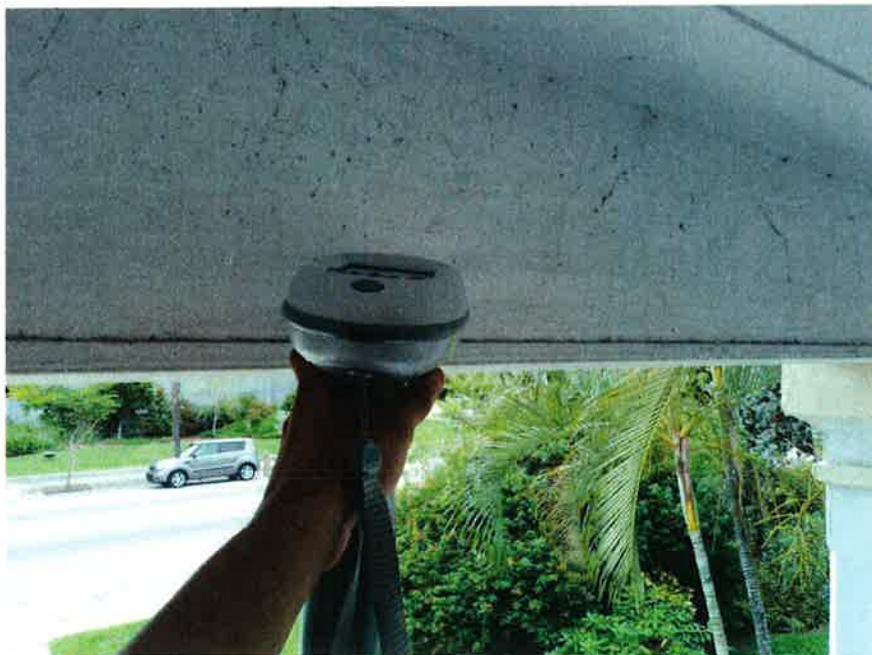
DESCRIPTION: Exterior beam paint
LOCATION: Building A front of the school
COLOR: White top layer
XRF NUMBER: Page #17, XRF# 548
CONDITION: Not intact

Photograph #24: Exterior wood beam paint identified with LBP during this inspection (XRF #548).

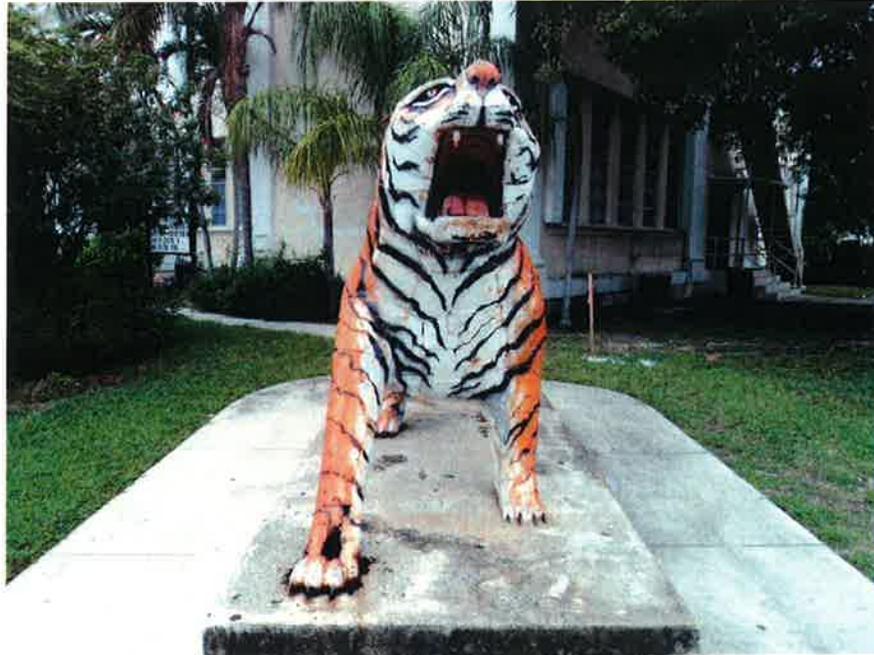
DESCRIPTION: Tiger statue
LOCATION: Building A front of the school
COLOR: Orange top layer
XRF NUMBER: Page #17, XRF# 550
CONDITION: Not intact

Photograph #25: Exterior metal tiger statue paint identified with LBP during this (XRF #548).

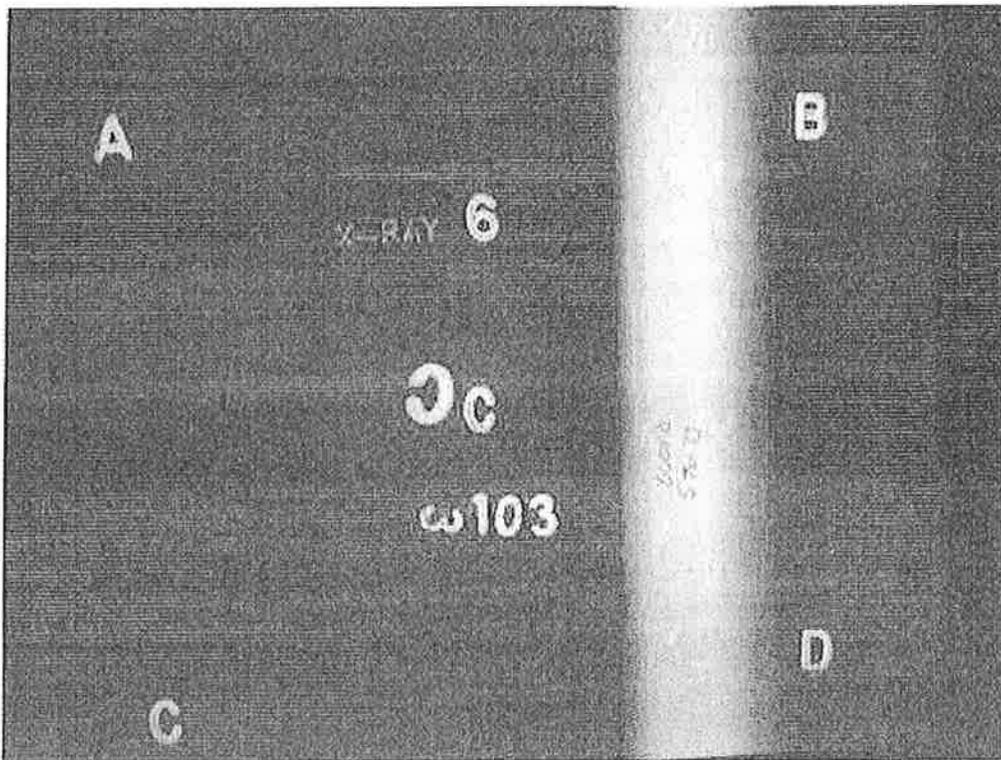
W 103 – Auditorium, First Floor – North Side – East Side Column 101 X-Ray # 6

A 24" wide x 48" high area was scanned on the east side of column 101. The GPR scans showed indications both vertical and horizontal. A 14" x 17" radiograph was taken at the intersecting points of the GPR indications at a height of 44" from the floor to the top of the film. The radiograph showed the wall to be made of wood lathing and plaster. The radiograph confirmed that the GPR indications were a pattern of nail heads.
