THE CITY OF KEY WEST

Peary Court Housing Complex

Floodplain Management

Site Visit Observations

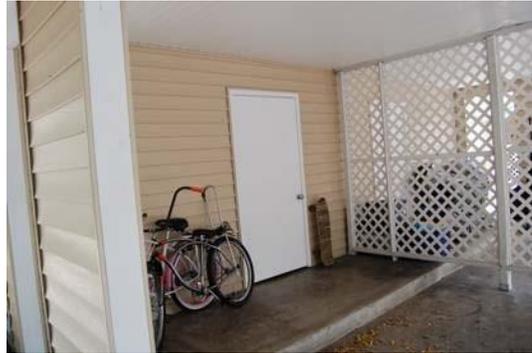
Enclosed Accessory Structures Below BFE - Every dwelling unit observed includes a freestanding unattached enclosed storage area and carport.

Preliminary elevation readings tend to indicate most, if not all of these enclosed areas are below BFE. As such, these enclosed areas are required to have at least two flood vents, but none were observed on any of these structures.

1. Determine if the numerous air-conditioning compressors are in fact below BFE, and should be elevated.
2. Installation of at least two appropriately sized flood vents in each of the accessory storage enclosures attached to the carports. If engineered flood vents are used, they must be certified by a Florida licensed engineer.
3. Installation of flood vents in the two guard shacks or removal of these structures.

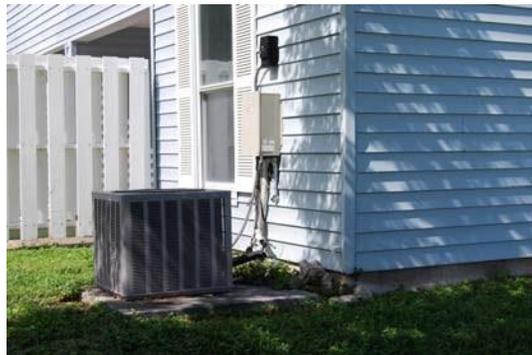
Exterior Air-conditioning Compressors Below BFE - Each dwelling unit has at least one air-conditioning compressor mounted on a concrete pad a few inches lower than the dwelling's first floor.

Judging from preliminary elevation readings for the first floors, it would appear most, if not all, these air compressors may be below BFE.

City code [Sec. 34-91(2)], requires air conditioning equipment to be located so as to prevent water from entering or accumulating within the components during conditions of flooding.

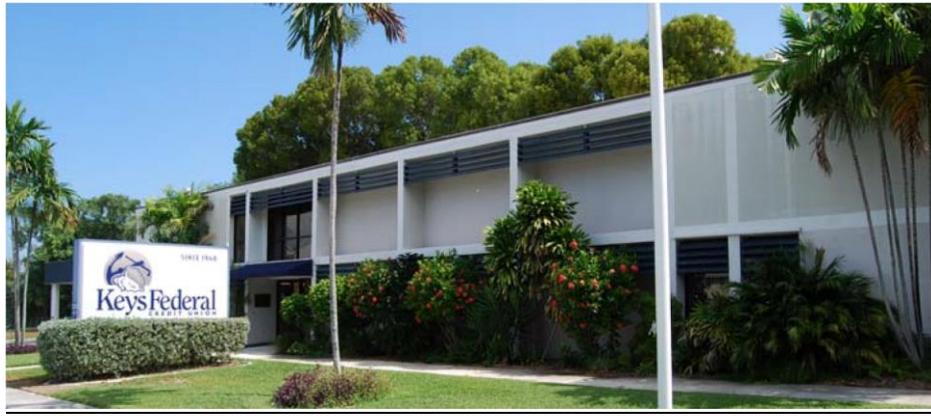
- Main Bank Building: Clearly, original construction occurred pre-FIRM. However, the building has been Substantially Improved, supposedly during the 1990s. If accurate, the renovations would make the structure Post-FIRM and require compliance with floodplain regulations. However, whereas the renovations

- Preliminary elevation figures were provided, but these two structures were identified by only one height reading. There's no indication to which of these two structures this height reading applies. If this reading is for the older main bank building, then this structure is above BFE. However, if this reading is for the new secondary bank building, then the main building is considerably below BFE.
 - A subsequent conversation with the surveyor, indicates the preliminary elevation provided (+6.24-foot msl), was for the old main building. If so, then this building would be above BFE (AE-6 zone), eliminating flood compliance concerns. An official Elevation Certificate is needed for confirmation.

4. Ascertain, specifically, the elevation of the large commercial building currently occupied by a credit union, to determine compliance status.
5. Elevation Certificates from a Florida licensed land surveyor are required for every dwelling building (slabs, not individual units/addresses) and commercial structure, including guard shacks.
 - a. On the Elevation Certificates, the addresses should be ranged to include all street addresses shared by the single building (e.g. 323-327 Fraser Blvd.). Thereby making a single certificate applicable to every dwelling unit sharing the same slab.

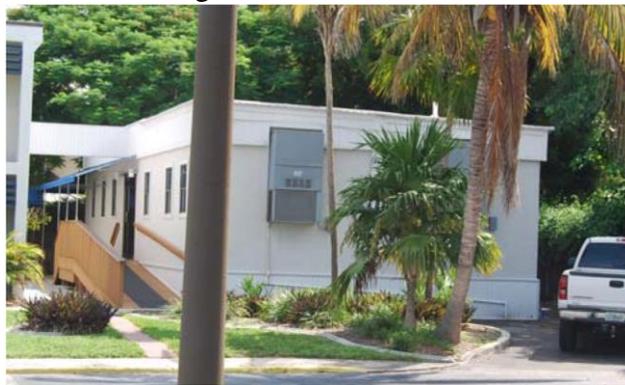
- **Secondary Bank Building:** A casual observation of this structure didn't disclose any floodplain compliance issues. Its first floor elevation is about two feet higher than that of the main bank building.

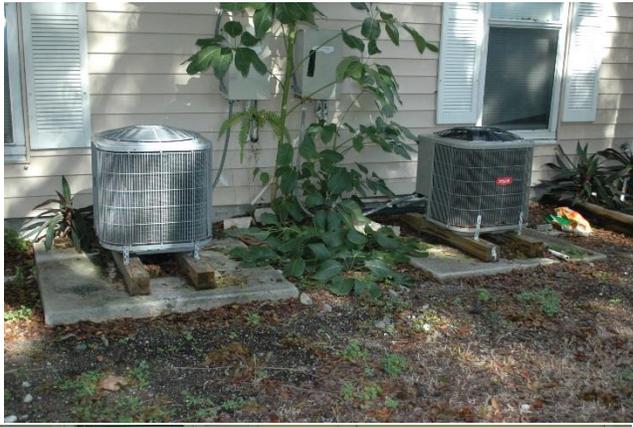
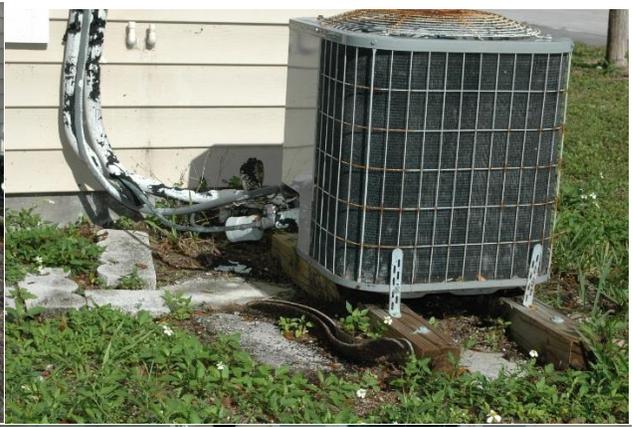
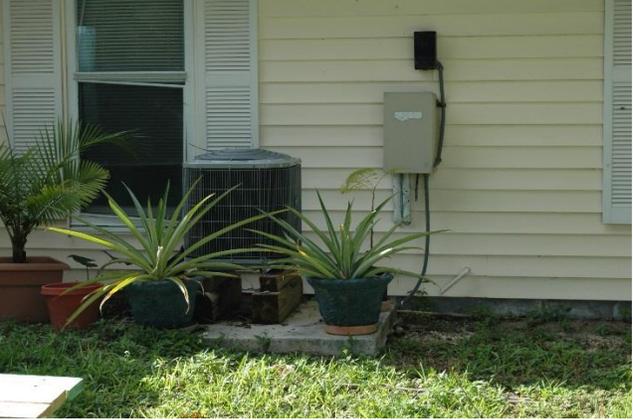
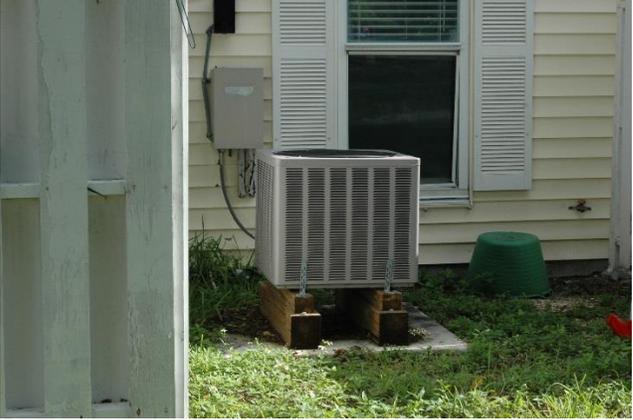
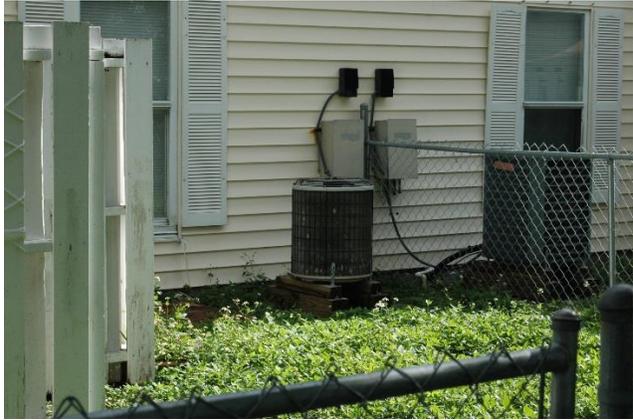
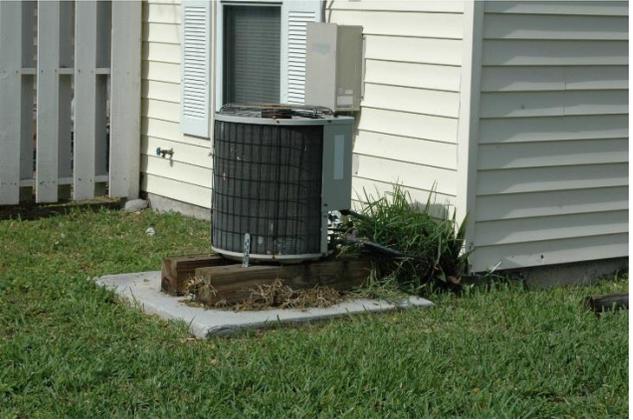
While not all the exterior compressors were found to have been elevated, it was apparent those with the greatest flood vulnerability had been elevated. In particular, more of the compressor units for buildings in the higher AE-7 flood zone area were observed to have been elevated. Fewer units in the lower AE-6 flood zone had been elevated, but those may not have required elevation.

Elevation of these compressor units was achieved with the insertion of pre-treated blocks of lumber under the compressor mounting brackets. The compressors were then mounted to these wooden blocks, and galvanized screw-anchors were utilized to secure the wooden block to the concrete equipment slabs below.

At one location, where the compressor was elevated by two wooden blocks between the compressor and concrete, a firm grasp and shaking of the compressor demonstrated the unit was securely mounted.
