## THE CITY OF KEY WEST

February 4, 2016

Peary Court Property Infrastructure Review  
City of Key West Engineering Services Department

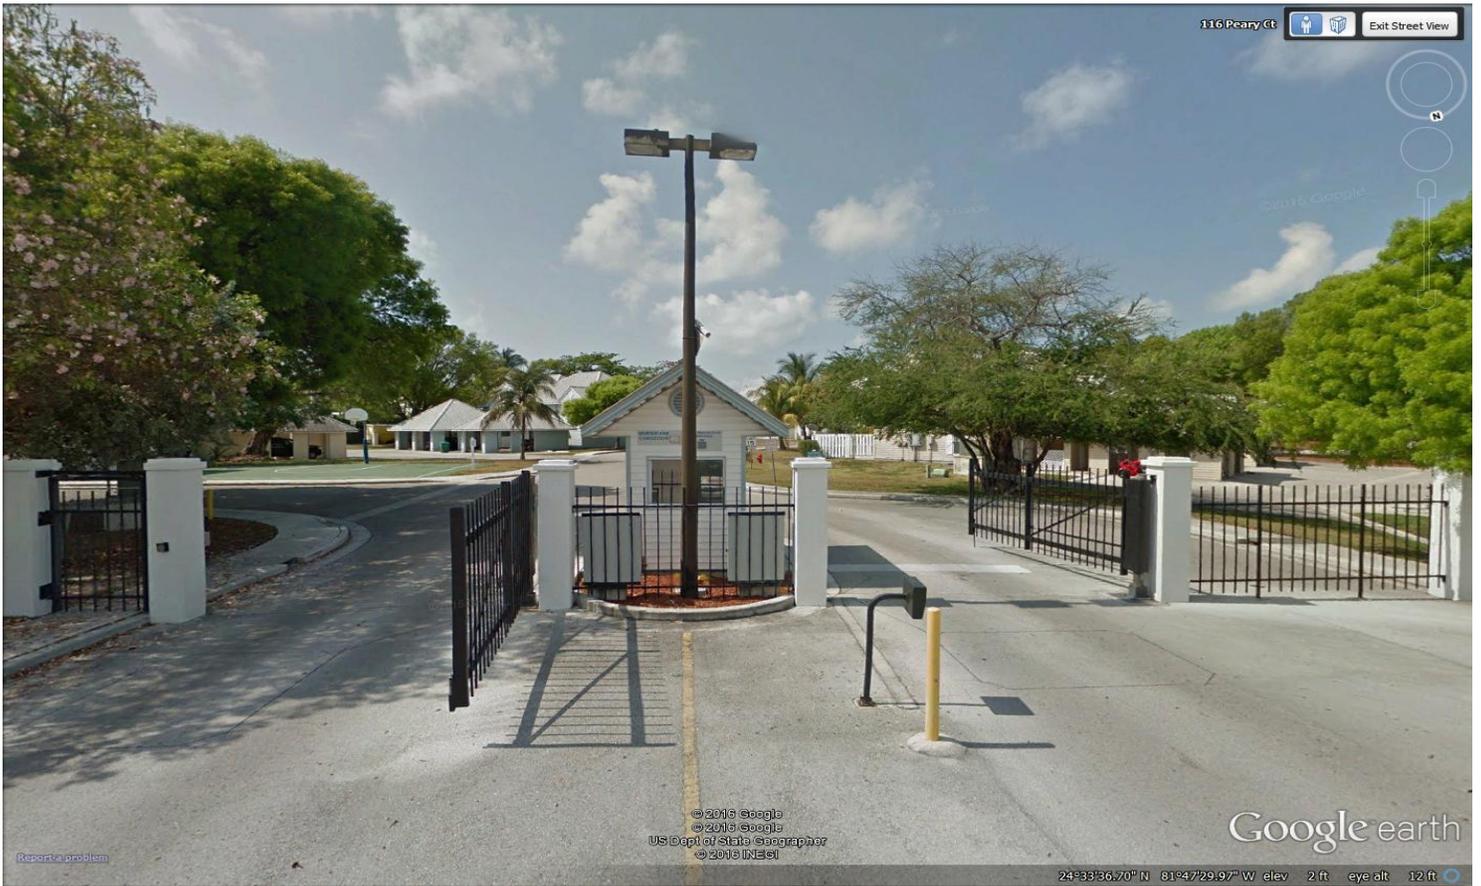
Figure 3 – Typical Fencing and Gate Entrance

**Perimeter Fencing and Gates** - Fencing and gates are standard local area Navy design including aluminum square tubing fence panels and concrete masonry unit fence posts. Fencing appears in original alignment and plumbness. Split drive entrance gates appear originally motorized with automated openers; however, these gates no longer include electrical service, controllers, or motors. (Figure 3 – Typical Fencing and Gate Entrance)

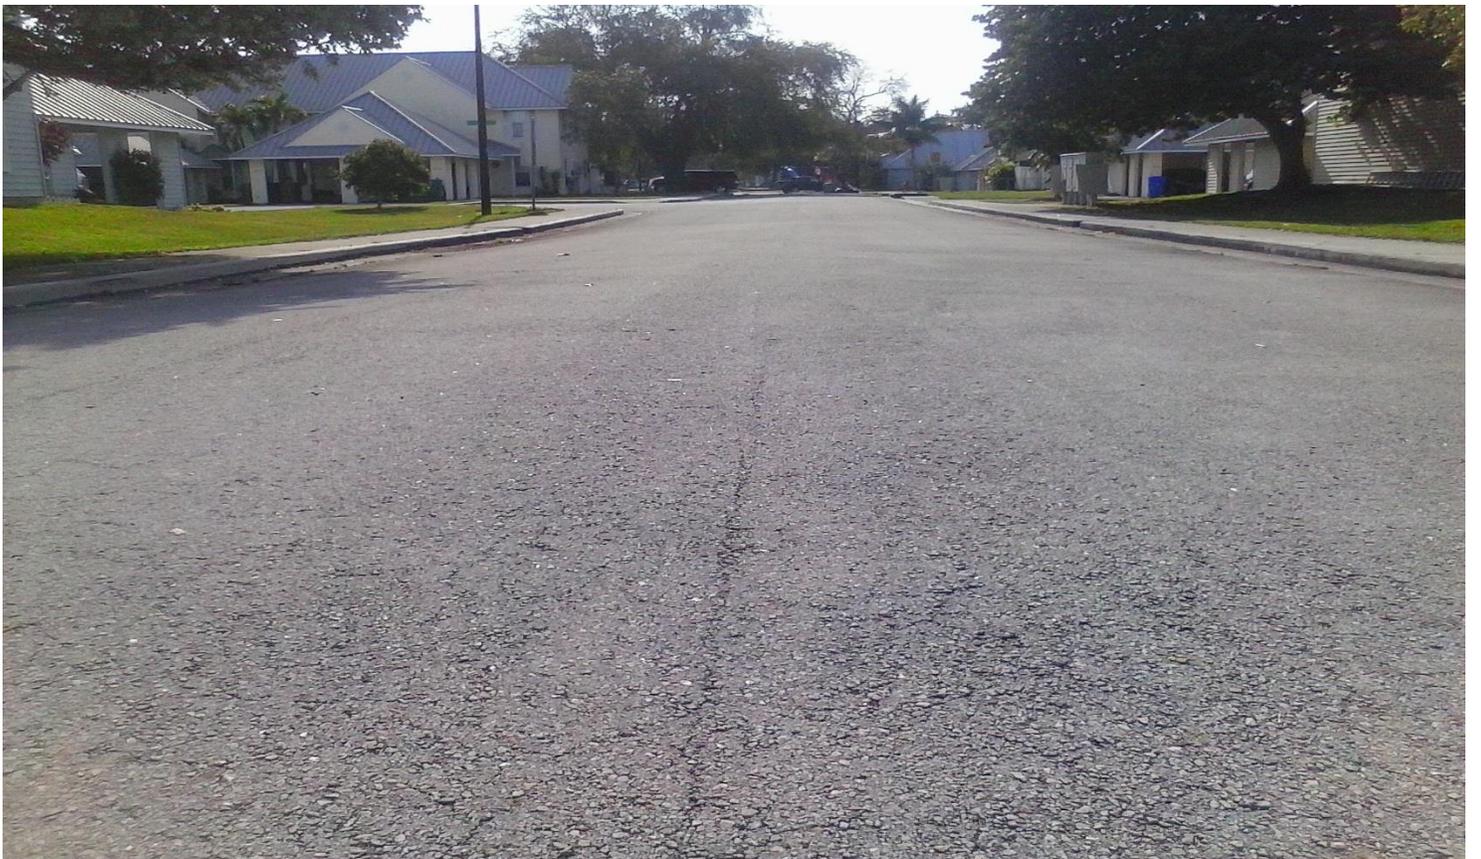
Figure 4 – Typical Roadway

**Vehicle Routing and Uncovered Parking** - Roadways within the development have natural traffic speed calming winding alignments and the typical section of roadway consists of 24 foot wide roadway divided into 2-12 foot wide vehicle lanes. Concrete curb and gutters and adjacent concrete sidewalks abut both sides of roadways. Asphalt paved driving surfaces are also provided to all building parking areas. Ample parking exists on asphalt surfacing throughout the property. Deterioration of pervious surfaces (grassy areas) resulting from vehicles parking off the asphalt was not observed. (Figures 4 and 5 – Typical Roadway and Drive)

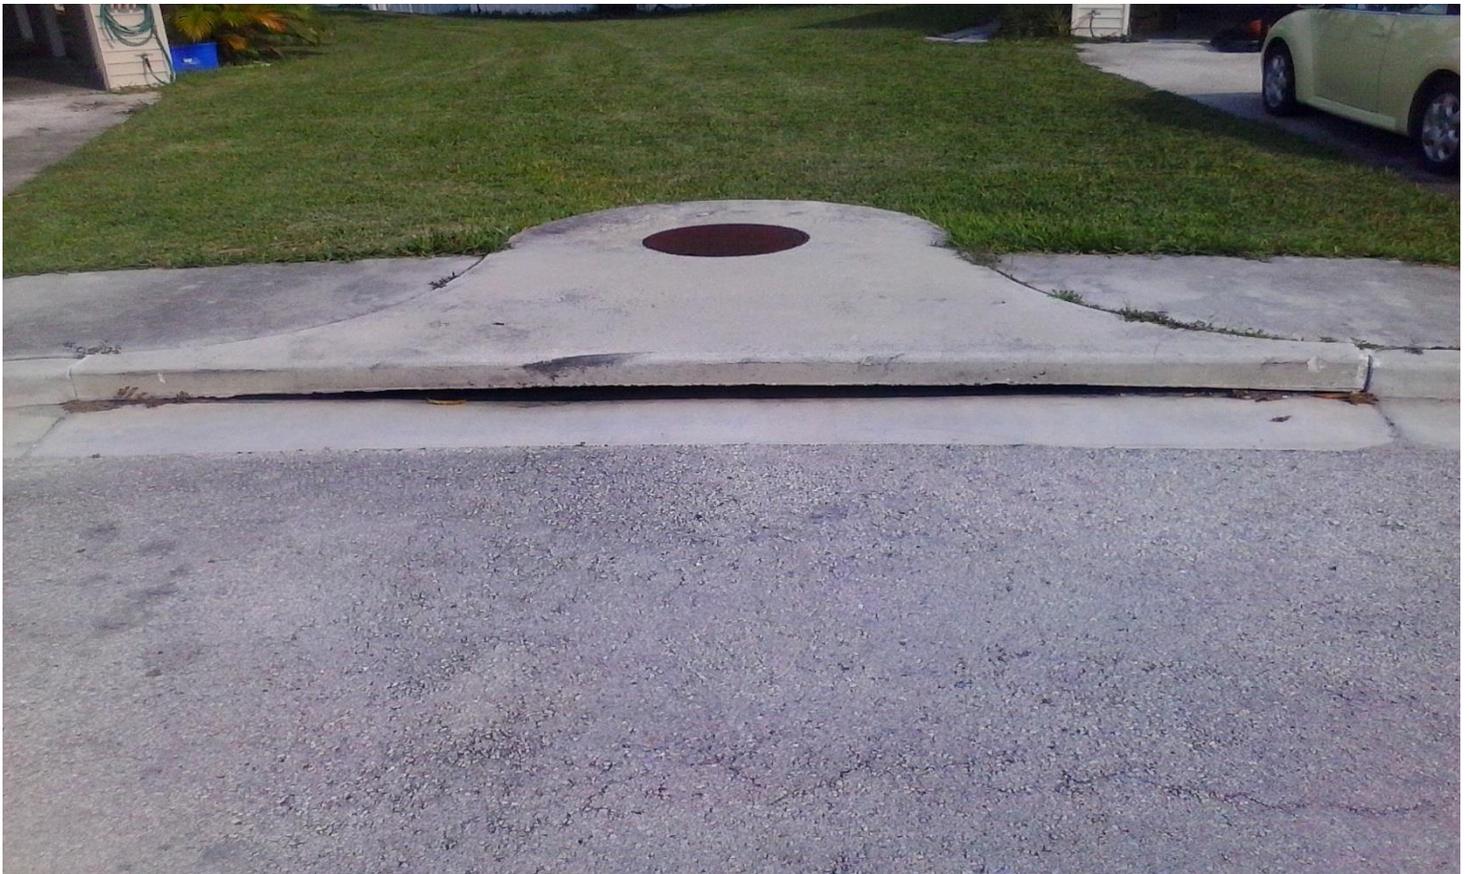
Figure 6 – Typical Curb Drop Inlet

**Stormwater Management** - The property contains a comprehensive stormwater management system with rainwater runoff remaining within the property boundary inside retention ponds. Roadway rainwater flows off the crowned roadway (elevated centerline) to concrete gutters on each side of the roadway. Rainwater then flows away from the roadway either into curb drop inlets or through sidewalk crosscuts onto grassy areas to catch basins, ultimately flowing through underground piping into one of five on-site stormwater retention ponds. Water appears to either percolate through or evaporate from the ponds. Evidence of injection wells and dewatering structures were not observed. (Figures 6 and 7 – Typical Curb Drop Inlet and Retention Pond)

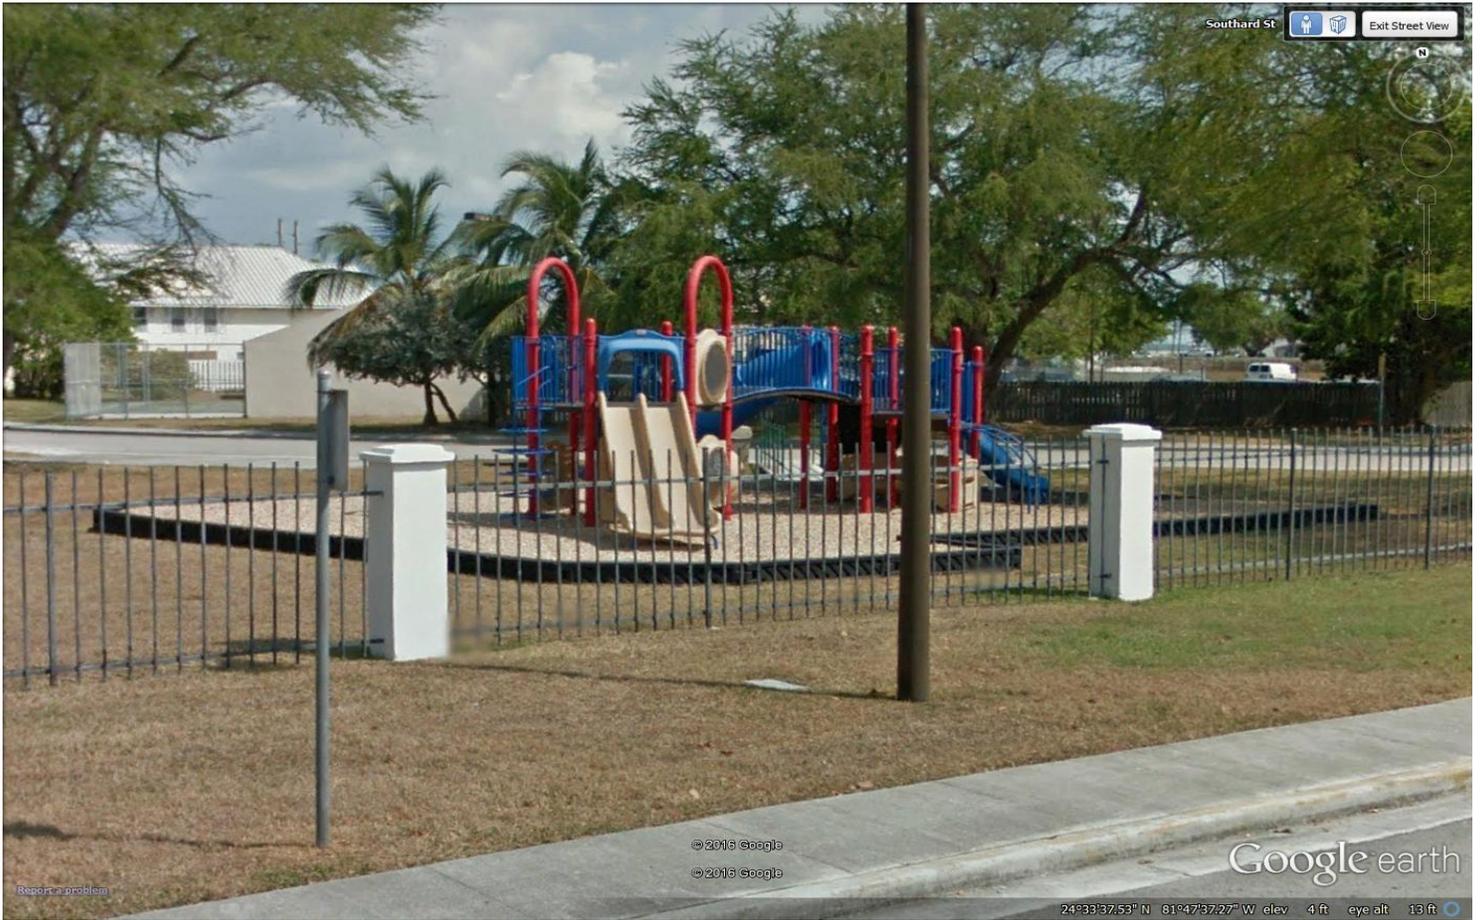
Figure 9 – Typical Playground

- Utilities are constructed underground, including electrical distribution to buildings and electrical service to street lighting.
- Playground equipment and playground areas appear updated over recent years through raising playground areas by adding gravel and retaining walls. Playground areas deserve a closer review for compliance with current Florida Building Codes ADA Accessibility and Fall Protection.

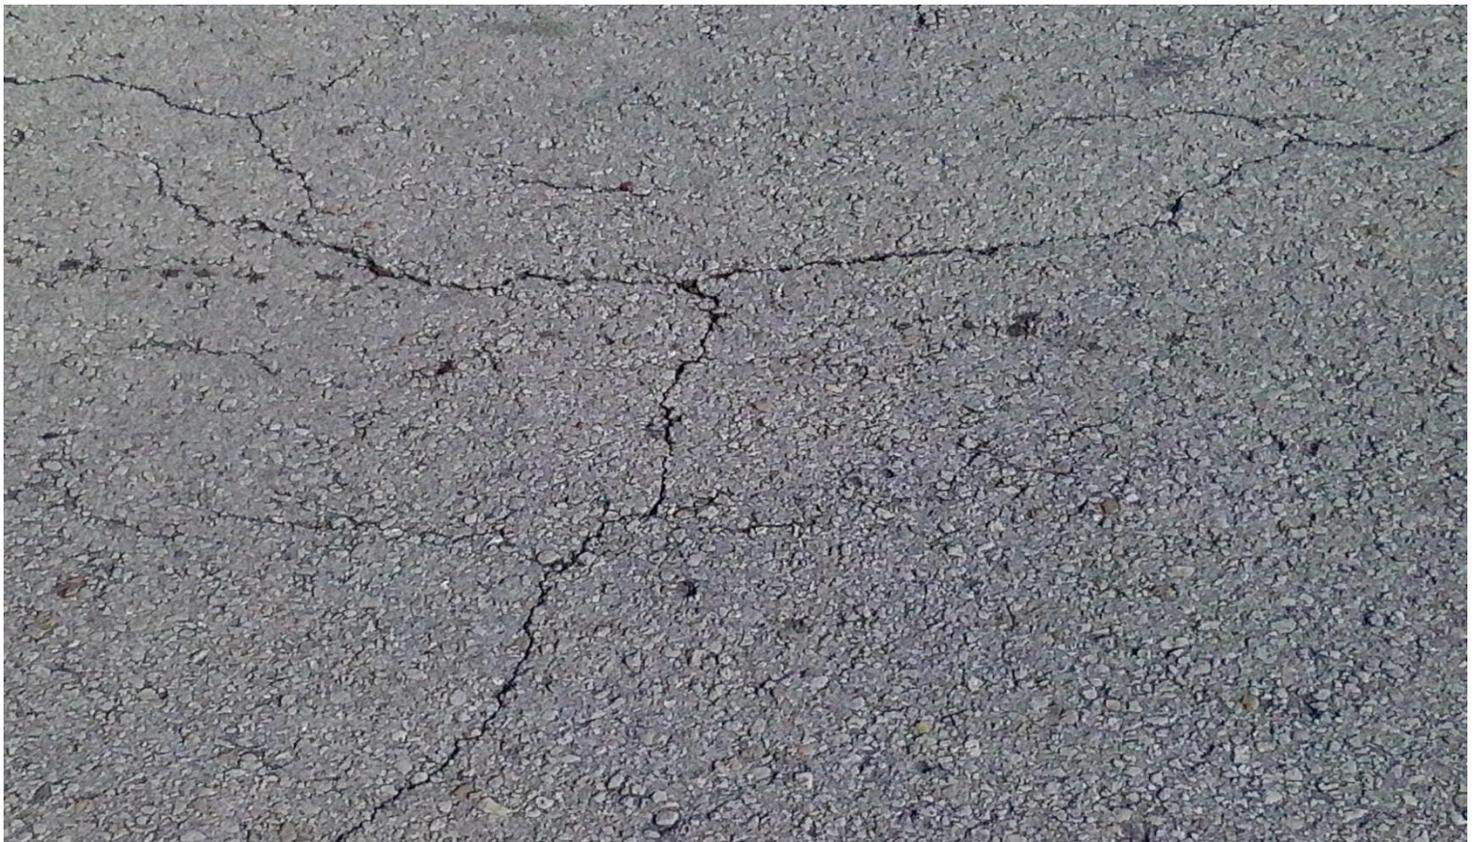
Figure 10 – Typical Asphalt Surface Condition

- Existing asphalt/concrete surface conditions do not indicate major repairs due to differential settlement issues throughout entire vehicle and pedestrian traffic patterns. Note that adequate maintenance of any asphalt pavement surface requires routine surface sealing on a 2 to 3 year interval, especially when considering extreme ultraviolet levels of the local area.

- Roadway centerline striping and crosswalk pavement markings were not installed during construction. Installing these pavement markings for delineating vehicle and pedestrian travel limits is recommended after sealing asphalt surfaces.

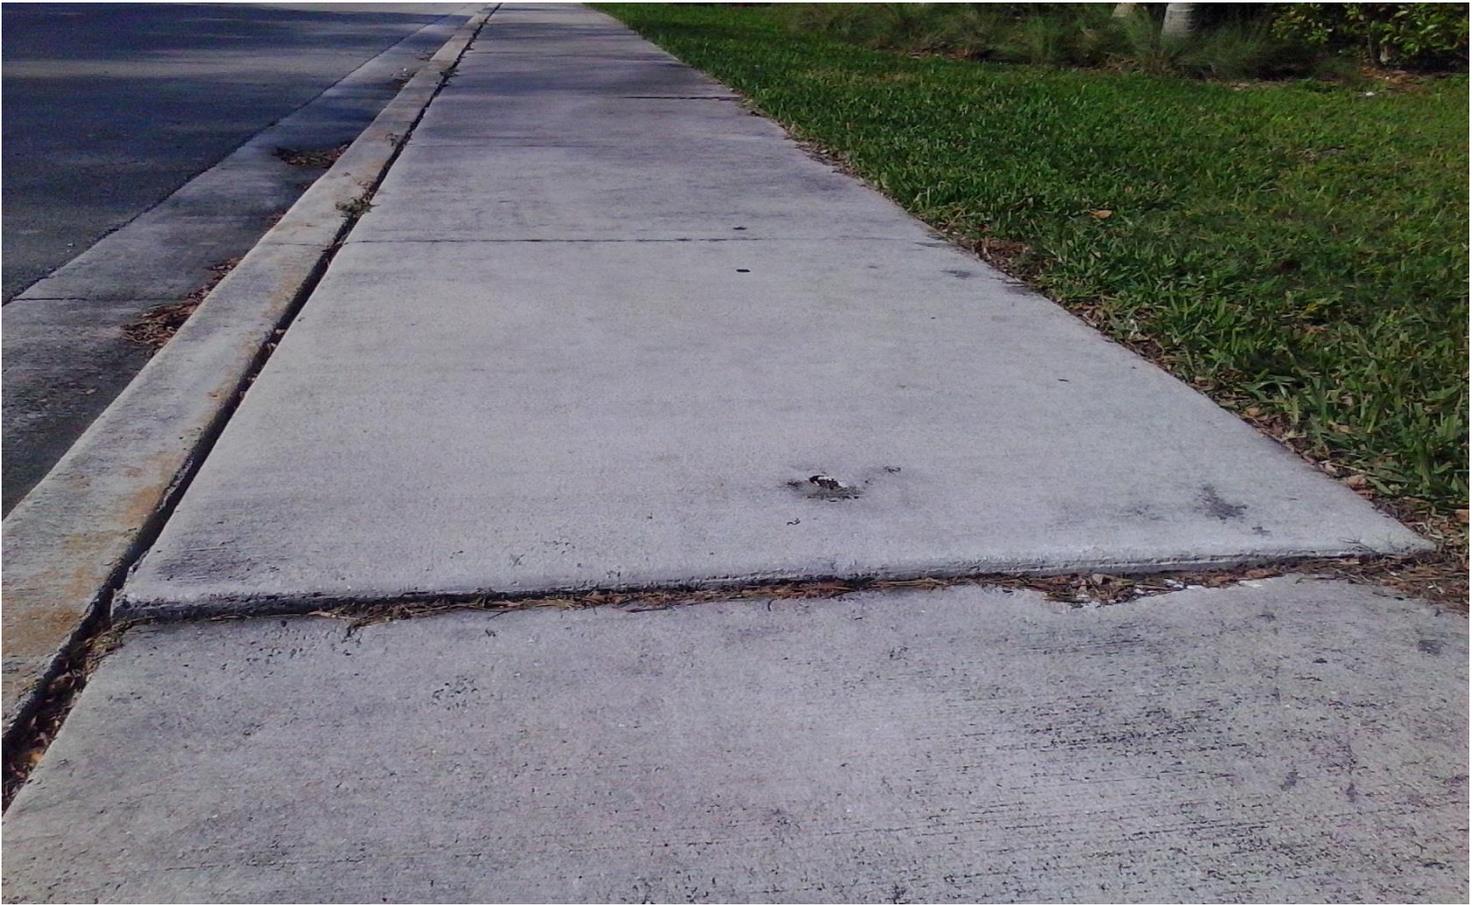
Figure 11 – Typical Sidewalk Settlement

- Sidewalk current conditions illustrate limited areas of differential settlement at control joints due to vegetation roots. In addition, a void typically exists between the back of roadway curb and sidewalk caused by expansion joint material settling. This expansion joint material settlement most likely resulted from design and construction lacking installation of a backer rod and joint sealant over expansion joint material.

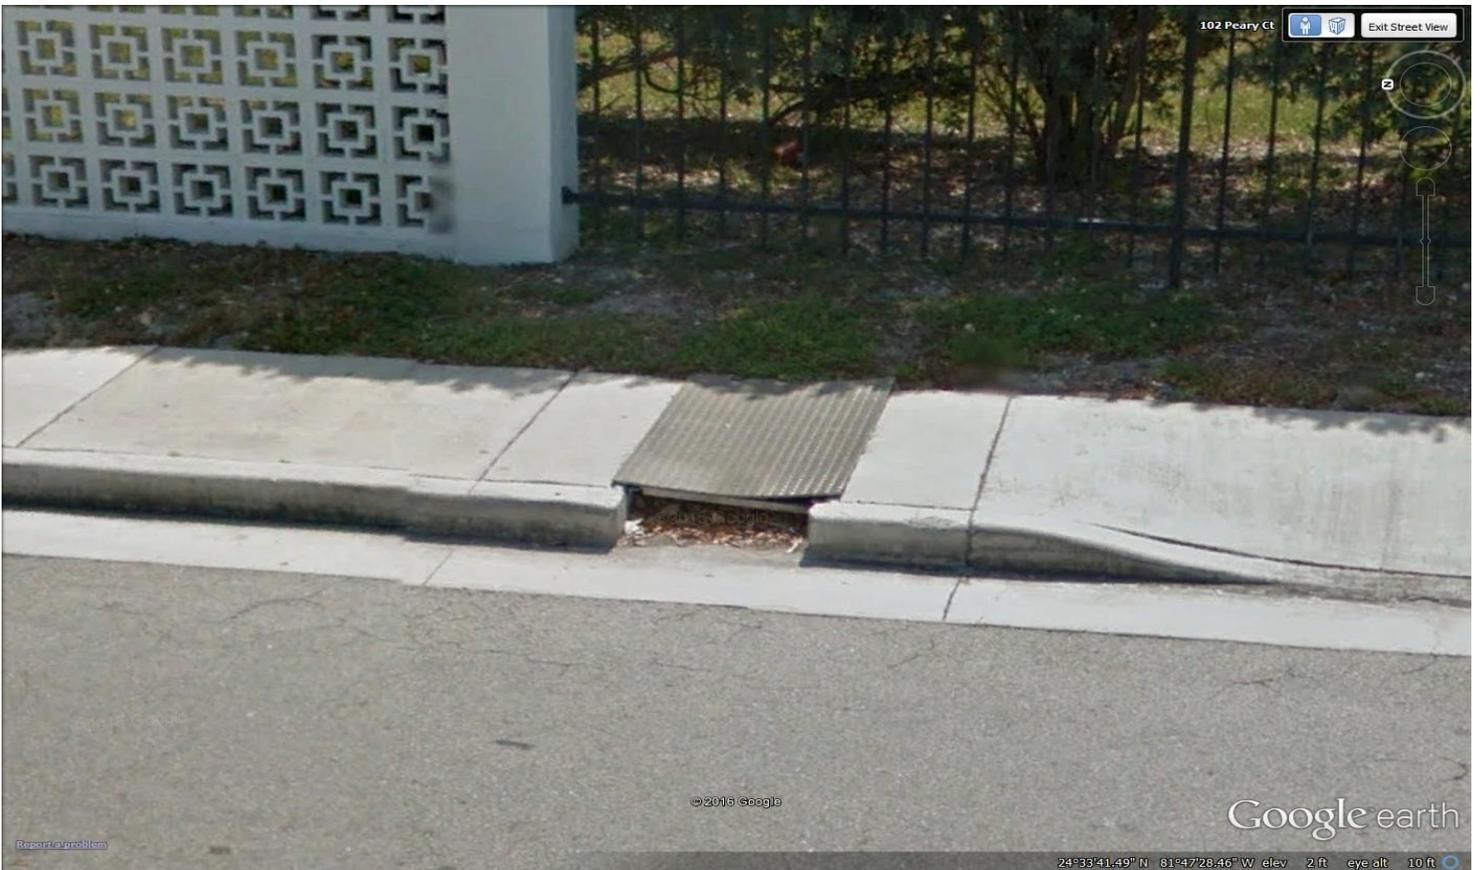
Figure 12 – Typical Sidewalk Cross Drain Cover

- Sidewalk crosscut drain covers appear permanently sprung (or bowed) thus requiring re-designing and replacing drain covers.
- A detailed pedestrian routing condition assessment recommended for complying with Florida Building Code's ADA Accessibility.

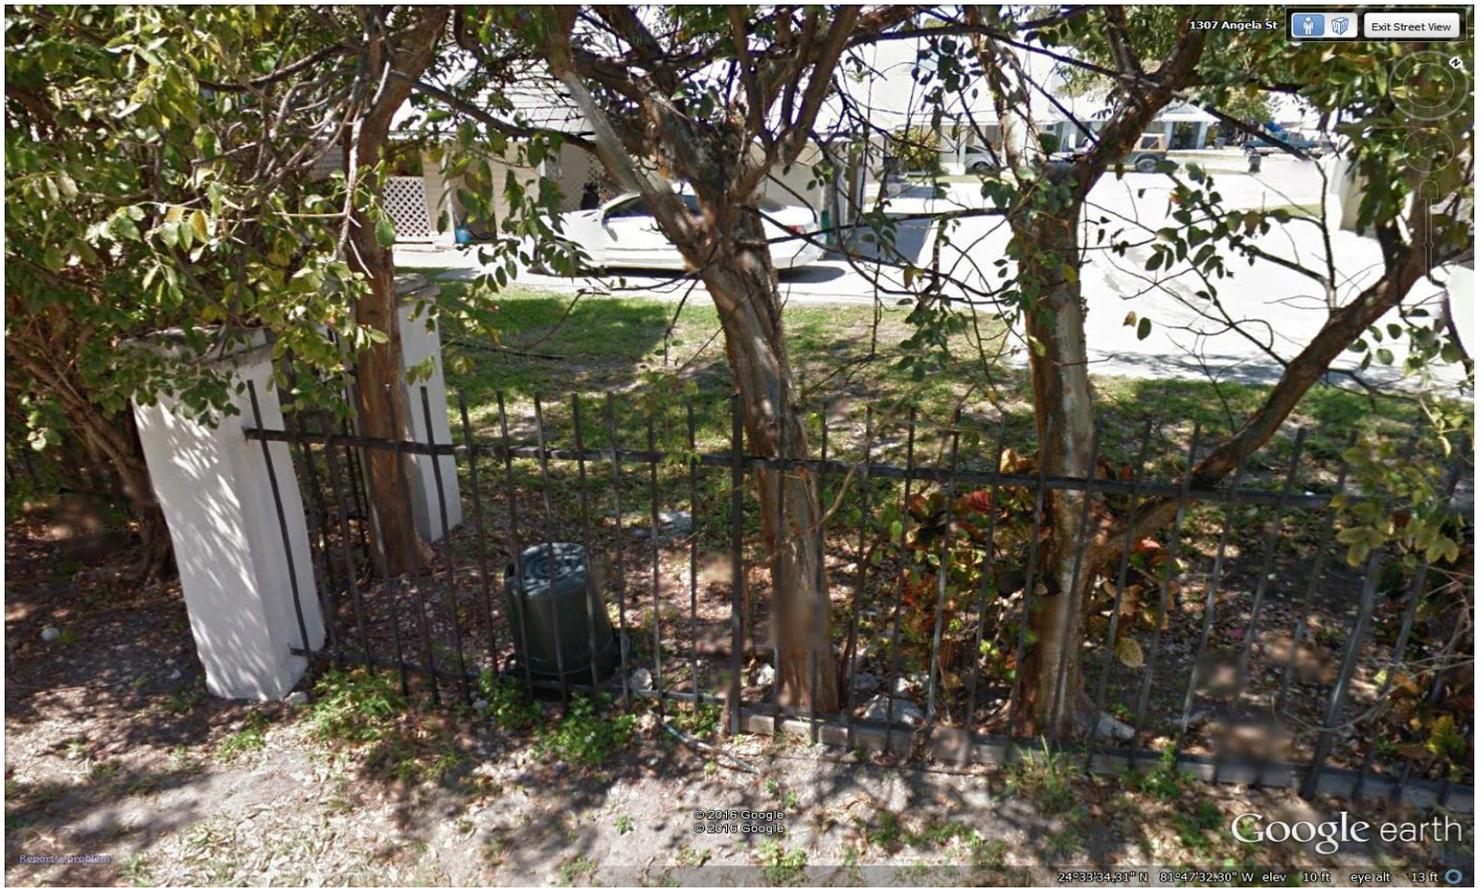
Figure 13 – Typical Fencing Vegetation Encroachment

- Replacing the roadway and sidewalks between the razed commercial (former credit union) building and associated parking lot in the center of the property recommended for providing a thoroughfare between all property buildings and public safety personnel alternate access/egress routes.
- The fencing alignment, plumbness, and finish appear satisfactory with exception to the portion of fencing along the south side of property, where vegetation is encroaching on fencing and damaging fencing material.
