## PRE-RENOVATION ASBESTOS CONTAINING MATERIALS SURVEY

101-111 Geraldine Street | Key West, Florida  
PM Project Number 06-3668-2

**Re: Pre-Renovation Asbestos Containing Materials Survey  
For the Former Key West Gas and Electric Company  
Located at 101-111 Geraldine Street in Key West, Florida  
PM Environmental, Inc. Project No. 06-3668-2**

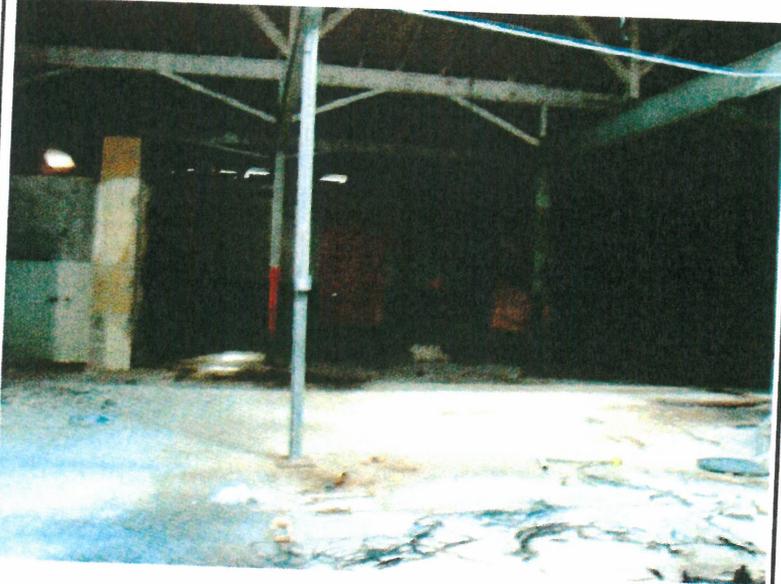
### Photograph 1

Typical view of the interior of the main building  
at the subject property.

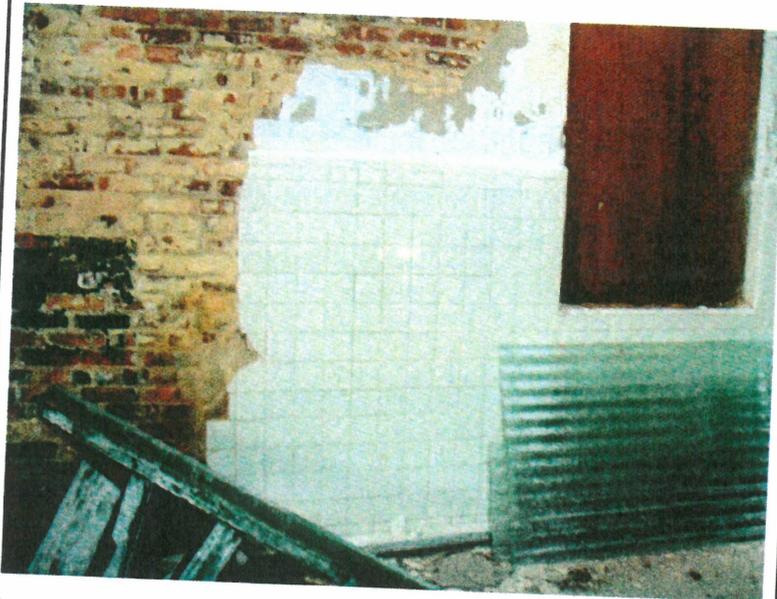
### Photograph 2

Tile on the wall of the former showers at the  
subject property

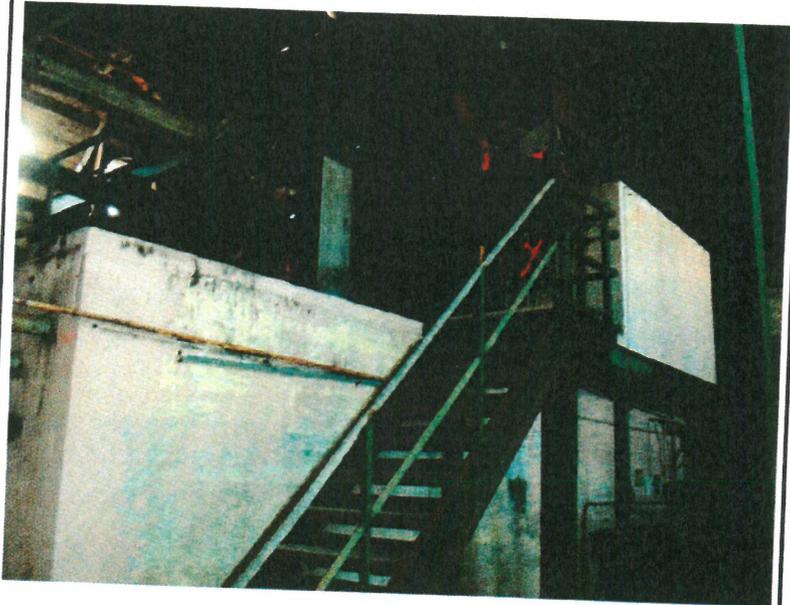
**Photograph 3**

Switch Station at the subject property.

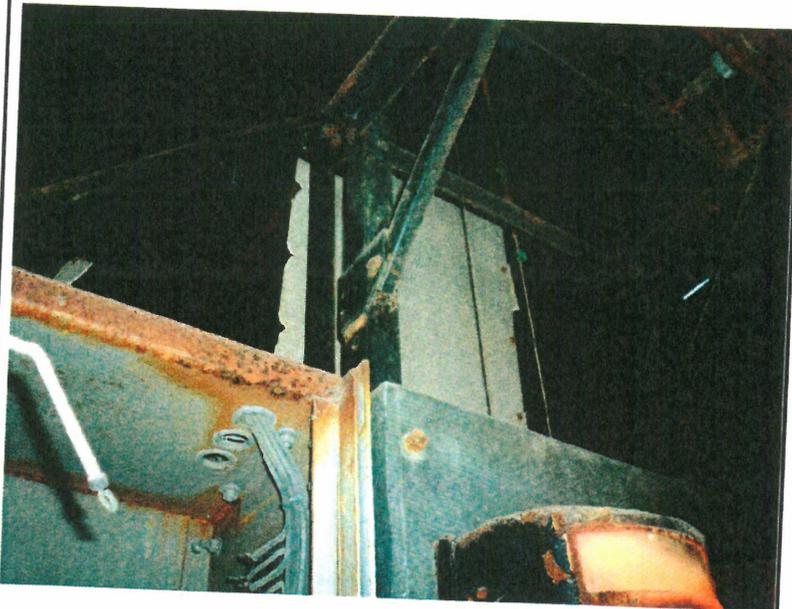
**Photograph 4**

Sample Id. No.	Material Type	Location	Condition	Estimated Quantity	% Asbestos
HA1:1-3	Brick Mortar	Main Building Walls	Good	3,000 SF	None Detected
<b>HA2:1</b>	<b>Transite Panels</b>	<b>Switch Station</b>	<b>Good</b>	<b>100 SF</b>	<b>15% Chrysotile</b>
<b>HA3:1-3</b>	<b>Wire Insulation</b>	<b>Electrical wires at the Switch Station</b>	<b>Good</b>	<b>2,000 LF</b>	<b>70% Chrysotile</b>
HA4:1-3	Brick Mortar	Blacksmith Shop	Good	840 SF	None Detected
HA5:1-3	Brick Mortar	Machine Shop	Good	1,240 SF	None Detected
<b>HA6:1-3</b>	<b>Window Glaze</b>	<b>Main Building Windows</b>	<b>Good</b>	<b>100 LF</b>	<b>5% Chrysotile</b>
HA7:1-3	Concrete Floor	Main Building Floor	Good	13,300 SF	None Detected
HA8:1-2	Tile Mastic	Former Shower Wall	Good	200 SF	None Detected
HA9:1-2	Floor Tile	Former Shower Floor	Good	350 LF	None Detected

View of Transite panel in the switch station.

The identified ACM should be removed by a licensed Asbestos abatement contractor prior to renovation activities. PM is available to help solicit bids to abatement contractors if requested. PM also recommends facilitating a site walk through to aid abatement contractors in visually locating all identified ACMs.

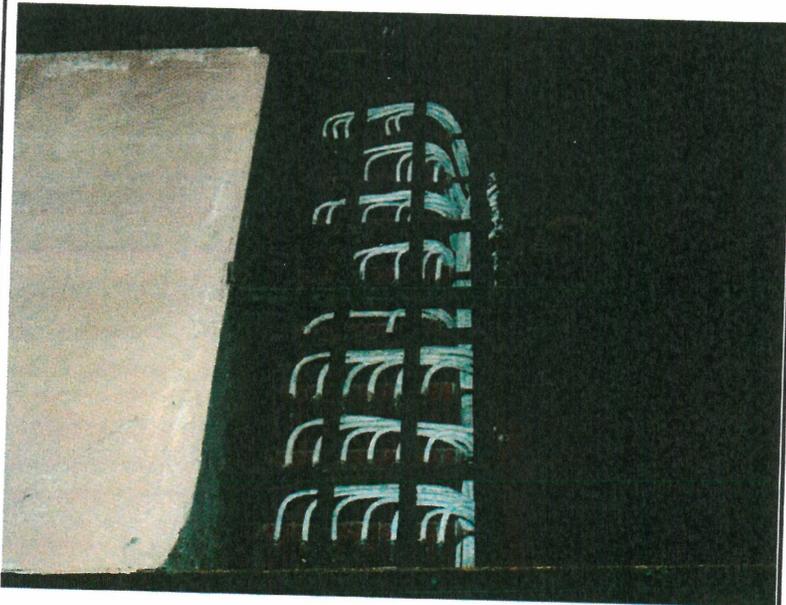
**Photograph 5**

Wires with ACM insulation at the switch station.

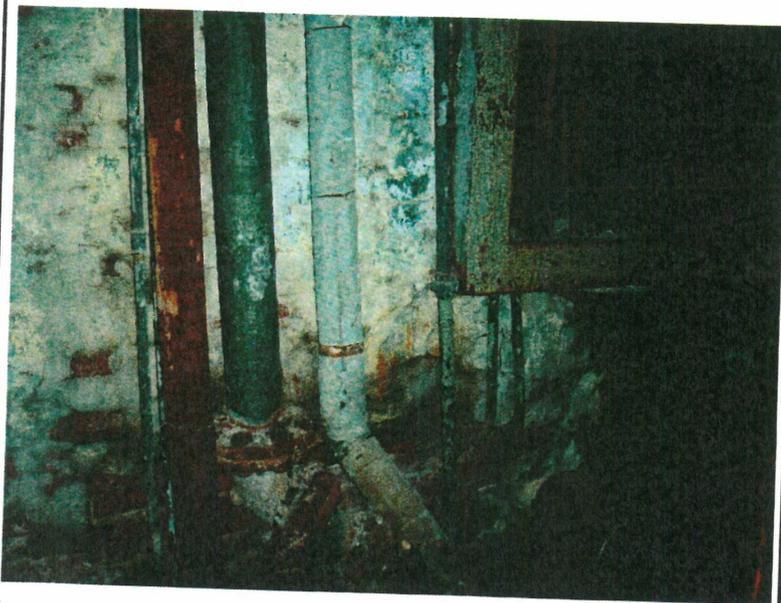
**Photograph 6**

Sample Id. No.	Material Type	Location	Condition	Estimated Quantity	% Asbestos
HA10:1-3	Window Glaze	Blacksmith Shop	Good	20 LF	None Detected
HA11:1-3	Concrete Floor	Blacksmith Shop	Good	432 SF	None Detected
HA12:1-3	Concrete Floor	Machine Shop	Good	945 SF	None Detected
<b>HA13: 1</b>	<b>Pipe Insulation</b>	<b>Main Building Pipe</b>	<b>Good</b>	<b>50 LF</b>	<b>35% Chrysotile</b>

Pipe insulation

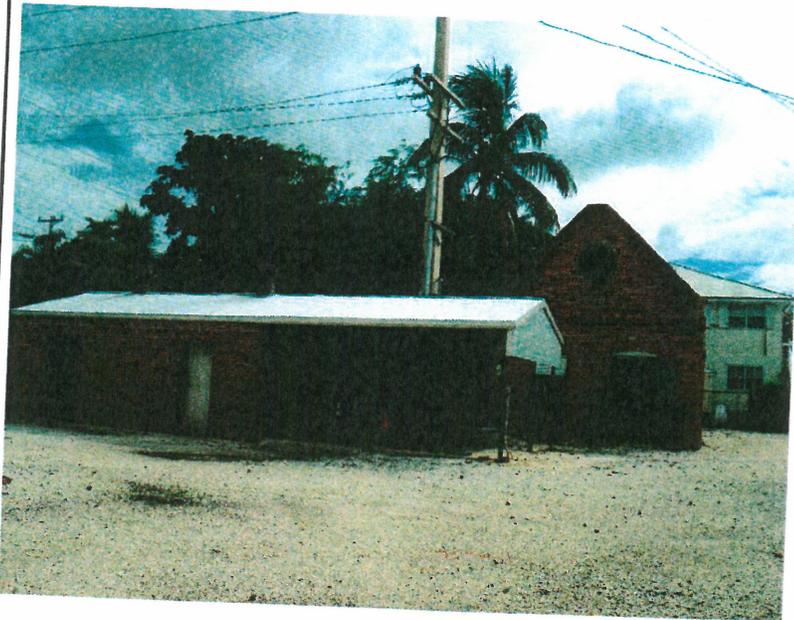
### Photograph 7

View of the Blacksmith Shop and Machine Shop

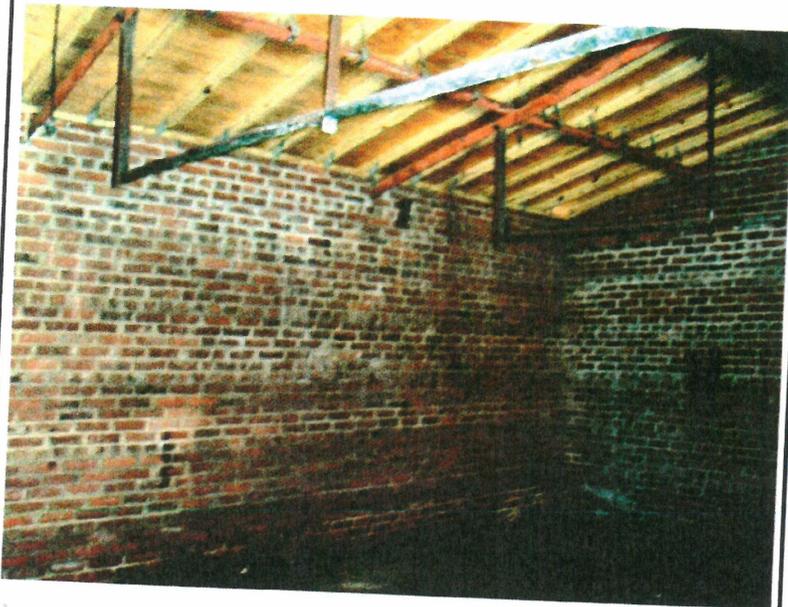
### Photograph 8

Interior view of the Blacksmith Shop

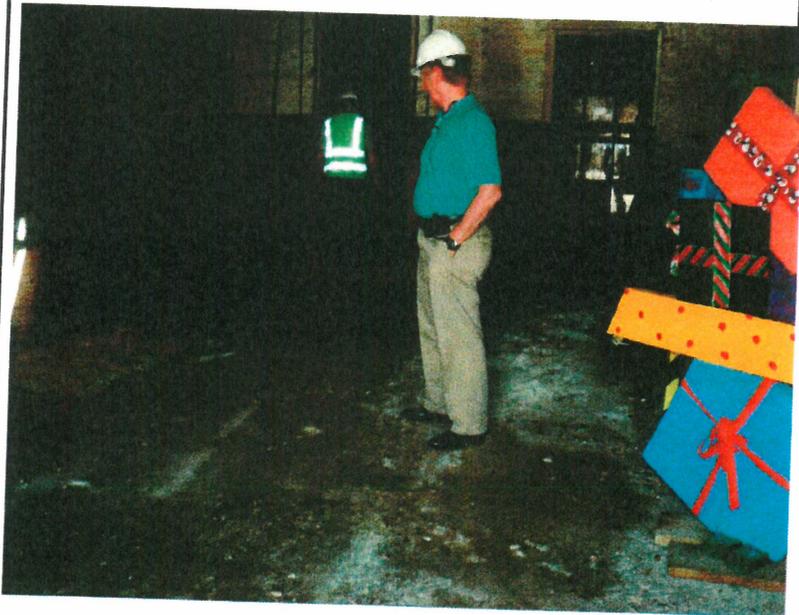
Photograph 9

Interior view of the Machine Shop.
