According to City engineering staff, an underground fuel storage tank was located in the vicinity of monitoring well (MW) number 1 (see Figure 1). This tank was removed in 1992, a closure assessment form was filed (see Attachment 1), and testing found contaminated groundwater (see Attachment 2). In 1996, an additional 2-inch diameter monitoring well was installed (MW-12) on private property adjacent to the City property, and samples were taken from this and all other monitoring wells in the vicinity. Results and recommendations were provided to the City in a report dated March 1996 (see Attachment 3). Additional testing of groundwater from all monitoring wells (with the exception of MW-12, which could not be found) was conducted in October 1999, and the results provided in both a November 8, 1999 monitoring report (see Attachment 4) and the June 2000 NAMP (see Attachment 5). Additional sampling and analysis of groundwater from MWs 1, 6, 8 and 10 was conducted in October 2000 and an NAMP addendum submitted (see Attachment 6) that resulted in DEP approval in December 2000 of a scope of work for an NAMP (see

GEOTECHNICAL ENGINEERING SERVICES
 CITY OF KEY WEST ADMINISTRATION BUILDING

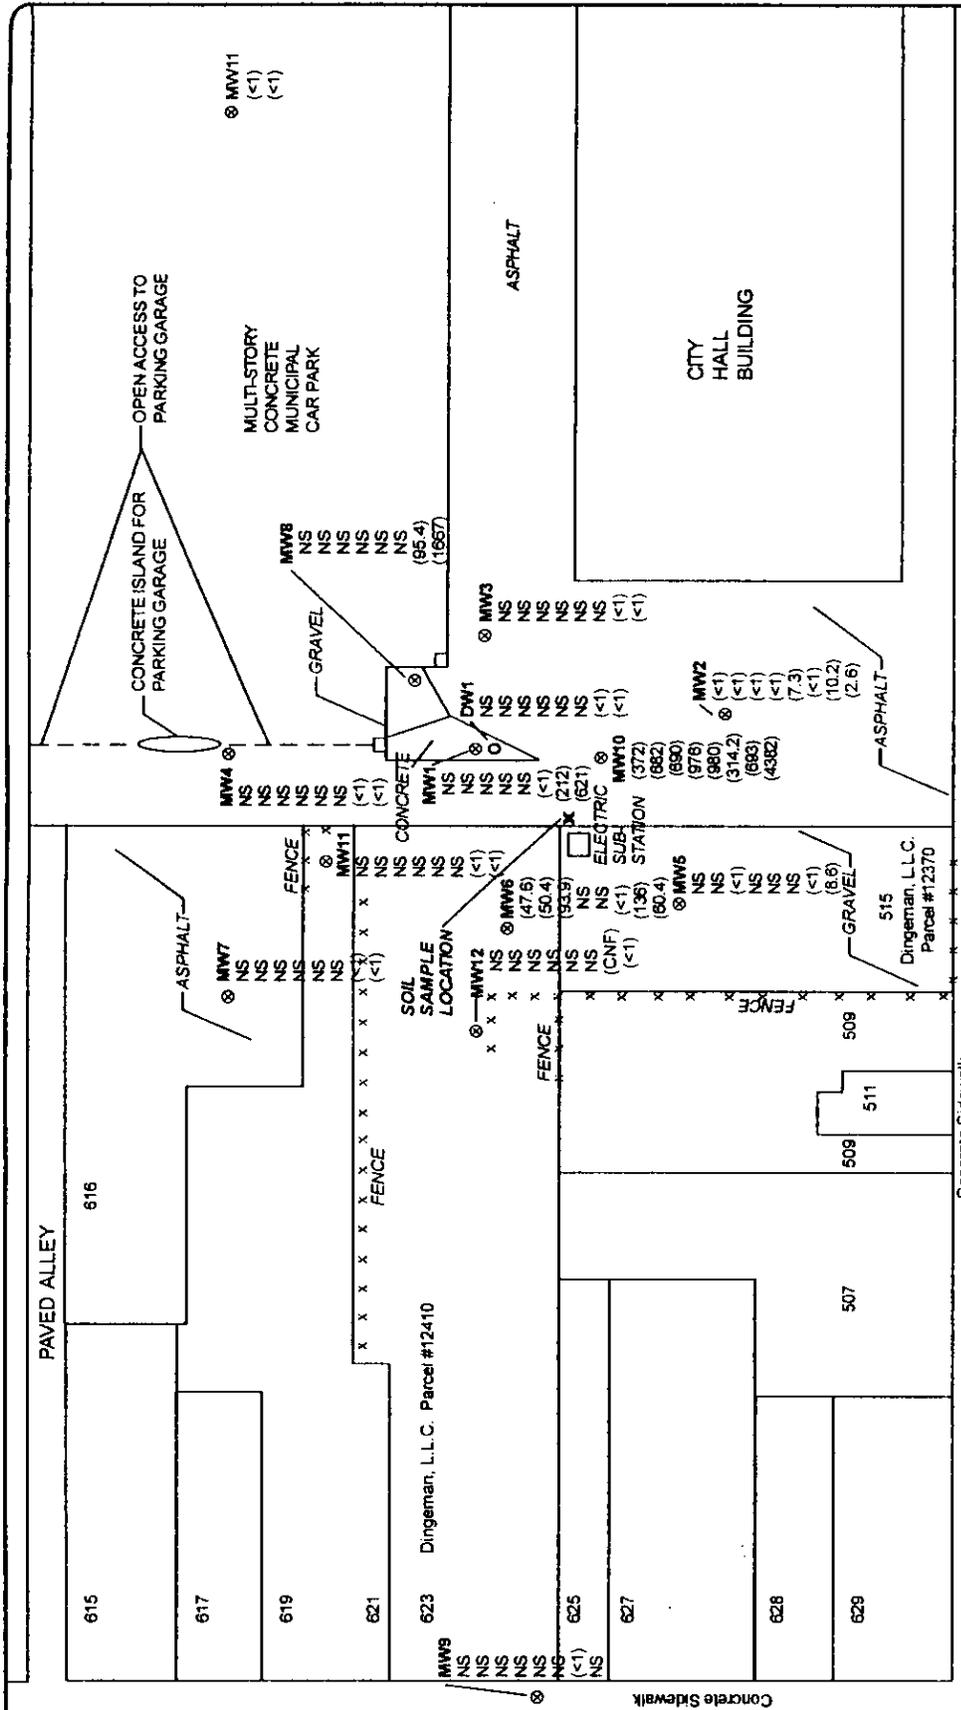
FIGURE 1

CITY OF KEY WEST
525 ANGELA STREET
KEY WEST, FLORIDA

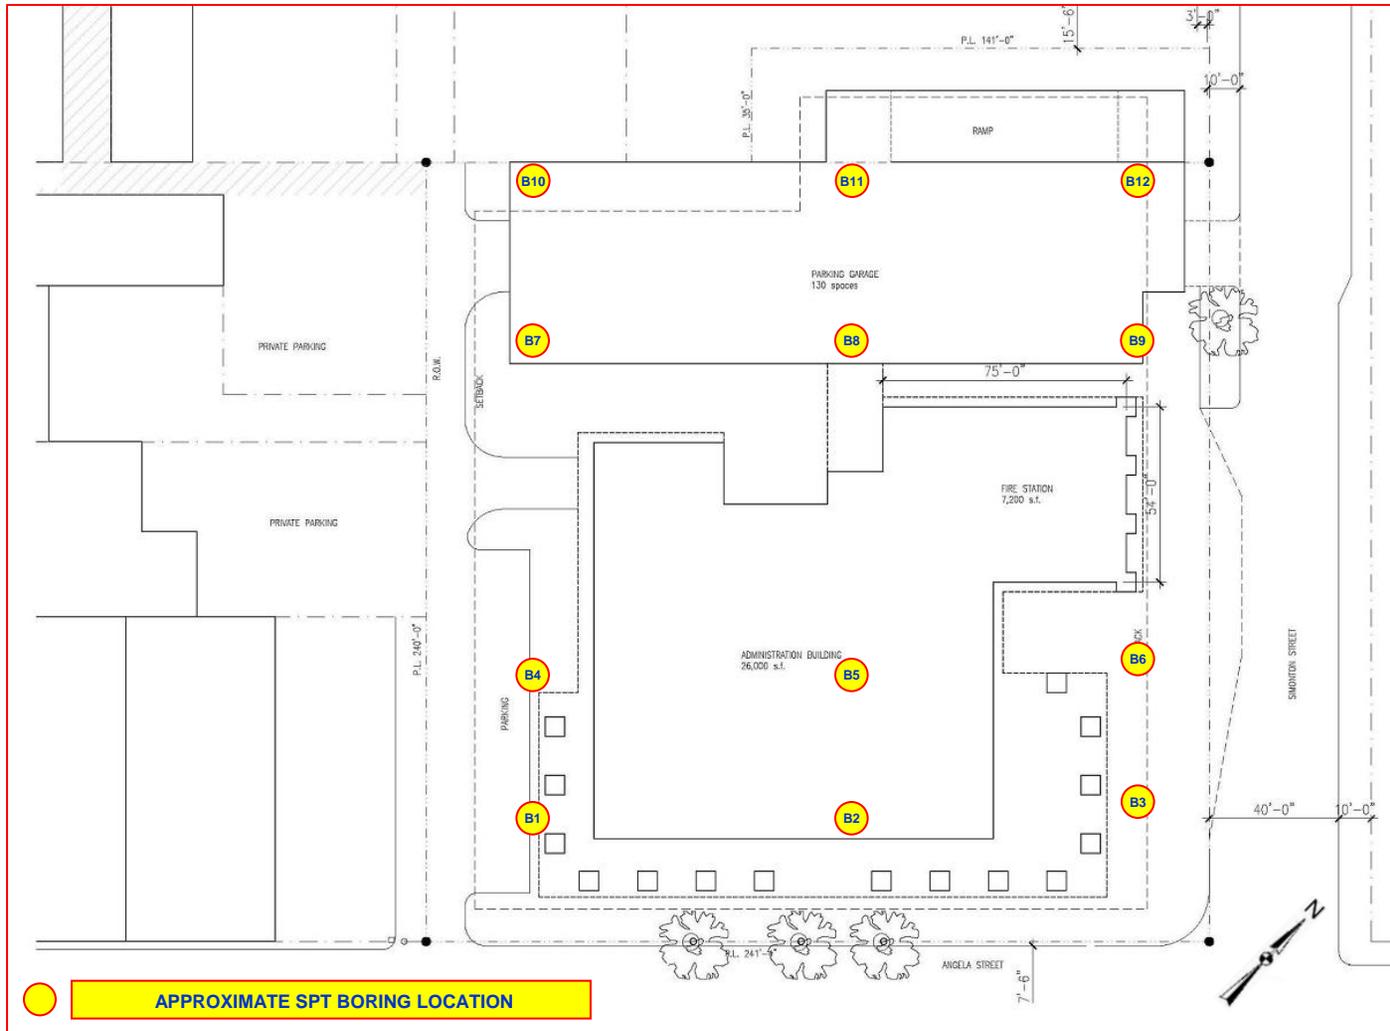
BORING LOCATION PLAN

GEOTECHNICAL ENGINEERING SERVICES
 CITY OF KEY WEST ADMINISTRATION BUILDING COMPLEX
 INTERSECTION OF ANGELA STREET AND SIMONTON STREET
 KEY WEST, FLORIDA

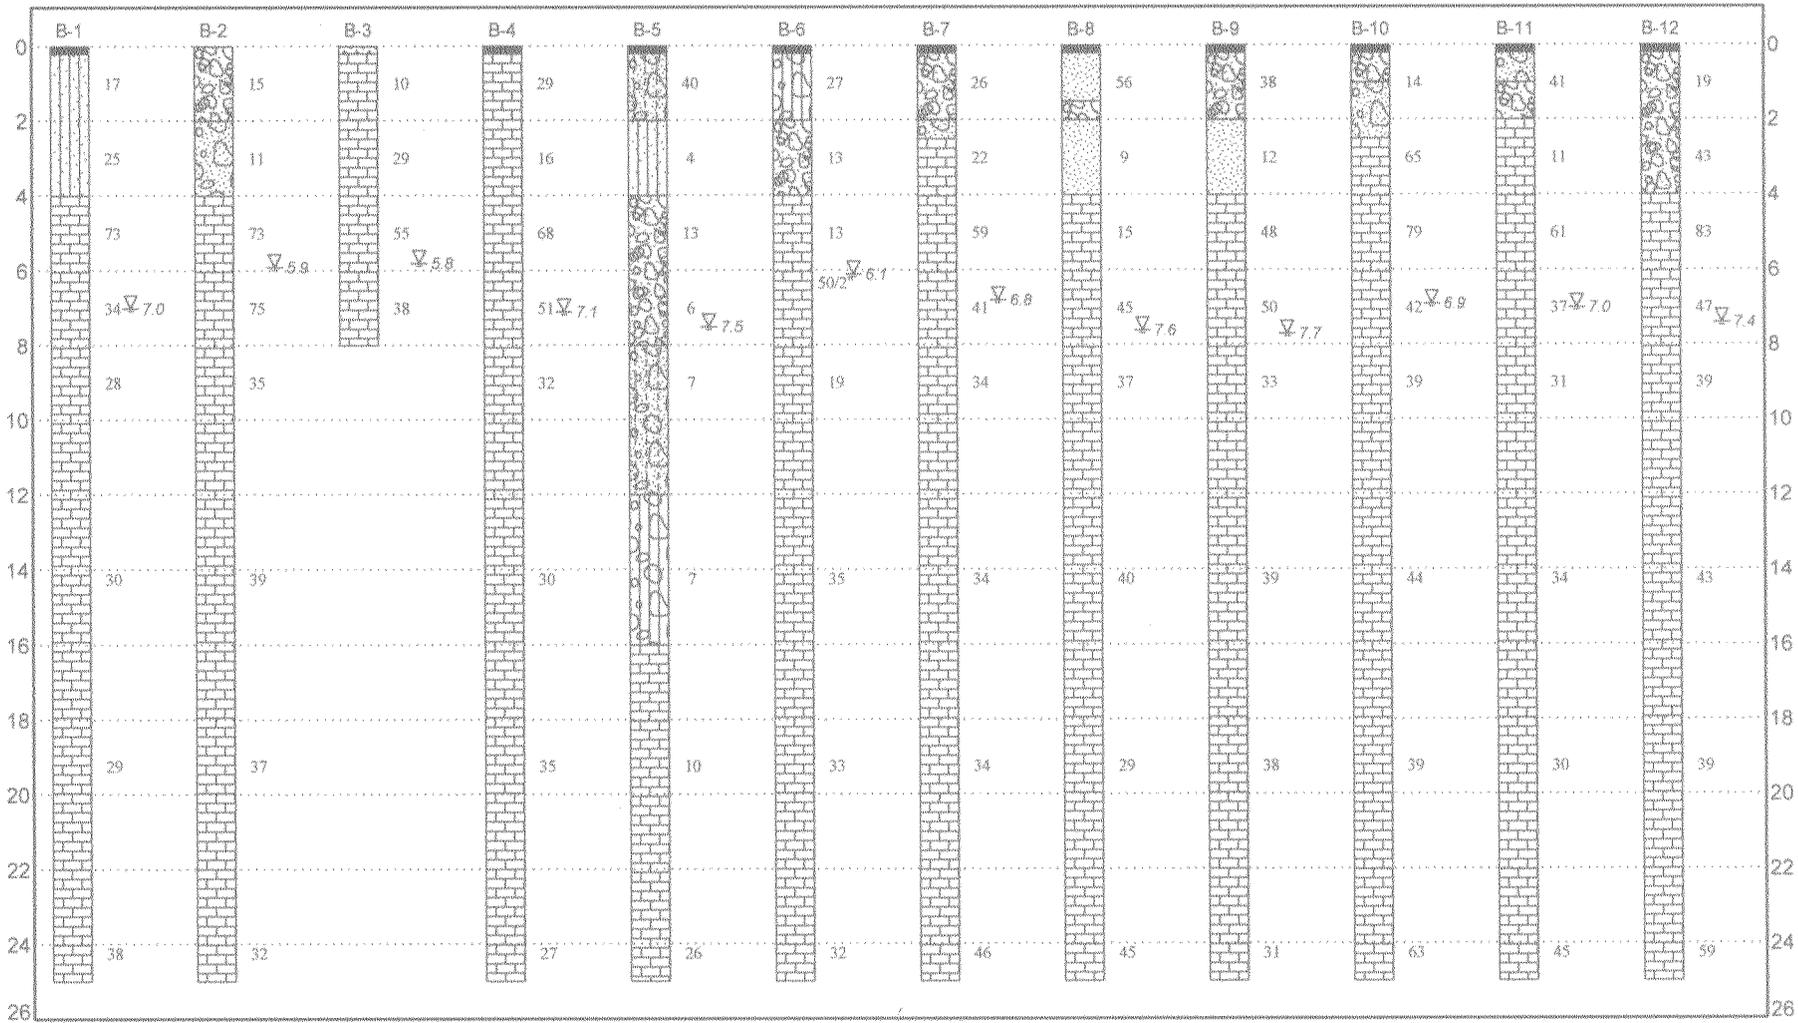
GENERALIZED SOIL PROFILE		
DATE DRAWN 07/13/2009	DRAWN BY / APPROVED BY CD / DB	SHEET NO.: 4
Client: MBI K2M ARCHITECTURE, INC.		
Project: CITY OF KEY WEST ADMINISTRATION BUILDING COMPLEX		
Location: KEY WEST, FLORIDA		
Number: 397-95037

- Asphaltic Pavement
- Sandy Silt
- Limestone
- Sandy Gravel
- Gravelly Sand
- Topsoil
- Gravelly Silty Sand
- Sand
- Gravelly Silt

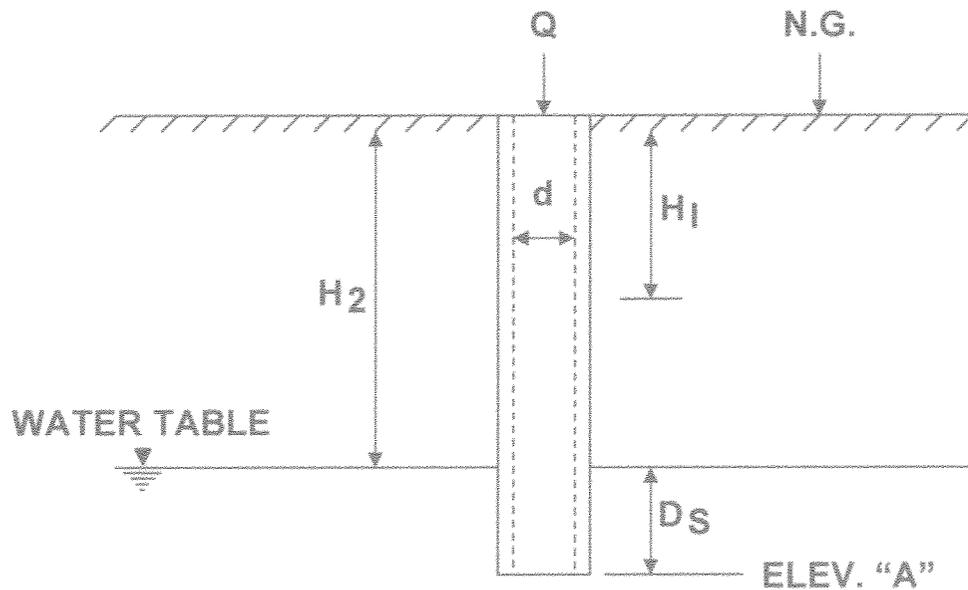
USUAL OPEN – HOLE TEST

- (1) The above hydraulic conductivity value is for a french drain installed to the same depth as the borehole test. The value represents an ultimate value. The designer should decide on the required factor of safety.
- (2) The hydraulic conductivity value was calculated based on the South Florida Water Management District's USUAL OPEN HOLE CONSTANT HEAD percolation test procedure as shown on **the following page**.
- (3) A hole diameter of six inches was used in the computation of the Hydraulic Conductivity value presented in the above table.
- (4) The water table depth (prior to test) was adjusted to 5 feet to avoid a negative head value.

$$K = \frac{4Q}{\pi d (2H_2^2 + 4H_2D_S + H_2d)}$$

K= HYDRAULIC CONDUCTIVITY (CFS/FT.² - FT.HEAD)
