Historic Architectural Review Commission

Agenda Packet

Item 5.a.3

5b7- Request to replace porch columns- #936 United Street- Applicant: **Wayne Garcia (H10-01-92)**

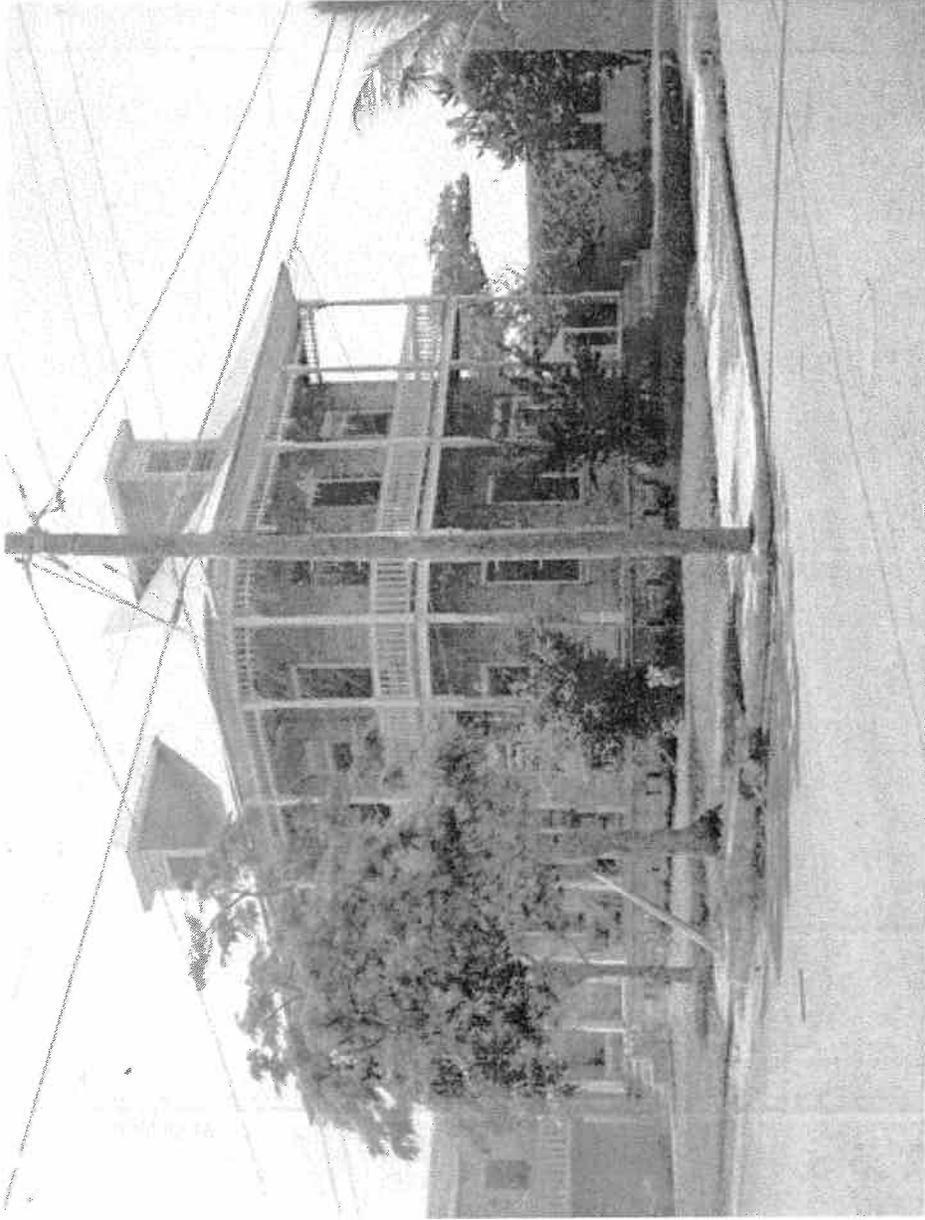
#936 United Street- Monroe County Library- Property Appraisers files circa 1965

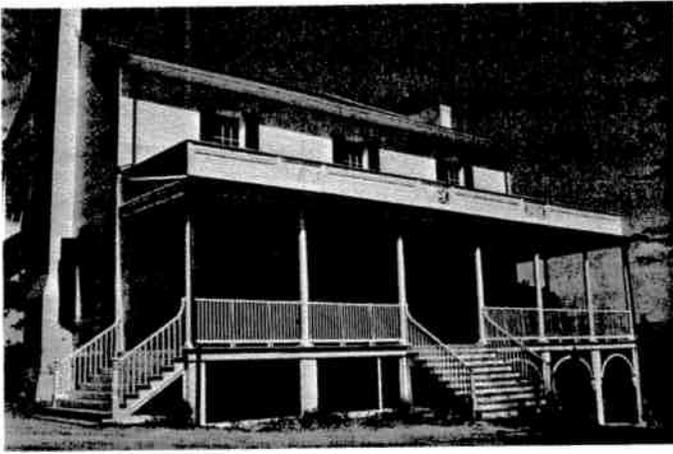
Figure 2. Porches not only help define the architectural character of a building but also serve as living areas. They can be designed to take advantage of surrounding views. Cedar Grove, the home of the nineteenth-century landscape painter Thomas Cole, has an L-shaped veranda on the front and a two-story porch on the rear, providing an enviable view of the Catskill Mountains. Photo: Marilyn Kaplan.

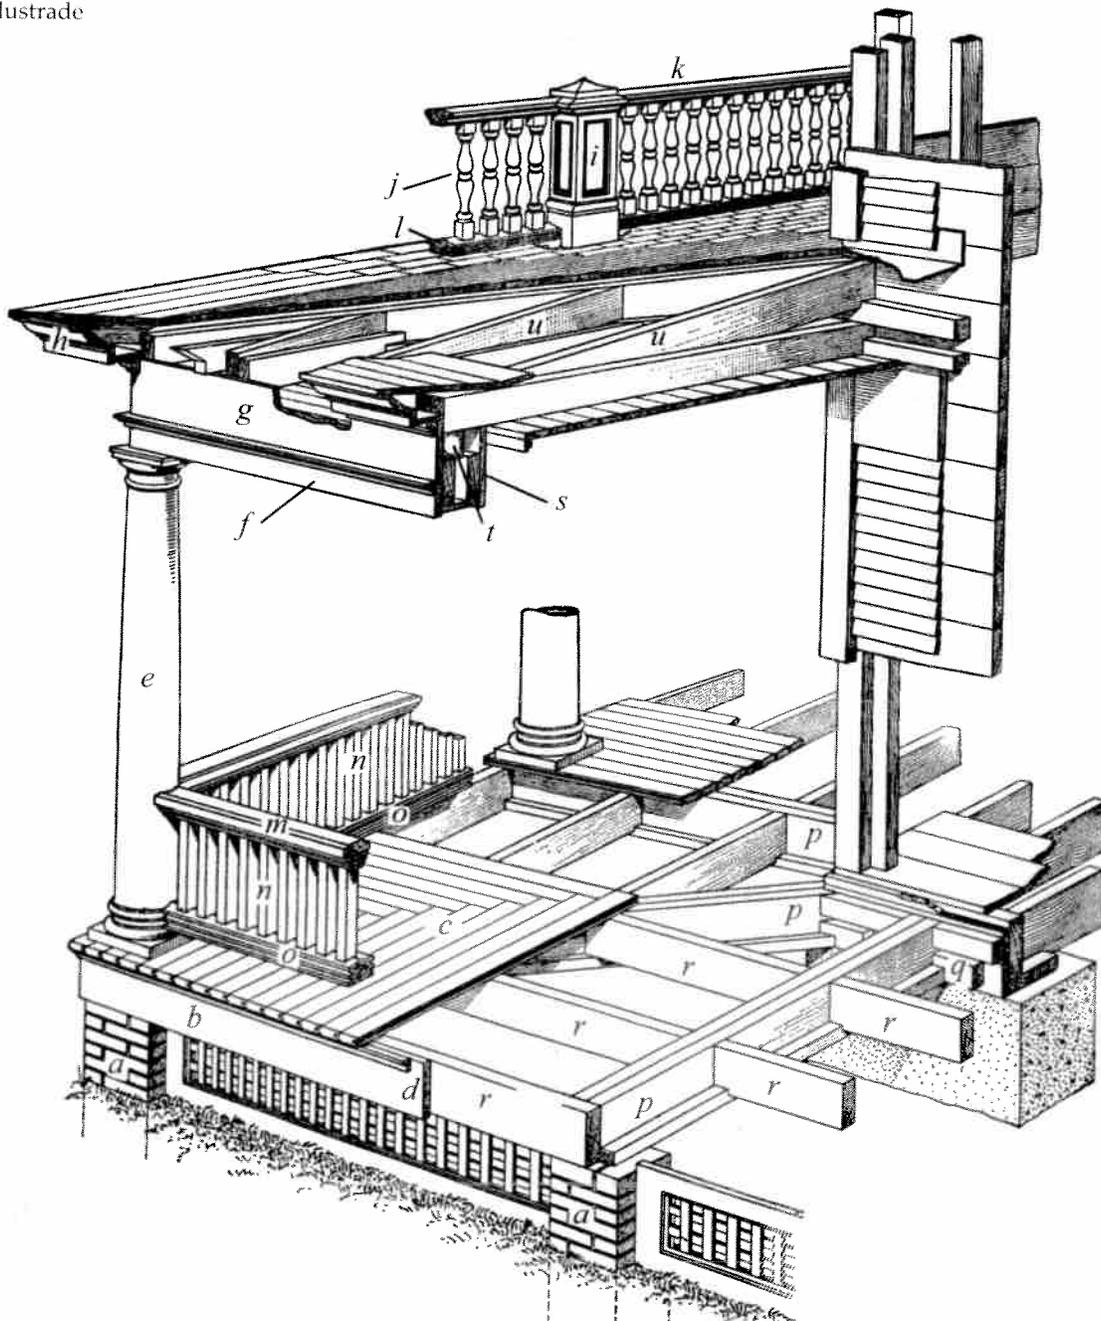
Drawing courtesy of Thomson Education Direct.

- s - Beams inside the entablature span from column to column, support plate
- t - Plate of the entablature rests on beams, supports roof rafters and ceiling beams
- u - Rafter of the roof structural system

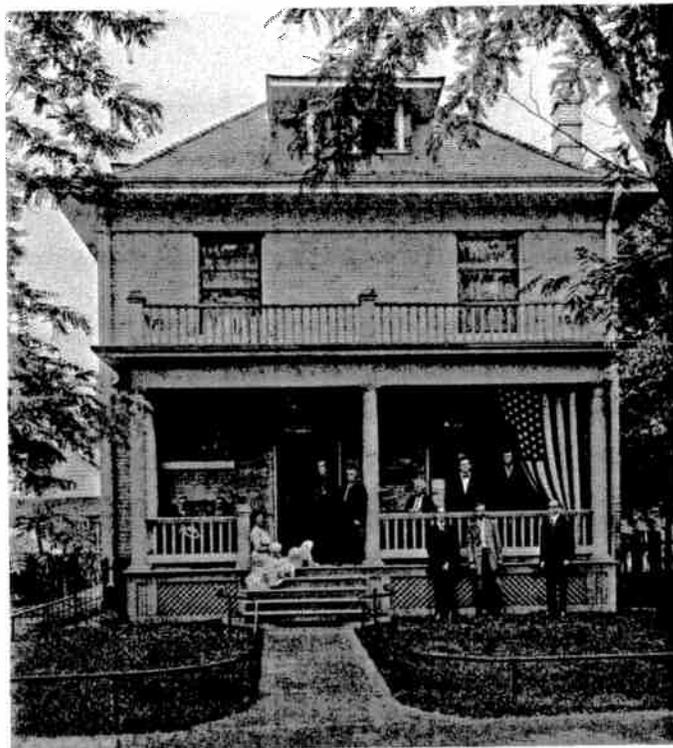
Figure 4. Celebrating the 4th of July in 1912, this gathering of family and friends reflects the popularity of the porch as a social gathering place. While not overly ornate, each detail of the porch from the roof balustrade to the turned columns to the simple lattice work facing the deck contributes to its character, creating in effect the dominant architectural feature of the building. Photo: © Utah State Historical Society

The open qualities are one of the key features of most historic porches. Overall size, shape and design are obviously important components as well. There are numerous other contributing features which may exist, including the shape of the porch roof, the way a large porch is divided into distinct bays as with columns, the nature of the supporting foundation, the style and size of columns and balustrade, and whether the porch is raised or largely at grade. The simplicity of a porch or its richness in detail will also help define it. Materials are usually important as well, not just the wood features, but also whether other materials exist such as masonry columns and steps (Fig 4).

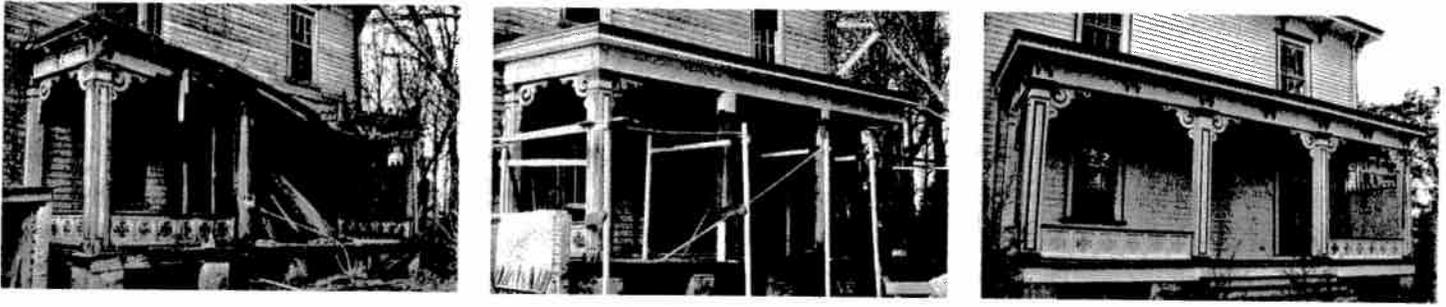
Figure 5. Even historic porches that appear to be in total disrepair may be repairable. While the roof needed replacement, much of this porch was repaired, including such features as the decorative columns, ornamental brackets, and balustrade. Photos: John Leeke.

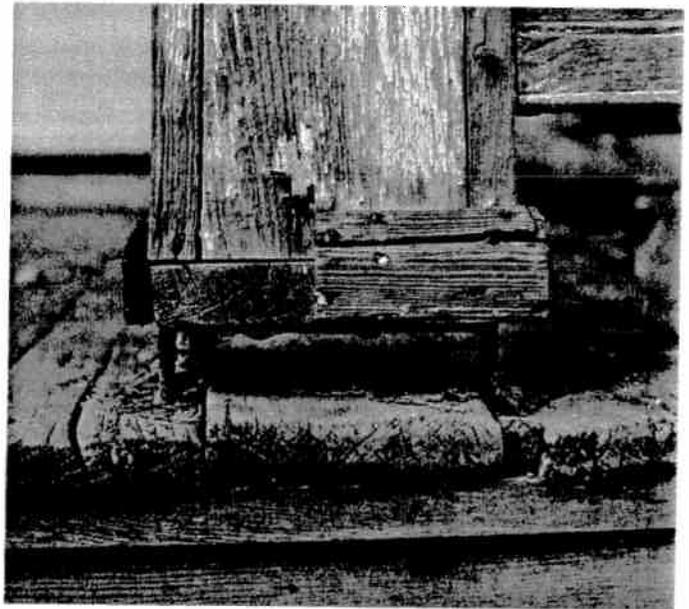
Figure 6. A traditional way to extend the life of porch posts was to place posts on metal feet, thereby providing a separation between the wood post and wood deck. This helped to prevent the wood post from rotting at the base. Early post feet were simple iron bars bent unto a stirrup shape. By the late nineteenth century manufactured cast-iron feet were common, consisting of a pair of disks separated by a short pipe. Post feet are still available today. Courtesy of Old-House Journal/Brian McNeil.

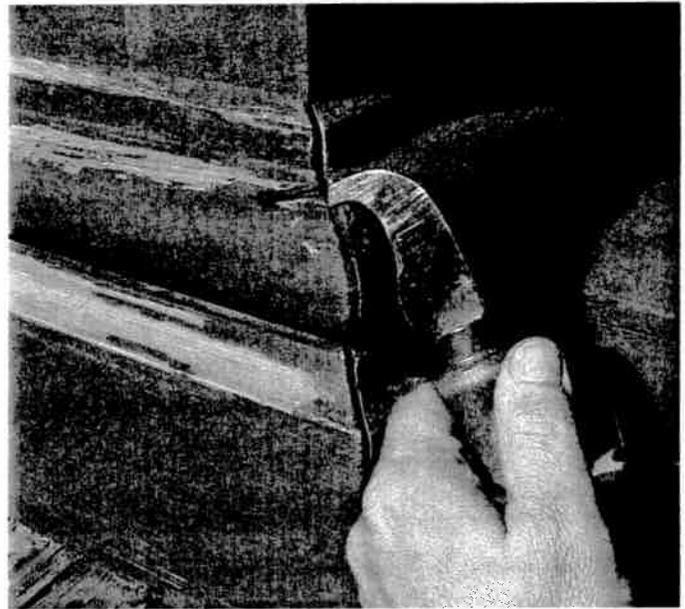
Figure 7. Common problems with porches that can contribute to serious wood decay include cracks in woodwork and joints that have opened up. Both provide an easy path for water seepage. Trapped moisture can foster peeling paint, wood decay and insect infestation. Open joints and cracks should be checked for evidence of more serious decay and marked for caulking or repair. Photo: John Leeke.

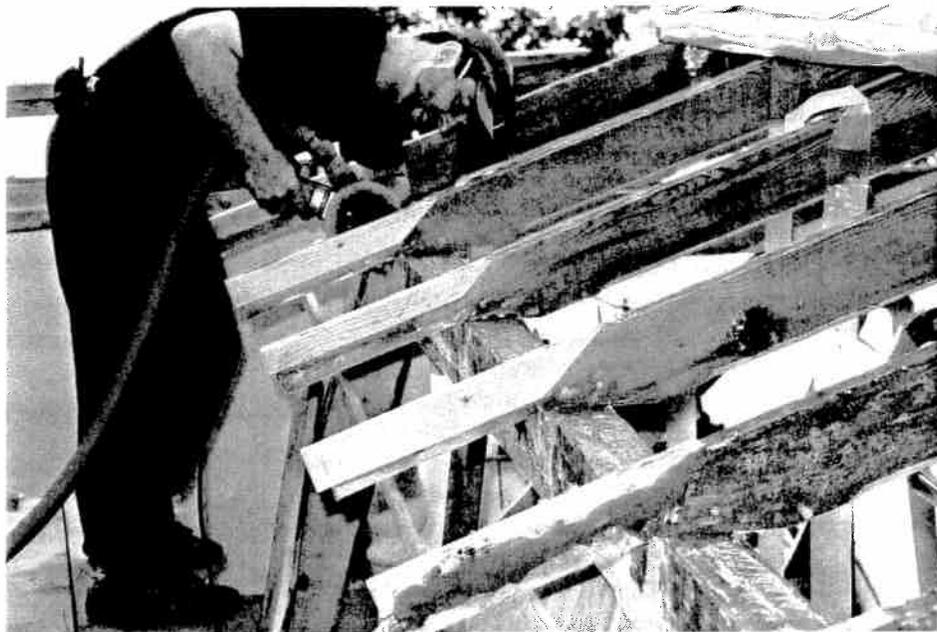
Figure 9. The ends of porch roof rafters are often susceptible to moisture decay. When concealed by a soffit or ceiling, rafters can be repaired by adding new sister boards. Where roof rafter ends are exposed, splicing new wood onto the old (dutchman repair) and use of epoxy consolidants and fillers both preserve sound historic fabric while retaining the historic appearance.
Photo: Paul Marlowe, Marlowe Restorations.

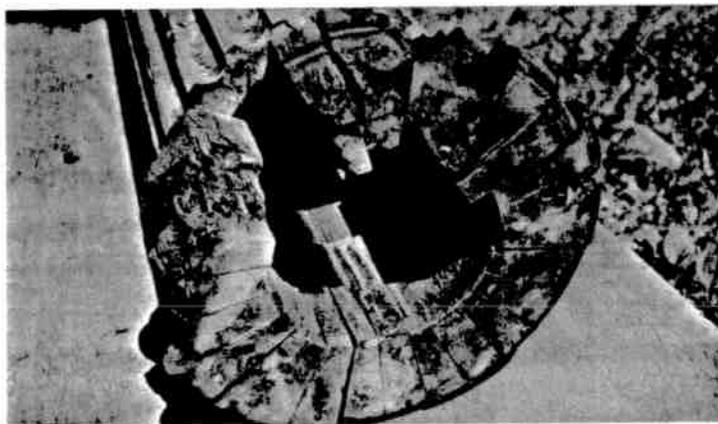
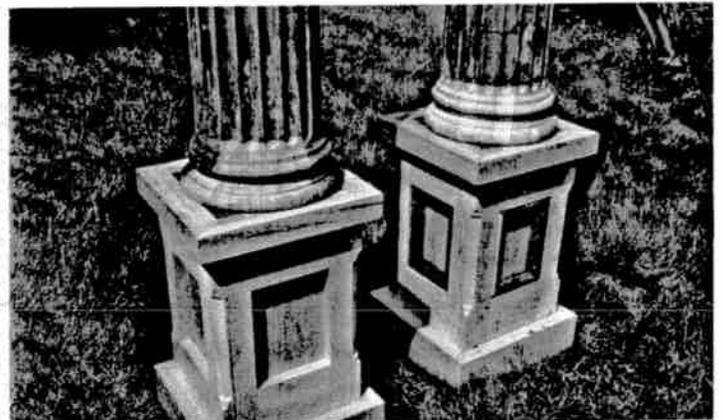
Figure 10. This nineteenth century porch column is made of wood staves, similar to the way a wood barrel is put together. After replacing the torus and making dutchman repairs to the apophyte along the base, the column and pedestal are ready to be reinstalled on the porch. Photos: NPS files.

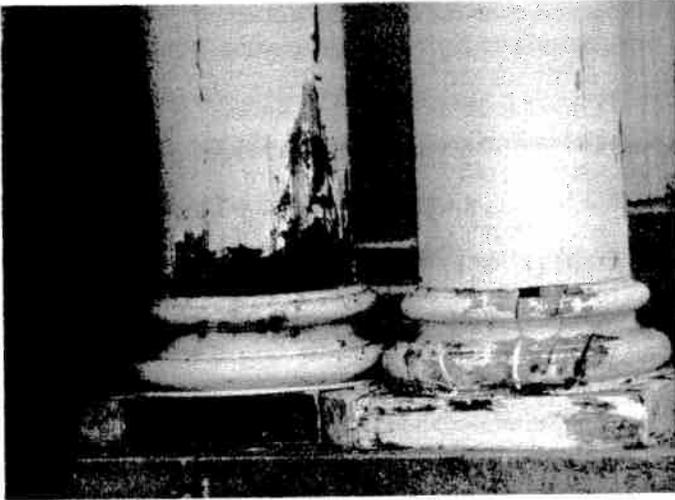
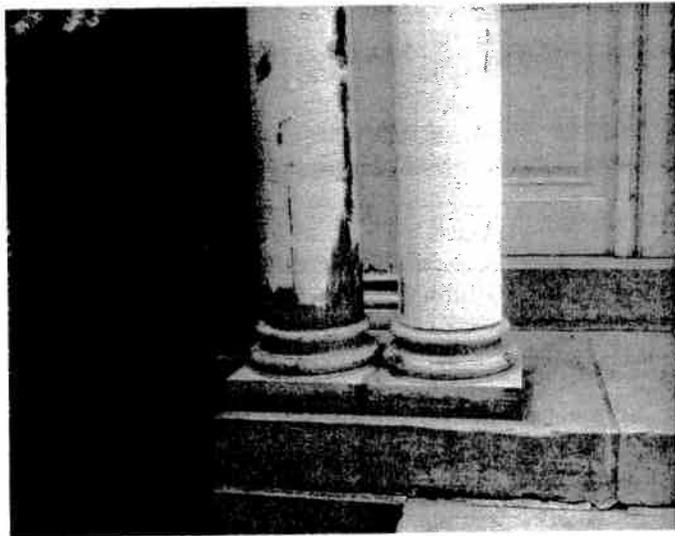
Figure 11. The lower shaft of the porch columns had decayed as water wicked up through the end grain (top). The column shafts were repaired in place by cutting out the deteriorated wood and making repairs using epoxy consolidants and fillers. (bottom). The column bases were replaced. Photos: Paul Marlowe, Marlowe Restorations.

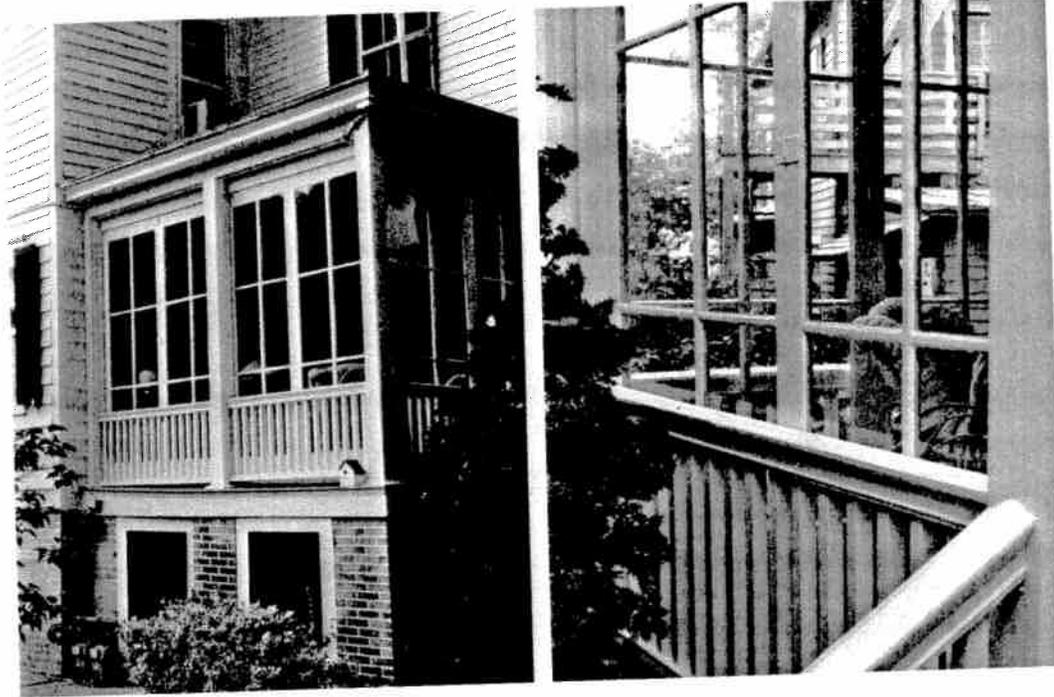
Figure 12. This old porch enclosure, located on the back side of a house, has acquired significance over time and is remarkable both in the appropriateness of its detailing for use by others today, as well as its high degree of maintenance. The enclosure is set behind the columns; the balustrade has been retained; and the light divisions and the size of the glass panes echo that of the windows above. Within each bay there are two well-crafted, inward swinging doors, providing for greater seasonal use of the porch. Photos: Charles Fisher.

Much of the character of a historic open porch is clearly its openness. Therefore, in most cases, a historic open porch should not be enclosed. If a porch enclosure is being considered, its significance and location—as well as the nature of the planned enclosure—play key roles in whether it can be done without changing the porch's and building's historic character. While it is almost never appropriate to enclose a front porch on a historic building to create interior space, enclosing a less prominent porch on a less visible elevation could have less impact. In addition, an enclosure should retain as many of the historic porch features as possible (Fig 12).

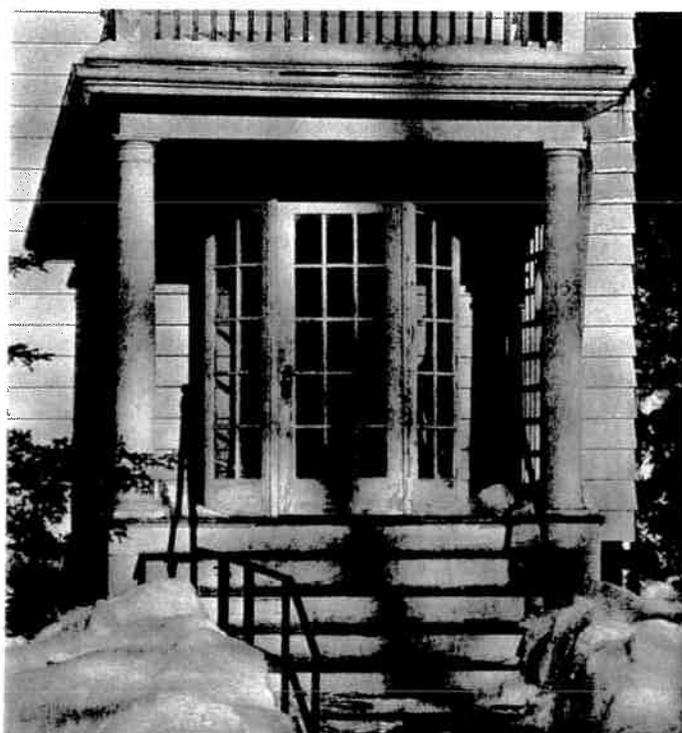
Figure 13. Particularly in New England, there is a cold weather tradition of installing temporary glass and wood panels at entrance doors, thereby creating an enclosed vestibule. These enclosures with their small divided lights were generally removed in the spring. Photo: John Leeke.

months while not permanently altering its appearance. In fact some have become historic features of buildings. Particularly in New England, there is a continuing tradition of installing relatively substantial glass and wood panels on porches during the winter, especially around an entrance door. These tended to have small divided lights. Sometimes porches were fully enclosed with a divided light glass door for entry, creating an enclosed vestibule that reduced the amount of cold air entering the house when the door was opened. Others consisted of simple sidewalls perpendicular to an existing entrance door, serving as a windbreak. Such enclosures were generally removed in the spring (Fig. 13).

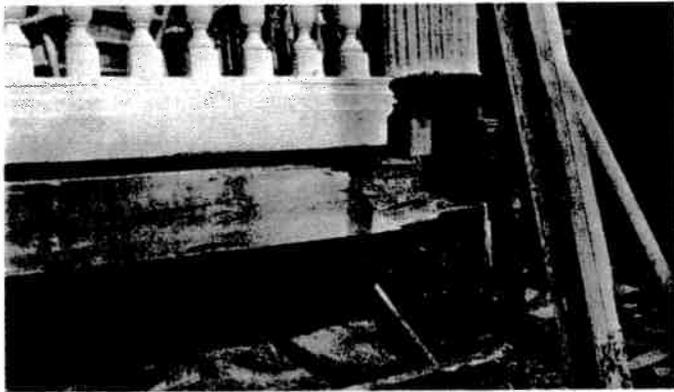
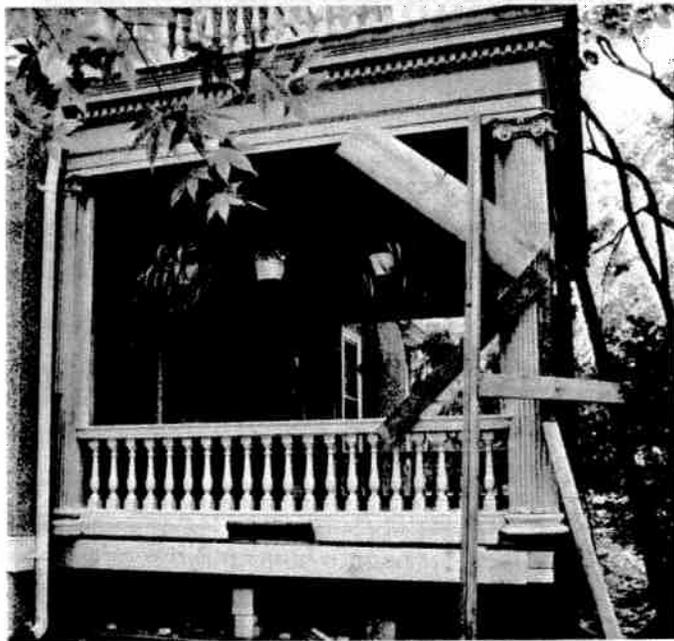
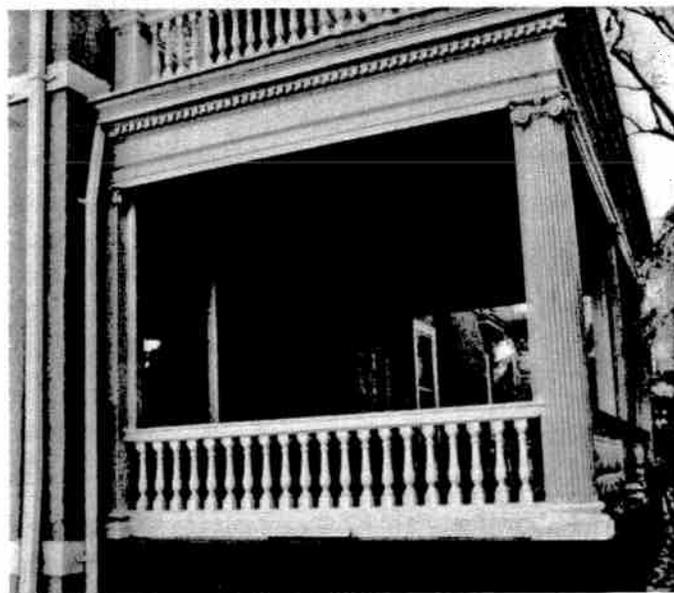
Figure 17. The porch's structural system must be capable of supporting today's loads. In this case moisture led to the deterioration of the wood girder at the corner, creating a major structural deficiency (top). A new solid timber was installed to replace the girder (middle); alternatively a built-up girder could have been used since a fascia board would conceal it. The column base was repaired and portions replaced and the balustrade and column reset and secured (bottom). Photos: Paul Marlowe, Marlowe Restorations.

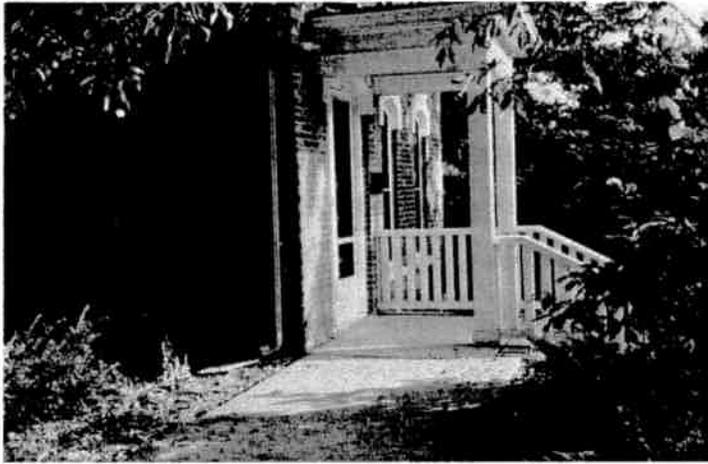
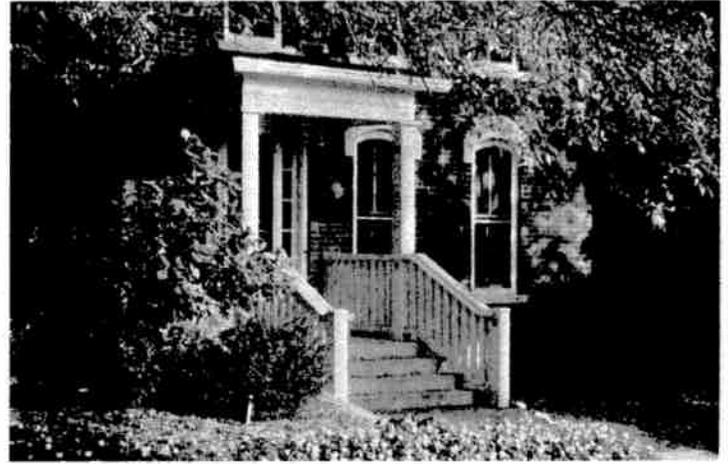
Figure 18. When a porch is used as a wheelchair accessible entrance, it may be possible to retain the historic stairs by adding a ramp parallel to the building. Through plantings and some re-grading, the new ramp built parallel to the building (left) allows retention of the historic stairs and does not impact the historic character of the entrance (right). Photo: Iowa State University Extension.

entrance alternative. It may be possible to retain the historic stairs by adding another entrance to the porch with the construction of a ramp parallel to the building (Fig. 18).

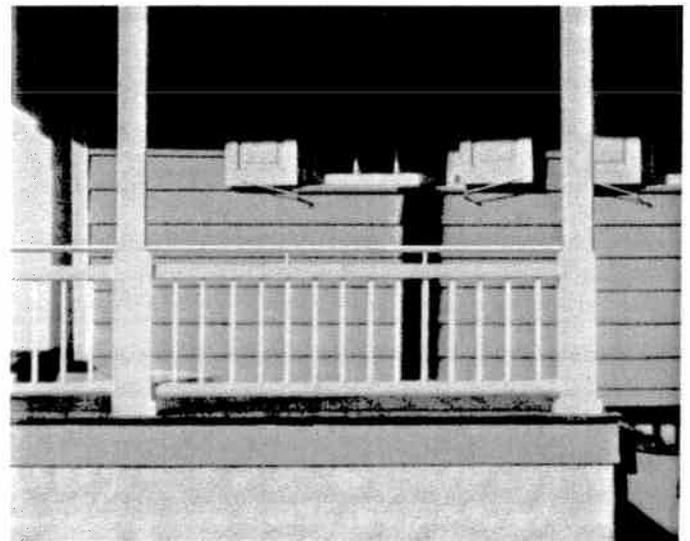
Figure 19. Historic porches generally have railings that measure 28 to 30 inches in height from the floor. When additional height is necessary for safety, a simple rail, added for illustration purposes in this photograph, can usually be installed above the historic balustrade, but it also has a minimum impact to the appearance of the porch. Photo: Charles Fisher.
