ASBESTOS INSPECTION REPORT

SOUTHERNMOST
WASTE TO ENERGY PLANT COMPLEX
5701 COLLEGE ROAD
KEY WEST, FLORIDA 33040

March 16, 2011
EE&G Project No. 2010-2498

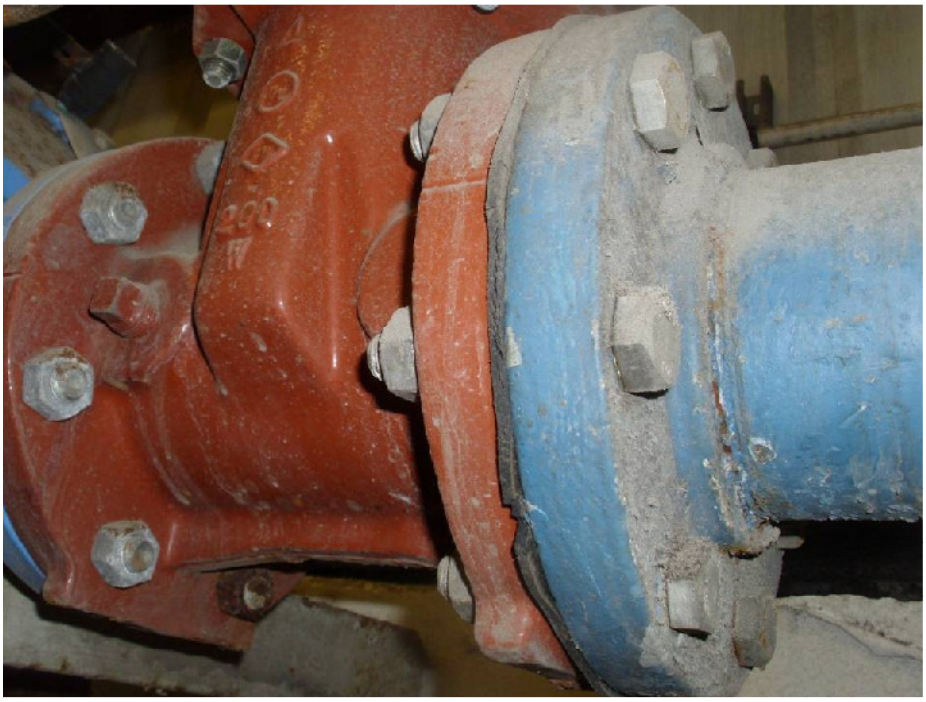
Photo 11: NonACM black gasket sampled during this inspection.

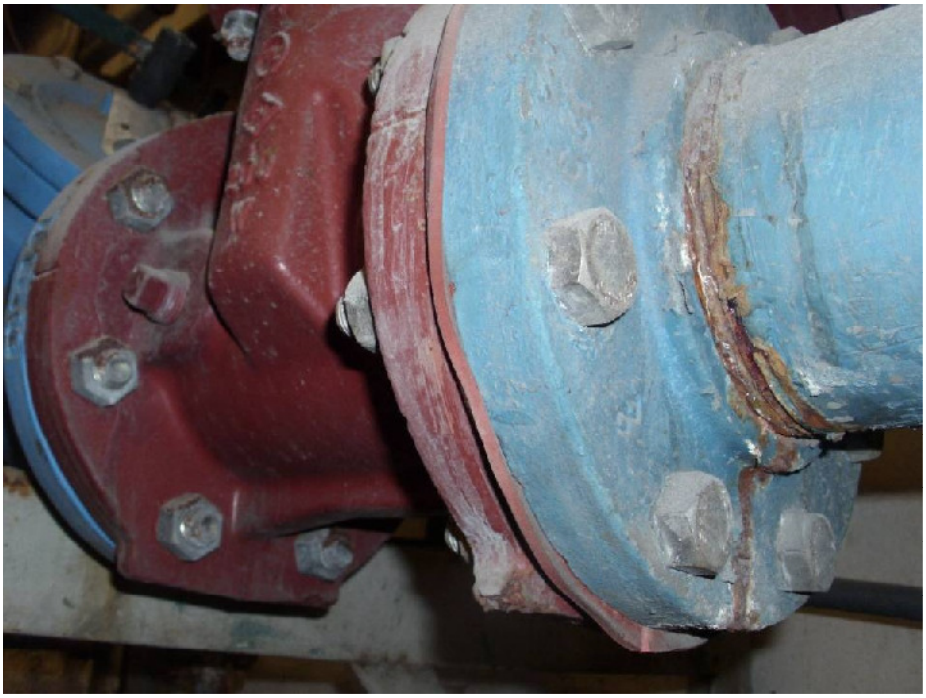
Photo 12: NonACM red gasket sampled during this inspection.
