SITE INSPECTION REPORT
KEY WEST GAS AND ELECTRIC CO.
KEY WEST, MONROE COUNTY, FLORIDA
EPA ID. No. FLN000410751
FDEP Comet Site ID #303264

August 16, 2012

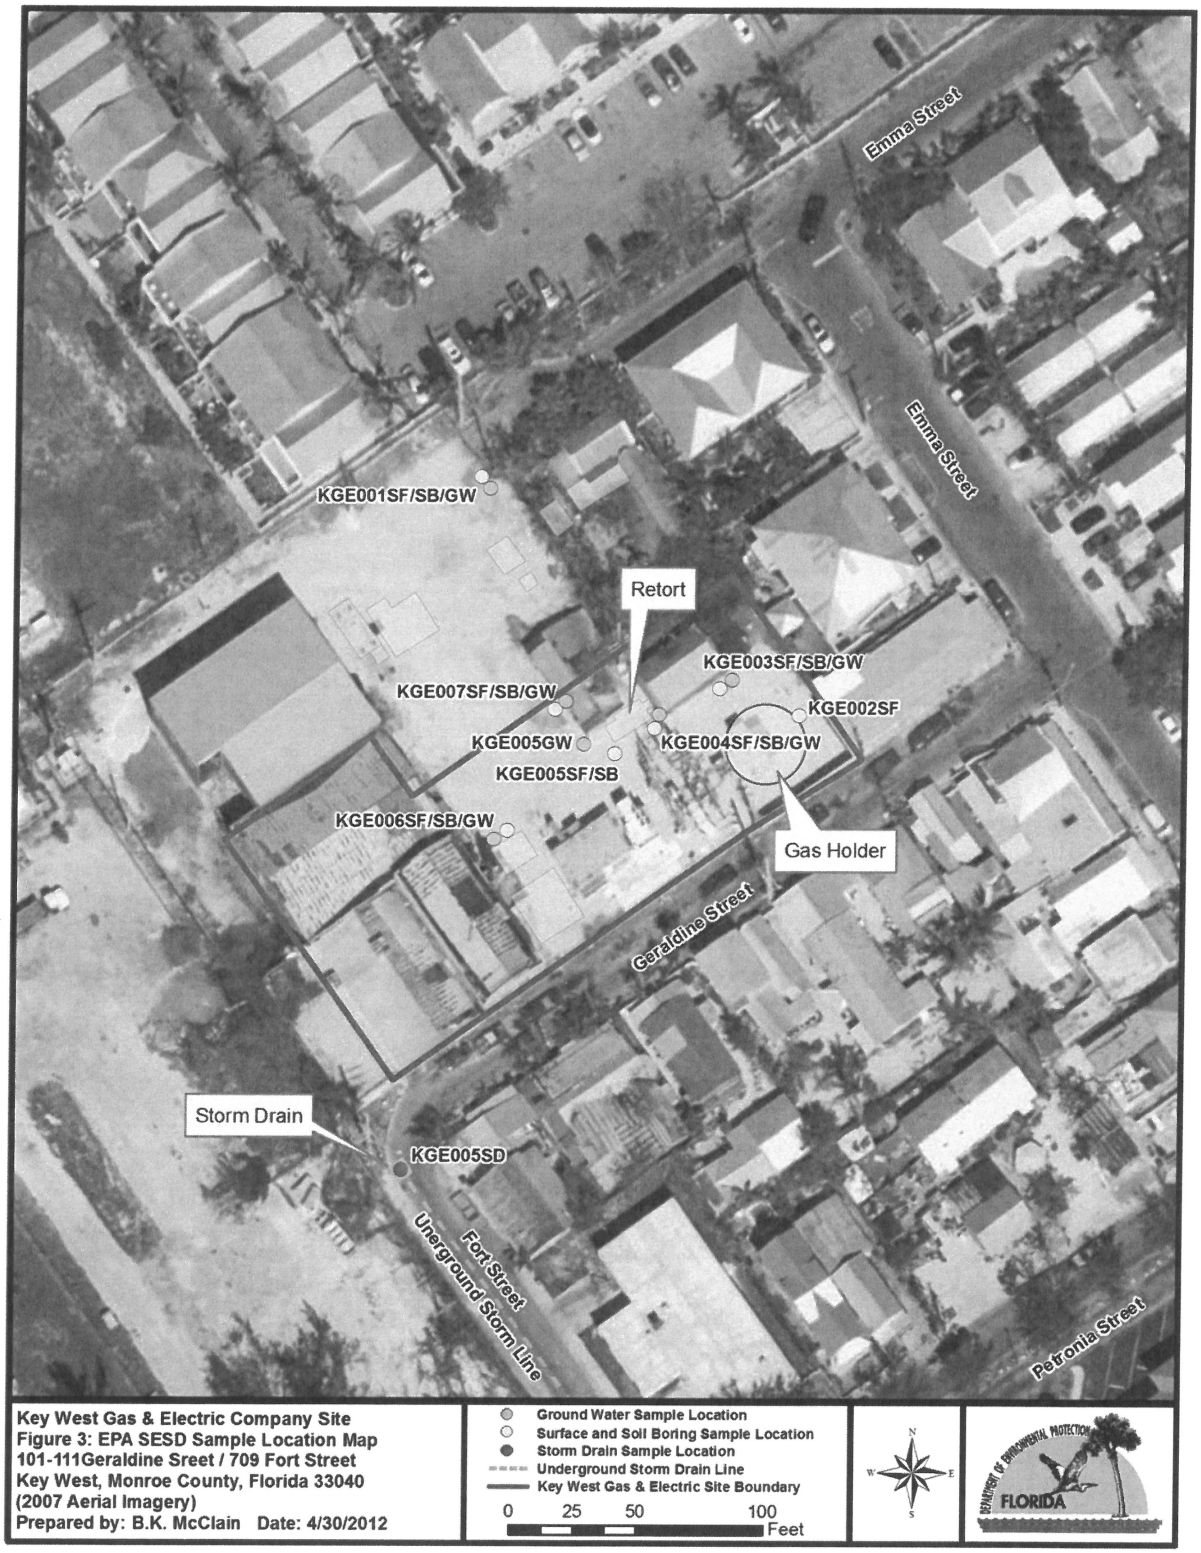
Detectable levels of metals, VOCs and semi-VOCs were found in site soils. The sample locations are shown on Figure 3 and the soil analytical results are presented on Tables 4a, 4b, 5a, 5b, 6a & 6b and Appendix C.
The metals detected included arsenic, chromium and lead. Arsenic was detected in surface soil sample KGE002SF (19 milligrams per kilogram [mg/kg]) in excess of the State of Florida Soil Cleanup Target Levels (SCTLs) for direct exposure for both residential (2.1 mg/kg) and industrial (12 mg/kg) settings. Elevated levels of lead were detected in background surface soil sample KGE001SF (900 mg/kg) and KGE006SF (440 mg/kg) in excess the State SCTL for direct exposure for residential (400 mg/kg) settings. Lead is a component of Gasifier ash and bag ore associated with MGPs. However, it is also used in paint, caulking, pipe work and roofing and was a former octane booster in gasoline [33, 67]. The chromium detection in subsurface soil sample KGE006SB was below State SCTL criteria.

groundwater leachability. Detectable levels of semi-VOCs, in particular PAHs, were found in the soil samples collected from the site. These levels were significantly above the background soil concentrations of KGE001SF/SB. The following PAHs were detected above State SCTLs for groundwater leacability criteria. They included benzo (a) anthracene (1,900 to 4,500 ug/kg), benzo (a) pyrene (10,000 to 19,000 ug/kg), benzo (b) fluoranthene (2,700 to 12,000 ug/kg), dibenzo (a, h) anthracene (1,500 to 7,000 ug/kg) and indeno (1,2,3-cd) pyrene (7,800 to 14,000 ug/kg). The benzo (a) pyrene toxic equivalent [BaP TEQ] concentrations in four locations (eight samples) exceeded the State SCTL for direct exposure under an industrial setting. The sample included KGE002SF, KGE004SF, KGE004SB, KGE604SB, KGE005SF, KGE005SB and KGE007SF. The soil BaP TEQ calculations are presented in Appendix F. The highest levels of PAHs were found in the KGE004 (KGE004SF/SB) and KGE005 (KGE005SF/SB) boring locations. These two locations were adjacent to the former MGP retort (Figures 2a, 3). Many of the detected PAHs are common to both MGPs and petroleum products [33, 34, 68].
