IMPROVEMENTS TO BRING THE CHURCH INTO ADA COMPLIANCE (BATHROOMS, RAMP, ETC.) STRUCTUR

REPORT AND
RECOMMENDATIONS

**ARCHITECTURAL CONDITIONS
AT THE CORNISH MEMORIAL
A.M.E. ZION CHURCH**

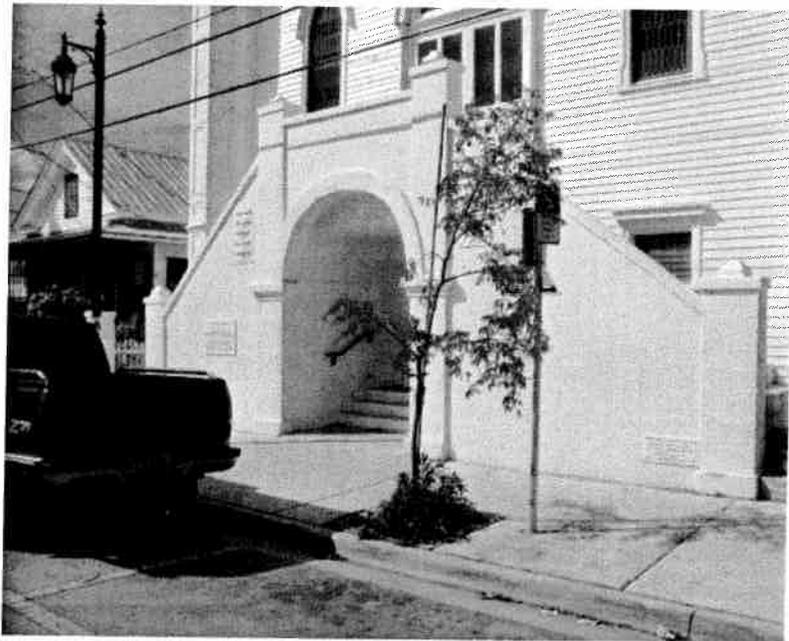
Figure 8 Spanish Colonial Stair

The twin concrete and stucco stairs at the front of the church, built in the early 1900s, shows a clear Cuban influence, with Spanish Colonial piers and a Roman arch (Figure 8).

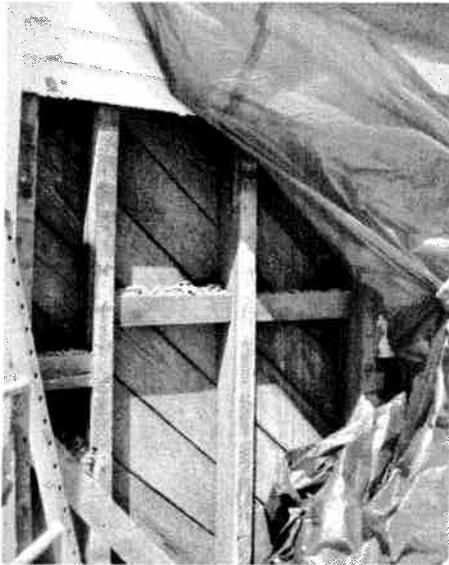
Figure 20 Exterior Wall

Walls are framed with 2"x 6", 3"x 6", and 4"x 6" studs and diagonal bracing (Figure 18), with studs running unbroken from a 6"x 6" continuous sill to a 4"x 6" (est.) top plate. Major studs and diagonal bracing are mortised into the sill and secured with hardwood pegs. Diagonal wood sheathing, 1"x 6" covers the inside face of the studs and 1/2"x 6" wood lap siding covers the stud's exterior face. Sheathing and siding are attached with cut nails. Wall studs and bracing members show little rot and damage (Figure 20). The 1/2"x 6" lap siding shows moderate deterioration through cupping and subsequent cracking.

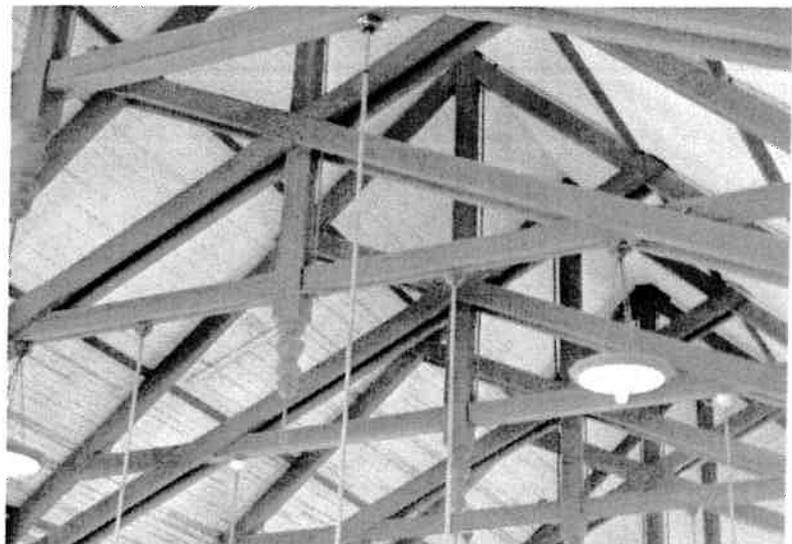
Figure 21 Roof Trusses

The roof structure consists of nine modified wood scissors trusses with collar ties and king posts spaced at 9'-8" and resting upon the top plate of the walls (Figure 19). Upon the trusses and running perpendicular to them to the gable ends of the building are 4"x 4" wood girts spaced at 7'-0". In turn, 2"x 6" rafters rest upon girts approximately 24 inches apart. The rafters are sheathed with 1"x 6" horizontal sheathing on their exterior face and 1x 6 tongue and groove ceiling boards on their inside face. The pitch of the of the roof is 12/12 (Forty-five degrees).

The roof structure appears to be in good condition generally, although the king posts of the trusses evidence stress cracks and the bottom chords of the trusses show slight deflection. (See also Connections and Storm Resistant Provisions, This Section).

4. Strengthen and Repair the Roof Trusses.

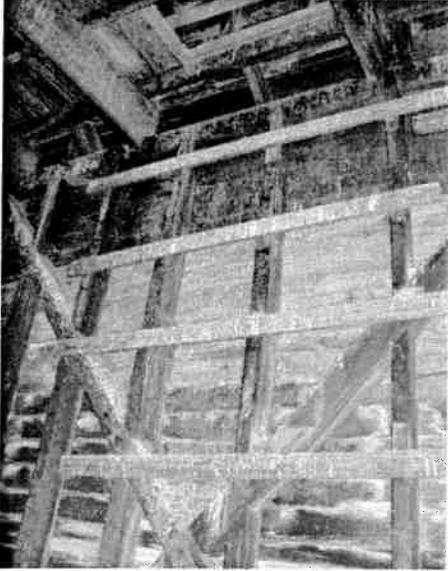
Figure 22 Bell Tower Structure

The bell tower structure is a timber frame with 6"x 6" corner posts, 4'x 6" "X" bracing, and 3"x 6" studs approximately twenty-four inches on center (Figure 22) and lap siding. There is no interior sheathing. The bell tower framing is in good condition. Modern sheet metal hurricane clips of questionable value have been added in various locations.

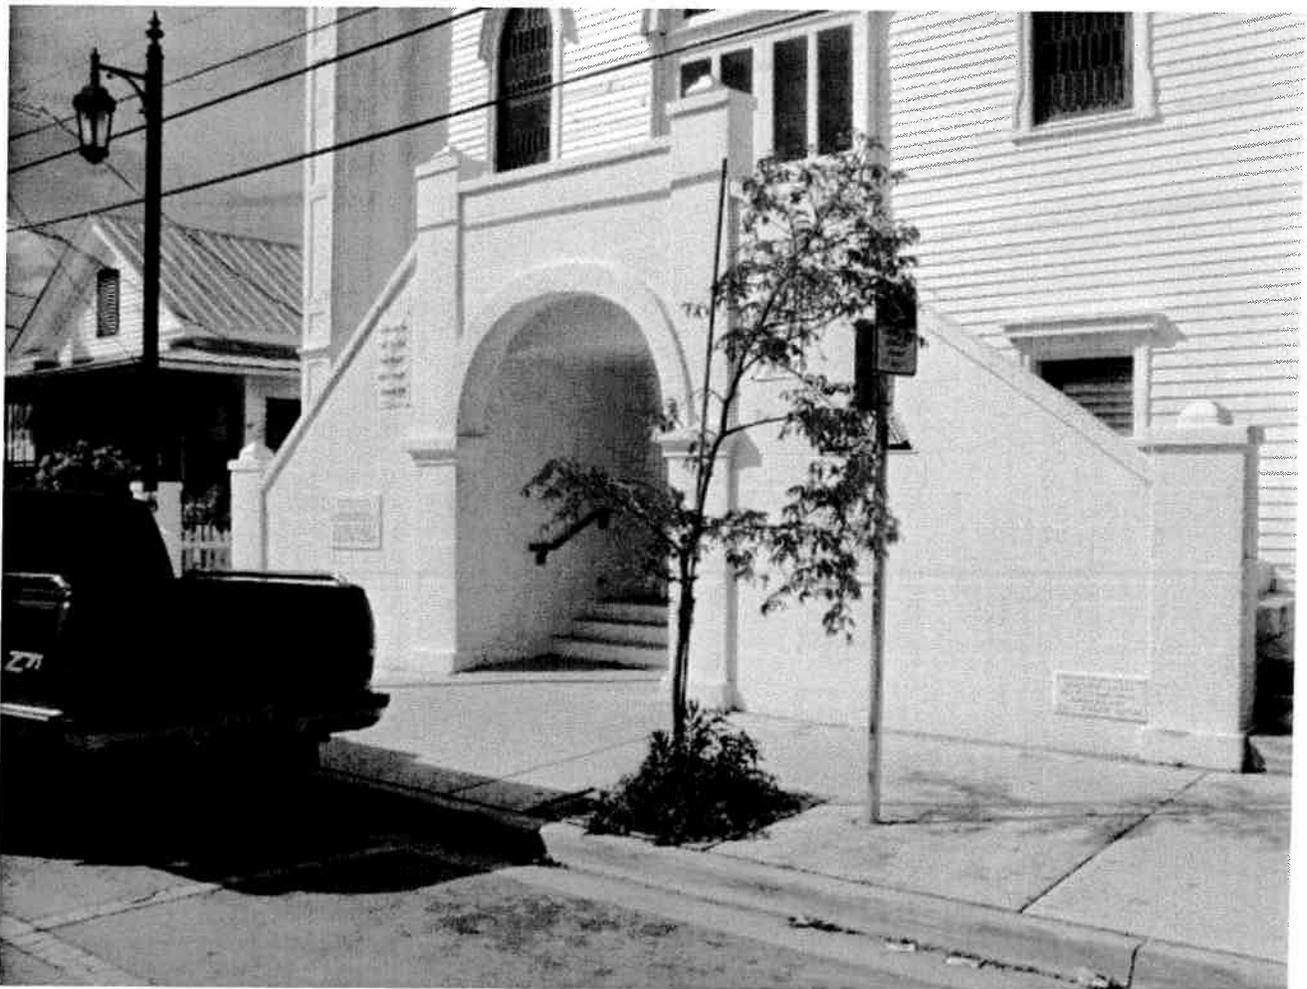
Figure 26 Concrete And Stucco Entrance Stair

The concrete and stucco stair at the East (entrance) side of the church constructed between 1899 and 1912 were likely designed and built to provide a grander entrance to the church (Figure 26), allowing the second floor nave to have an outside entrance directly from the street below. The entire stair structure is constructed of concrete. The type or quantity of reinforcing steel used is unknown at this time, However, the underside of the top landing shows serious

Spalling, a sign of corrosion of steel within concrete. The stairs do not meet the Florida Building Code for tread and riser proportions or handrail provision and can be considered hazardous (Figure 27).

10. Repair/rebuild the concrete stair at the front of the church.

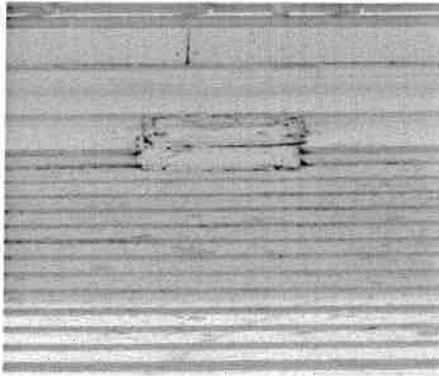
Figure 29 Patch

Unfortunately the rods and ground connections were removed. It is not known when or why. With the exception of one eyebolt—which may or may not have been original--all that remain is one patch on the exterior wall where it is believed a rod emerged from the roof plate (Figure 28).

It is reasonable to believe that the rod and cables were an integral part of the original builder's structural design and that their removal is a cause of the church's lean to the Northwest, as well as the deflection observed in the bottom chords of the roof truss.

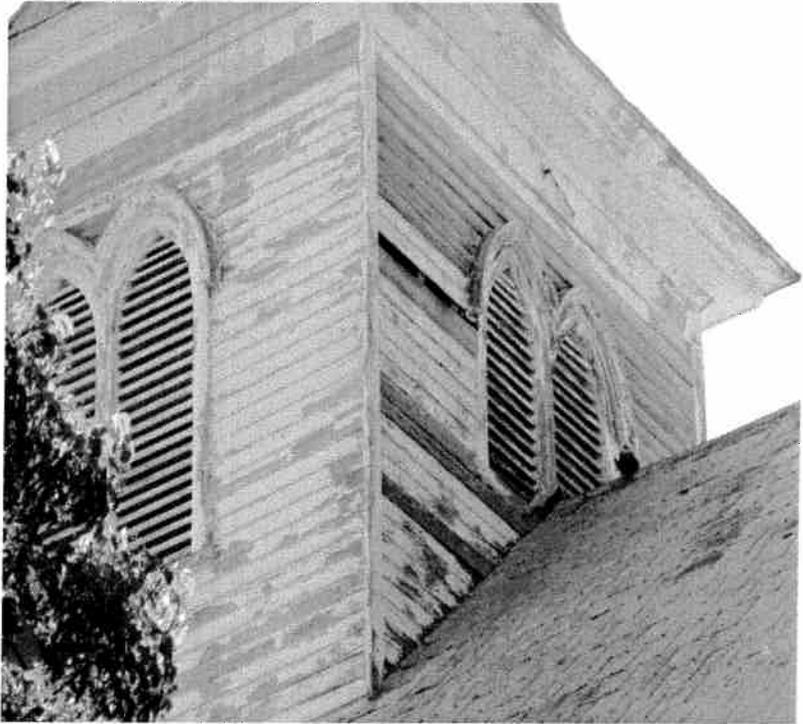
Figure 32 Bell Tower

The walls of the bell tower and turrets are covered in lap siding and louvered ventilation windows are on all four sides (Figure 32).

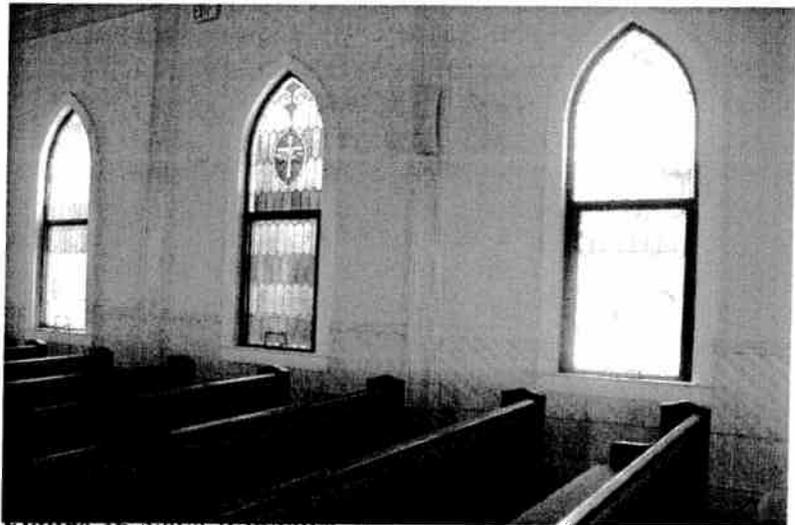
Figure 36 Nave windows

The nave has twenty-two traditional gothic-arched stained glass windows and one crescent shaped clerestory window with clear glass. The sanctuary has two gothic-arched and one large roman-arched stained glass window. Above the second floor entrance doors there is a stained glass transom. (Figures 9, 10, 13, 14, 36 and 37). They are fixed into modern aluminum frames. Seventeen windows on the ground floor align with the second floor windows above. These are glass jalousie windows.

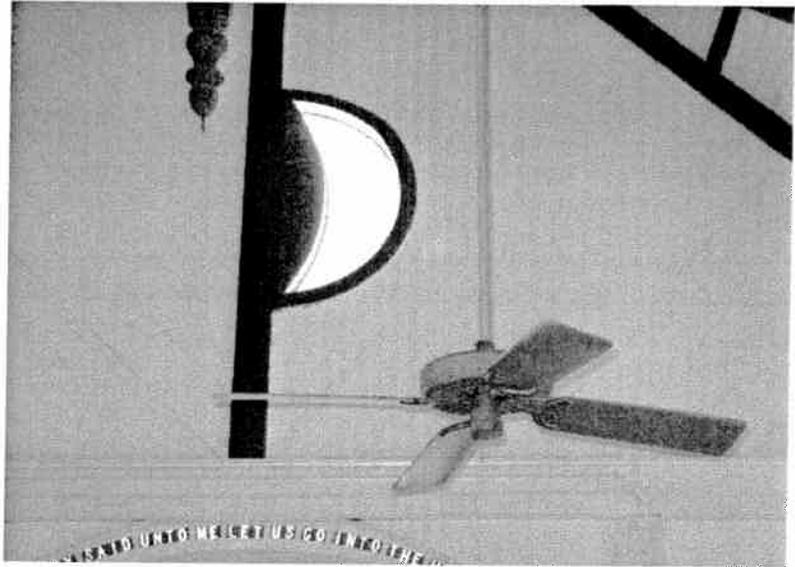
Figure 37 Crescent Shaped Window

The stained glass windows are in good condition generally, with few broken panes. The jalousie windows on the ground level are in deteriorating condition, largely non-operational and in some instances sealed with exposed expandable foam insulation (Figure 38). The crescent-shaped window frame is badly deteriorated and allows water to penetrate into the exterior wall.

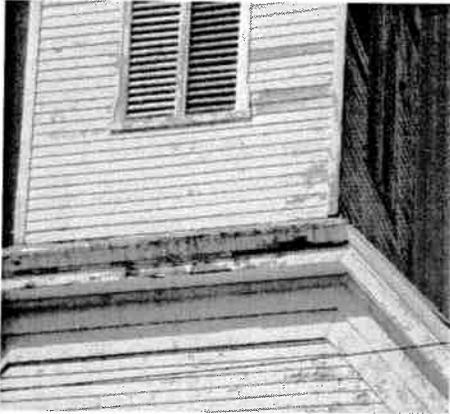
Figure 40 Cornice

Except for recently repaired areas the exterior walls are sided and trimmed entirely of old growth long leaf pine harvested from Northern Florida or Georgia (known today as “Dade County Pine”). The entire church is painted white. It has wood lap siding with wood corner boards, window and door trim, and a classical cornice at the roof eave with frieze and crown molding (Figure 40). The condition of the siding and trim is more or less deteriorated, most notably at the turrets. In some areas it is falling off the building (Figure 23). Door trim and thresholds at exterior doors are in deteriorated condition (Figure 41). Window sills are typically in the need of repair or replacement. The paint on the church is peeling, blistering and falling off.

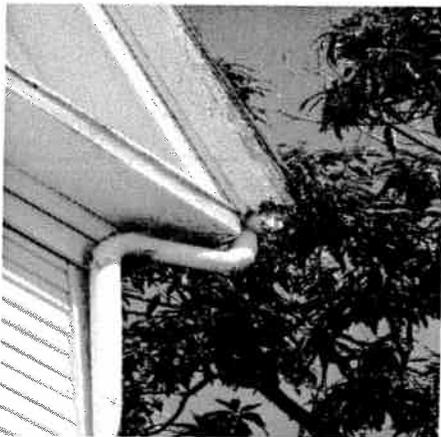
Figure 42 Gable Eave

The eaves, consisting of crown, fascia and soffit are in fair condition everywhere except at the junction of the gutters and downspouts, where dry rot and water damage are evident (Figure 42).

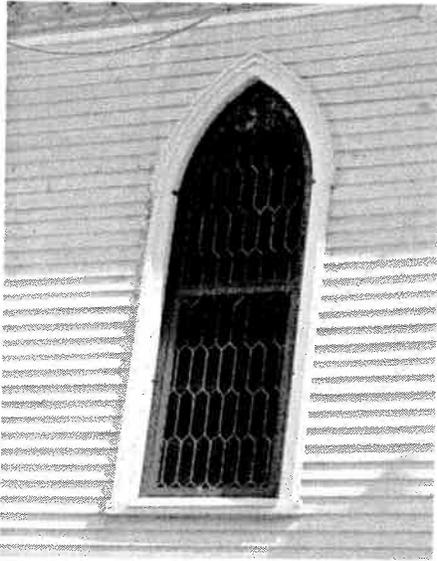
Figure 45 Bronze Finish

The windows and doors are described the previous section of the report as it pertains to weather protection. From the standpoint of their appearance and finish, generally the stained glass windows are good condition, having been replaced in 1990 and show relatively few areas in need of repair (Figure 44). However, it must be added that the frames and mullion are bronze anodized aluminum, which is an inappropriate material for a historic church. In addition to failing to replicate the original painted wood windows the bronze material is dark and renders the window opening as a

“dark hole”(Figure 45). The original windows would have had painted frames and mullions, providing a far richer appearance.

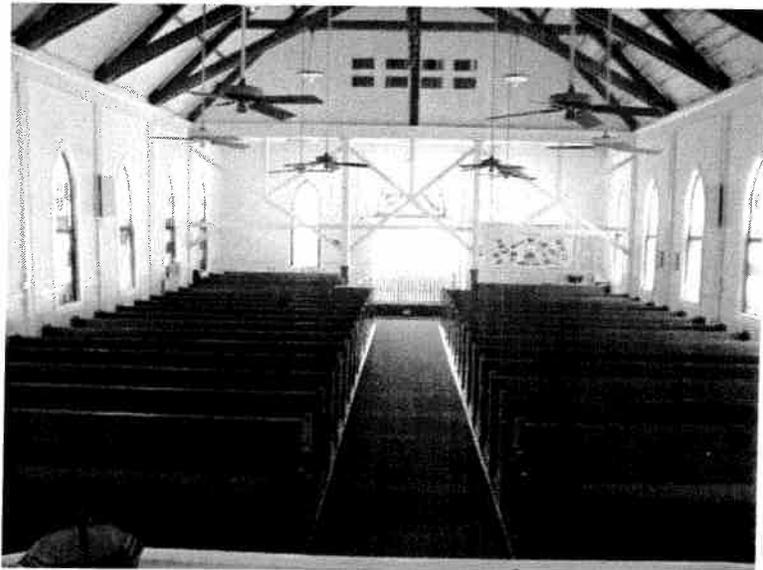
Figure 46 Nave

The nave and sanctuary on the second floor is one large space (Figure 46). The floor consists of the aisles, which are carpeted and the floor under the pews, which is a varnished wood platform, raised three inches (Figure 45). The floor under the carpet is tongue and groove pine as is the raised platform. Both are original and believed to be long-leafed Northern Florida and Georgia first growth yellow pine, known in Key West as “Dade County” pine. The pews are varnished oak and are not original, having been installed in 1964. The backs of the pews are fabric, badly faded.

The floor beneath the carpet is in poor condition owing to layers of carpet glue, and moisture and termite damage. The platform is in good condition.

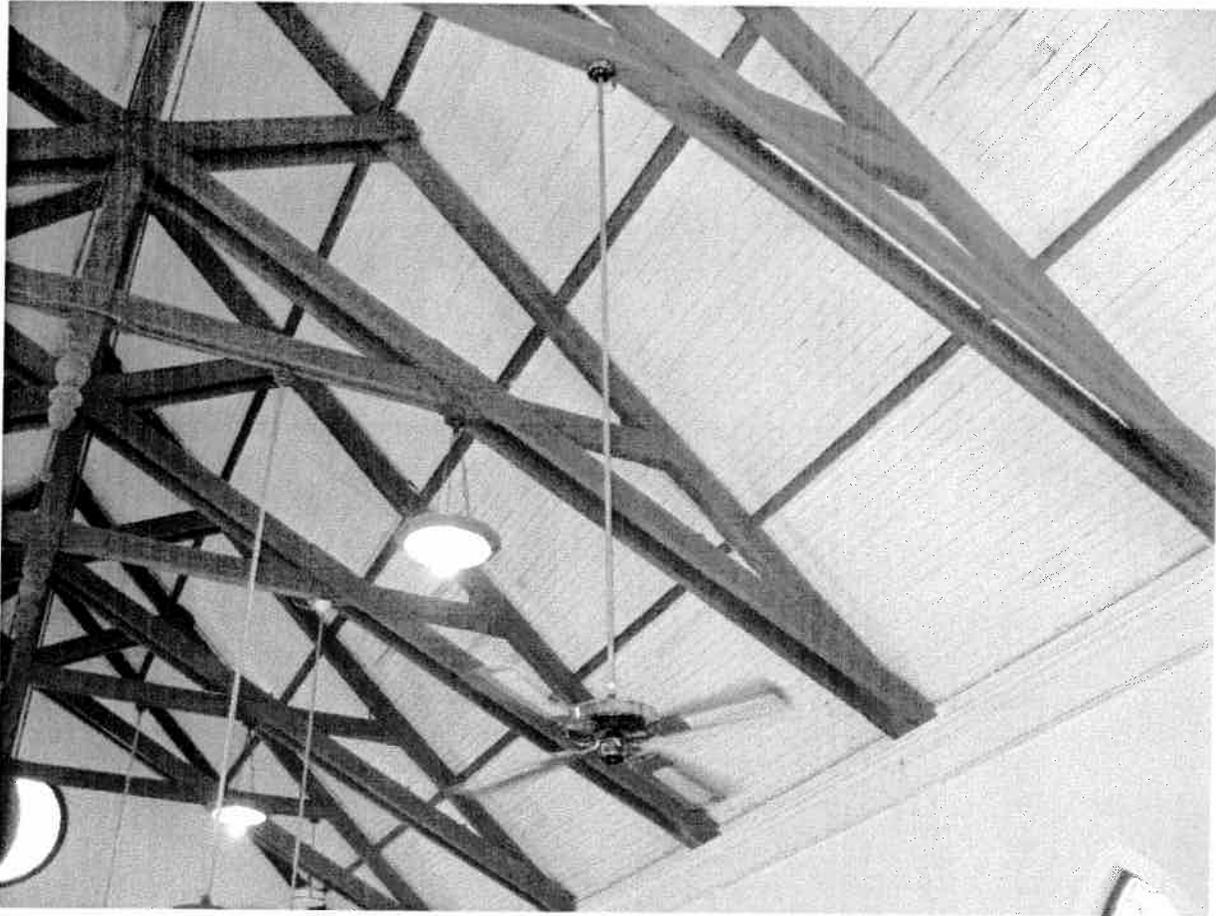
Figure 48 Painted Trusses

The ceiling is painted tongue and groove pine, and shows loss of paint from water damage. The roof trusses, visually the most striking architectural element in the space, are

constructed of large timbers and are painted a matte brown.(Figure 48).

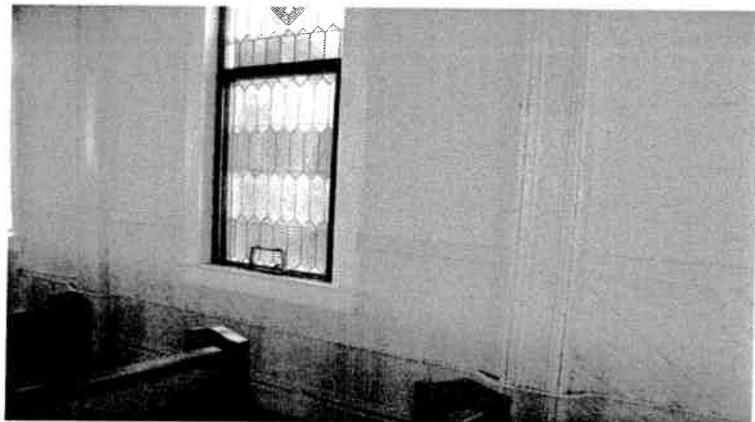
Figure 49 Interior Woodwork

The nave and sanctuary walls consist of wood wainscoting and plaster board walls, all painted. The style is generally Victorian. The wood wainscot consists of a Victorian base molding, diagonally placed bead board dado, and a chair rail, all painted high gloss to match (Figure 49).

All three components, wainscot, pilasters, and cornice are in various state of age and damage and need repair and painting. The plaster walls are painted with a matte white paint that has chalked badly, is discolored, and shows structural cracks due to settlement (Figure 50).

9. Repair and restore all wood work, including wainscoting, window and door trim, crown molding, the alter and choir railings, and other woodwork.

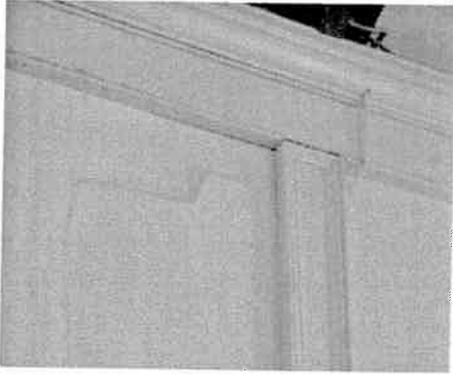
Figure 50 Plaster Wall

Decorative wood pilasters from the floor to the top of the wall are spaced to fall below the ceiling trusses are trimmed with ogee moldings. Atop the pilasters is a continuous wood cornice consisting of a frieze and crowns (Figure 50). The pilasters and cornice are painted to match the wainscot.

10. Repair the plaster walls, either filling cracks and holes or replacing entire bays of wall board.

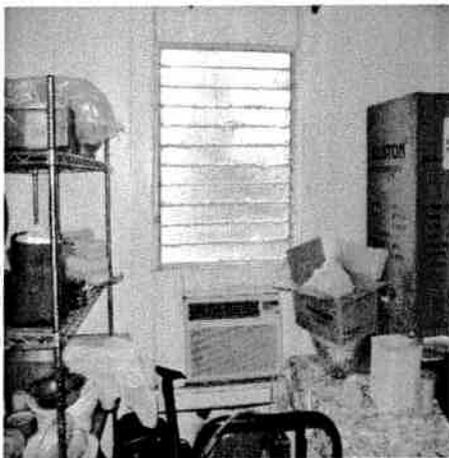
Figure 54 Jalousie Window

The windows are metal with glass jalousies and are generally sealed shut. The metal jalousie windows are old and work poorly or not at all. Some of the windows have been sealed shut with expandable foam insulation, which is unsightly (Figure 54).

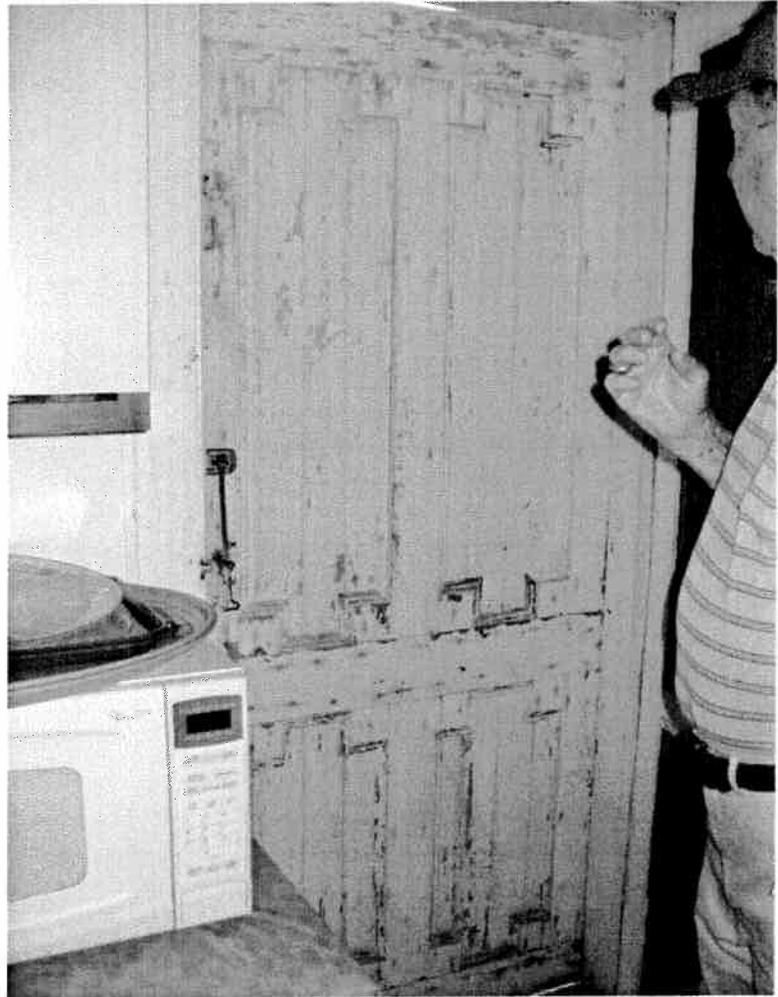
Figure 55 Original Door

The exterior egress doors are metal, without panic hardware. The interior doors are wood hollow core and in more or less poor condition depending upon the amount of termite damage. One door, however, a door leading out to the rear of the church, merits special mention as it appears to be original. This door is off the kitchen at the rear of the church and is a panel door with a liturgical design (Figure 55).

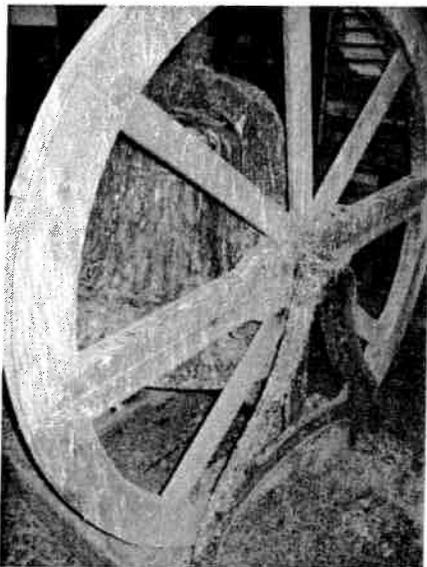
Figure 58 Bell

Within the bell tower is a handsome serviceable cast brass bell that appears to be valuable and worth restoring. It is not known if it is original (Figure 58).

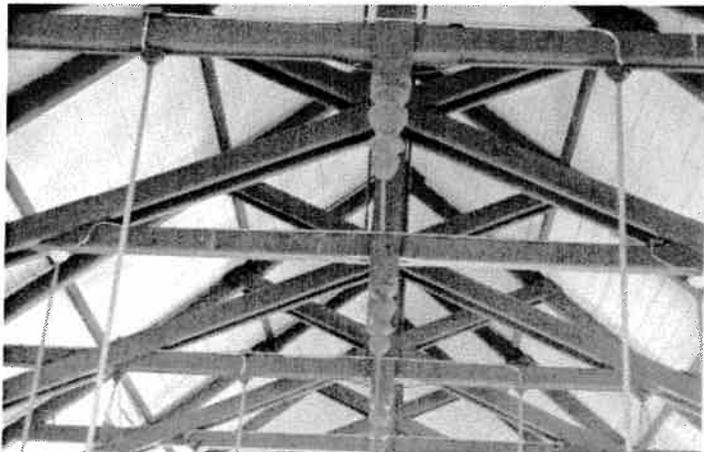
The existing service is 120/208 volt 3 phase, 4 wire 300 amp service to the NW corner of the building via KES pole B9-3 and B9-3A. The meter is Number 40251 (Figure 60). Each is in serviceable condition and can remain.

A great deal of exposed conduit serving fans and lights is evident and unsightly on the trusses in the main space, the nave of the church (Figure 61).

Figure 60 Electrical Service

Figure 61 Exposed Conduit on Trusses

This is an historic and aesthetic issue, not a safety issue. The church is a historic structure with a considerable investment in its restoration. Running exposed metal conduit on its interior walls is unacceptable in the strict historic sense, and unsightly by any standard. When the exterior siding is repaired and opportunity will open to install conduit in walls from the outside.

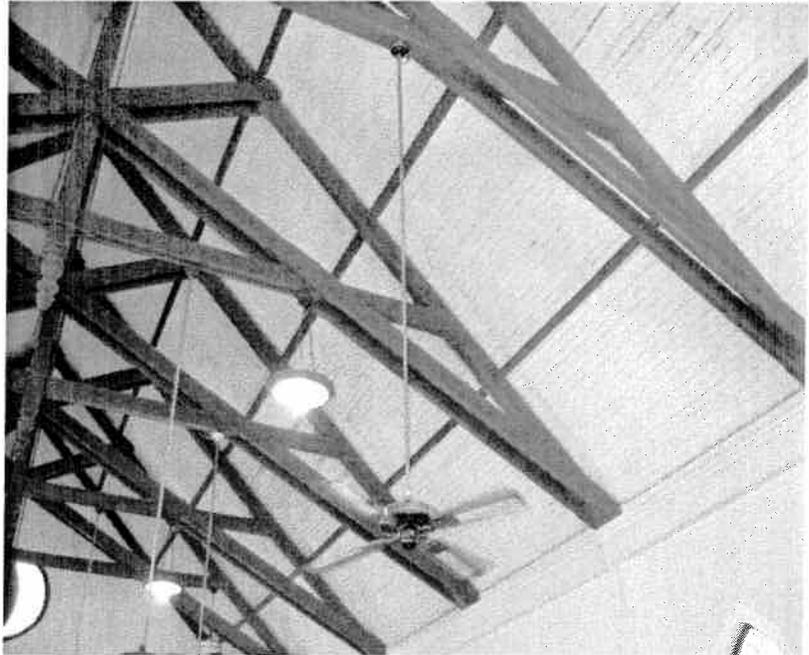
Figure 63 Nave Lighting and Fans

Second Floor Interior: Lighting at the nave and sanctuary (second floor) consists of very old hanging globes approximately twenty feet above the floor. These possible date from the early 20th century. The globes have been removed for ease of changing light bulbs; the light bulbs are bare (Figure 63). At the sanctuary shielded spotlights are mounted on the sidewall and are aimed down toward the lectern. They are portable and are plugged into a wall outlet next to the sanctuary niche. Two small stained glass fixtures hang from the ceiling.

5 Replace fans and lights in the Nave and Sanctuary.

Because the church does not need air conditioning in the sanctuary and nave year round ceiling fans are a good means to provide the fans for comfort control. Separate lighting, however becomes problematic as if not placed properly it will cause a discomfoting stroboscopic effect when the fans are running. This is the current condition.

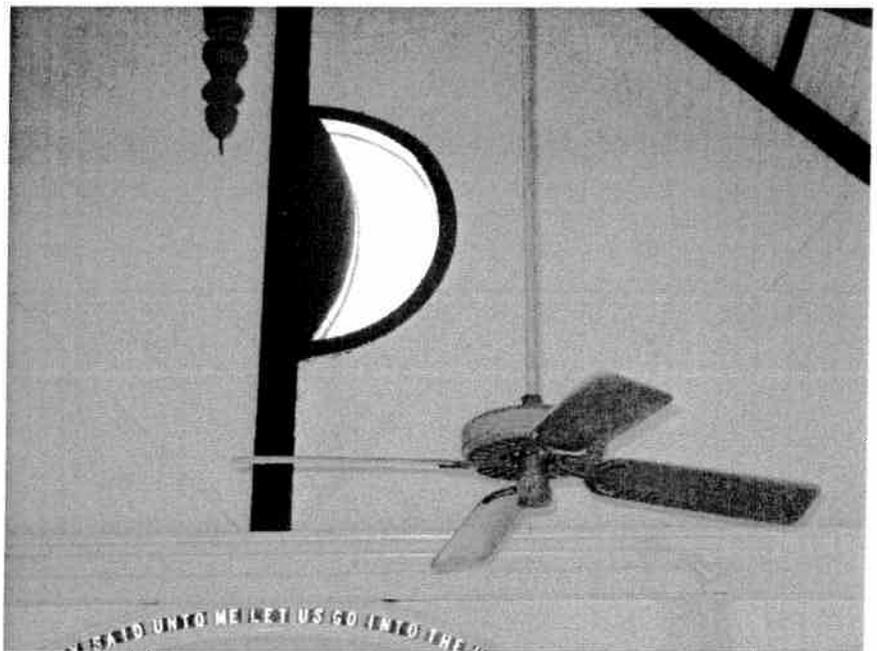
Figure 64 Nave and Sanctuary Fans

Eight ceiling fans suspended by ten foot down rods have been installed over the nave. The fans are a residential type of differing styles and are made by Hunter Fan Company (Figure 64). The fans are below the lights so when on create a stroboscopic effect below them.

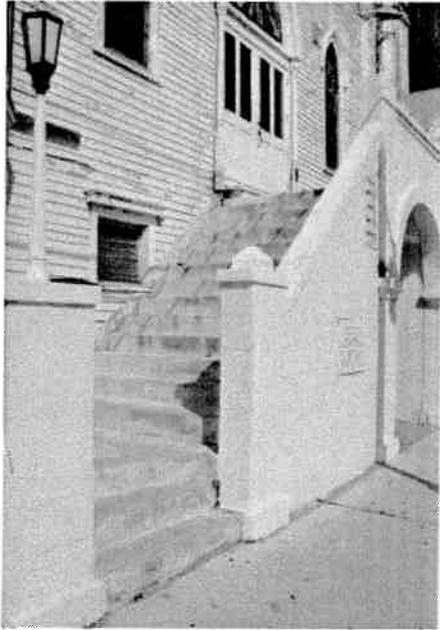
Fixture 65 Pole Lantern

Exterior: At the street the church has only a florescent strip fixture, which is mounted on the ceiling of the ground floor entrance vestibule. Lanterns are mounted on the stair pillars but are not operating (Figure 65).

7 Repair/replace lanterns at the front of the building.

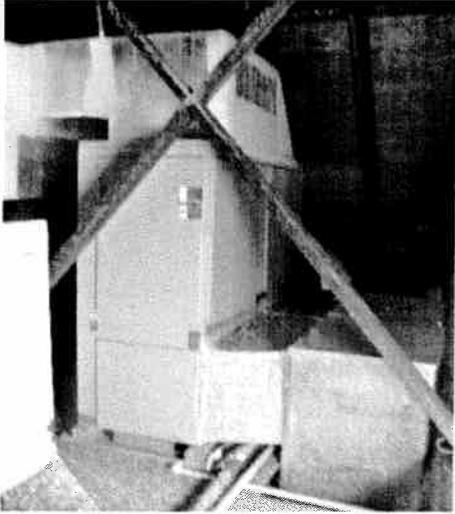
Figure 66 Air Handler in Attic

Second Floor: Servicing the nave and sanctuary, there are three split systems, two 15 ton and one 10 ton. The air handlers are located in the attic mezzanine below the bell tower and distribute air to the second floor through diffusers in the attic wall (Figures 66 and 67). Condensers for the units are located on concrete pads outside the building's North wall (Figure 68). The units are manufactured by Trane and have been in service for eleven years.

Because the central air conditioning system has been used relatively little (for Sunday service, and special services only, during hot months), yet is over ten years old it should be inspected and maintained on a regular basis. Filters should be changed every two to three months and the condensate drain should be blown out at the same time. A full maintenance check and coil cleaning should be done once a year.

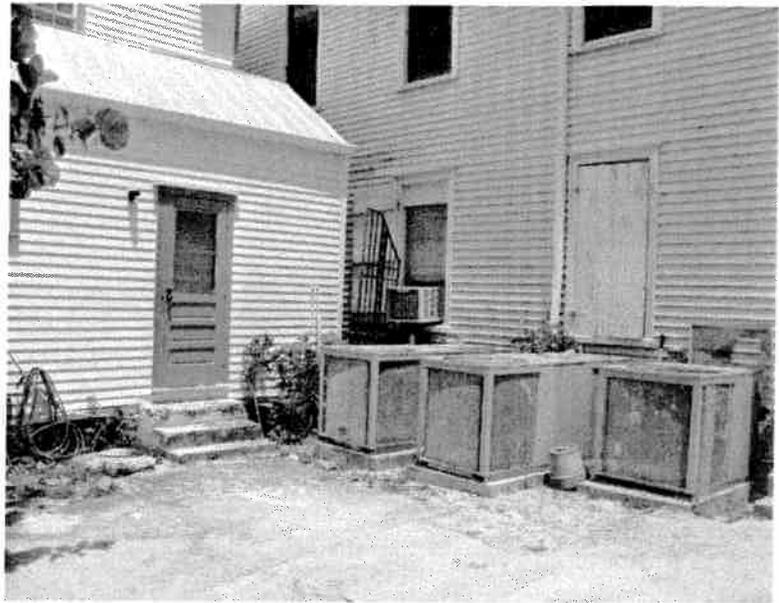
Figure 68 Condenser Units

As this air conditioning is used only for weekly services and the occasional Wedding or Funeral and thus have “low mileage” both the condensers and air handlers are in good serviceable condition. The coils have been inspected for this report and are not brittle.

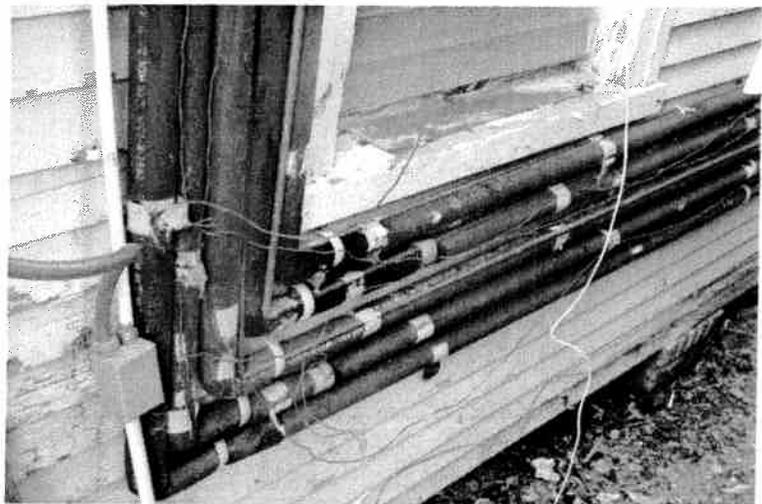
Figure 69 Refrigeration Lines

Refrigeration, vacuum, condensate, and electrical lines are run against the outside of the North wall up to the attic level, where they enter the building (Figure 69)

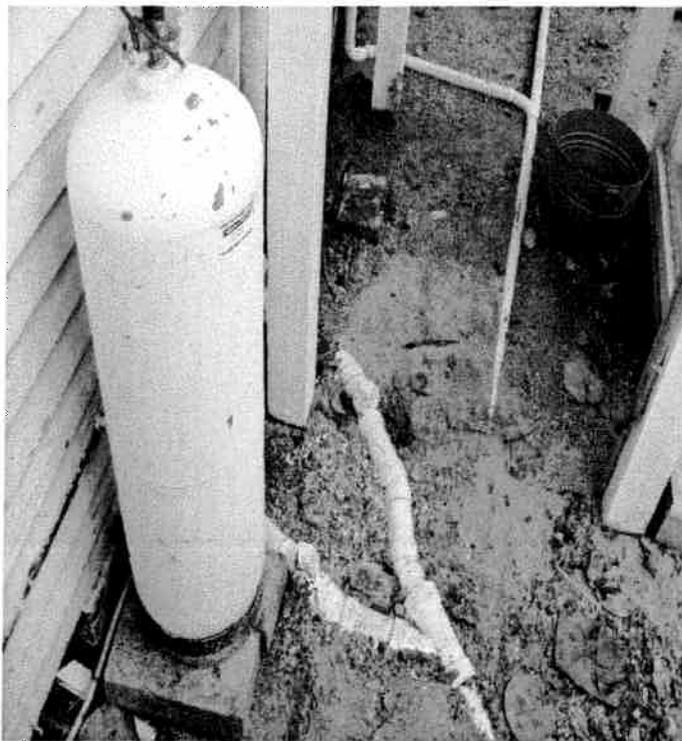
Figure 71 Propane Tank

Hot water is provided by an electric hot water heater and cook tops are served by propane gas from a tank mounted on the ground outside the North wall, adjacent to the kitchen (Figure 71).

- 1. The plumbing must be brought up to code.**

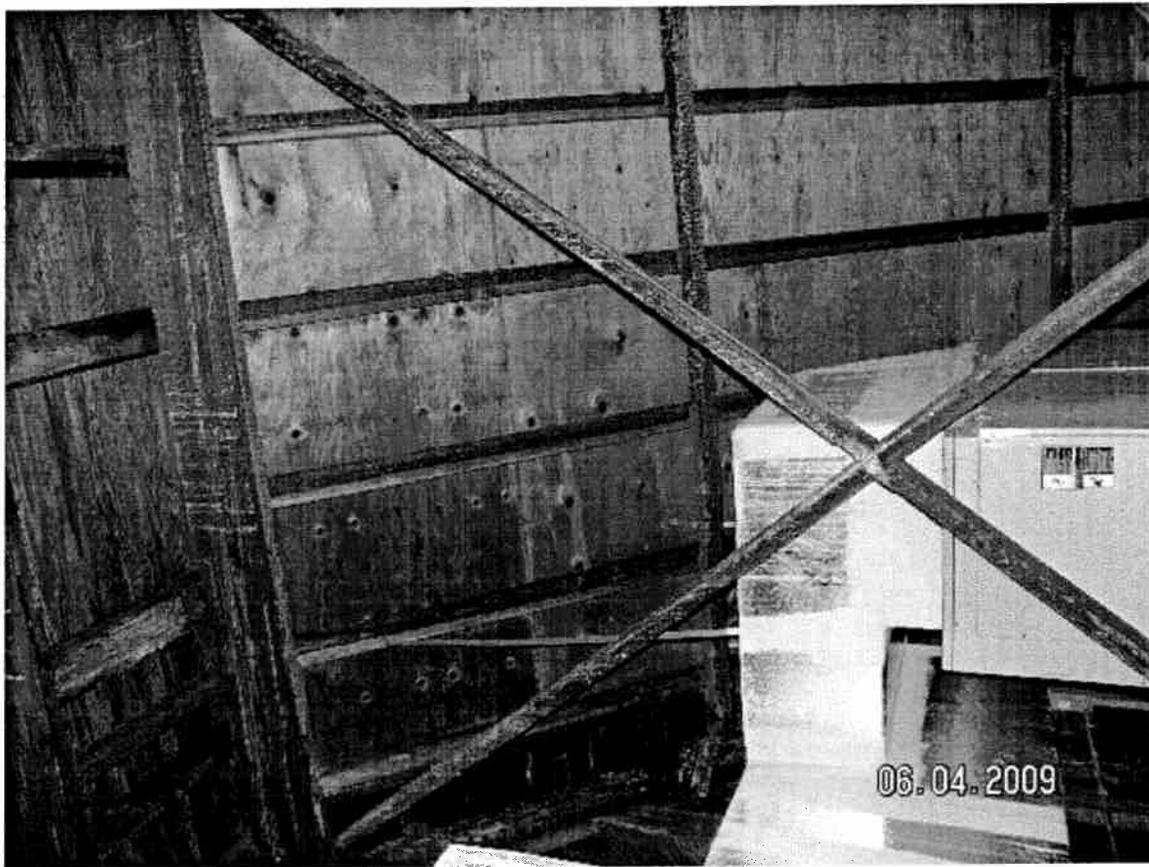
Wall between AC Loft and Nave

The AC Loft floor joist, 3x6 at 24" on center and spanning 12', are inadequate to safely support the existing AC equipment. The plywood floor deck needs to be replaced. The burned X-members removed. The wall separating the Nave needs to have additional plywood installed, if the truss style X-bracing below is to be removed. See page 14.

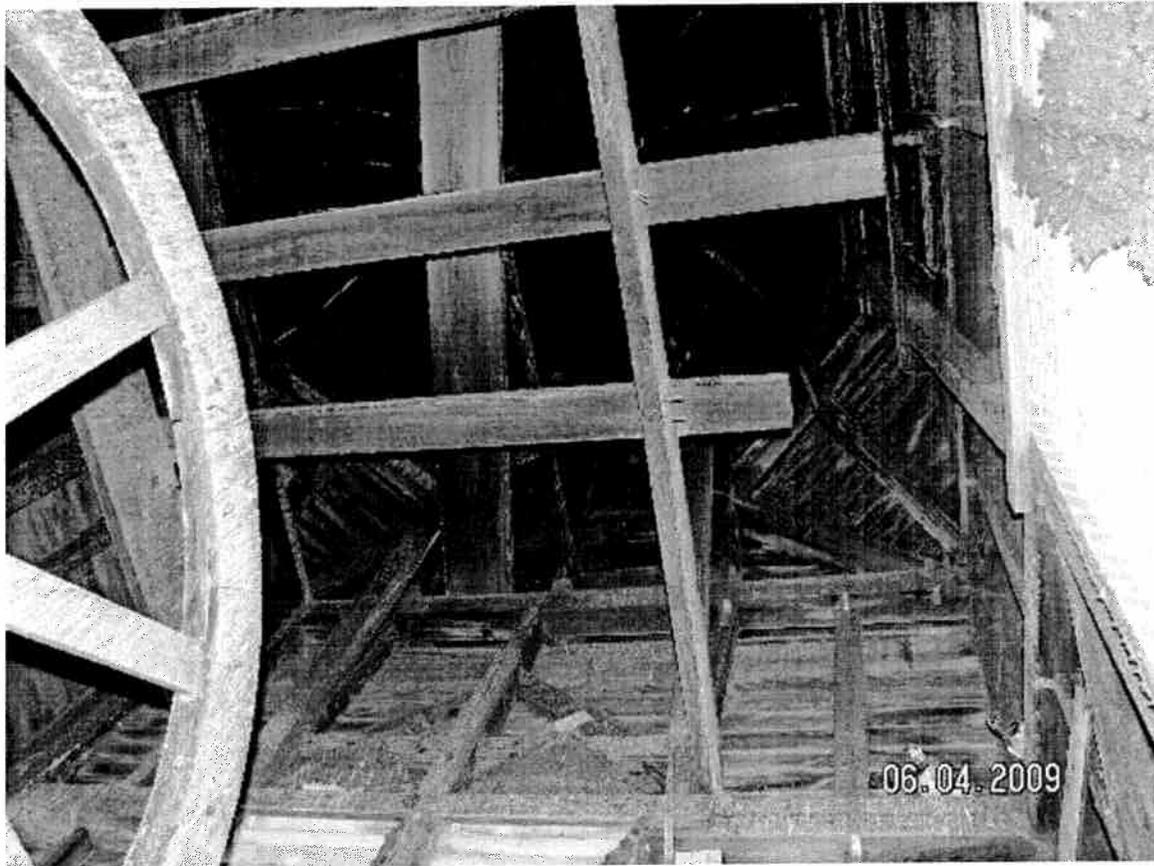
Looking up into the Belfry with a Steeple above.

The steeples and belfry can be stiffened considerably with steel straps and plywood. The steeples are currently having the exterior siding replaced and screwed into supporting members. This with some minimal strapping may be as stiff as can be expected. The attachment at the base of the steeples should be investigated. The Belfry also can be helped with some plywood and strapping on the walls.

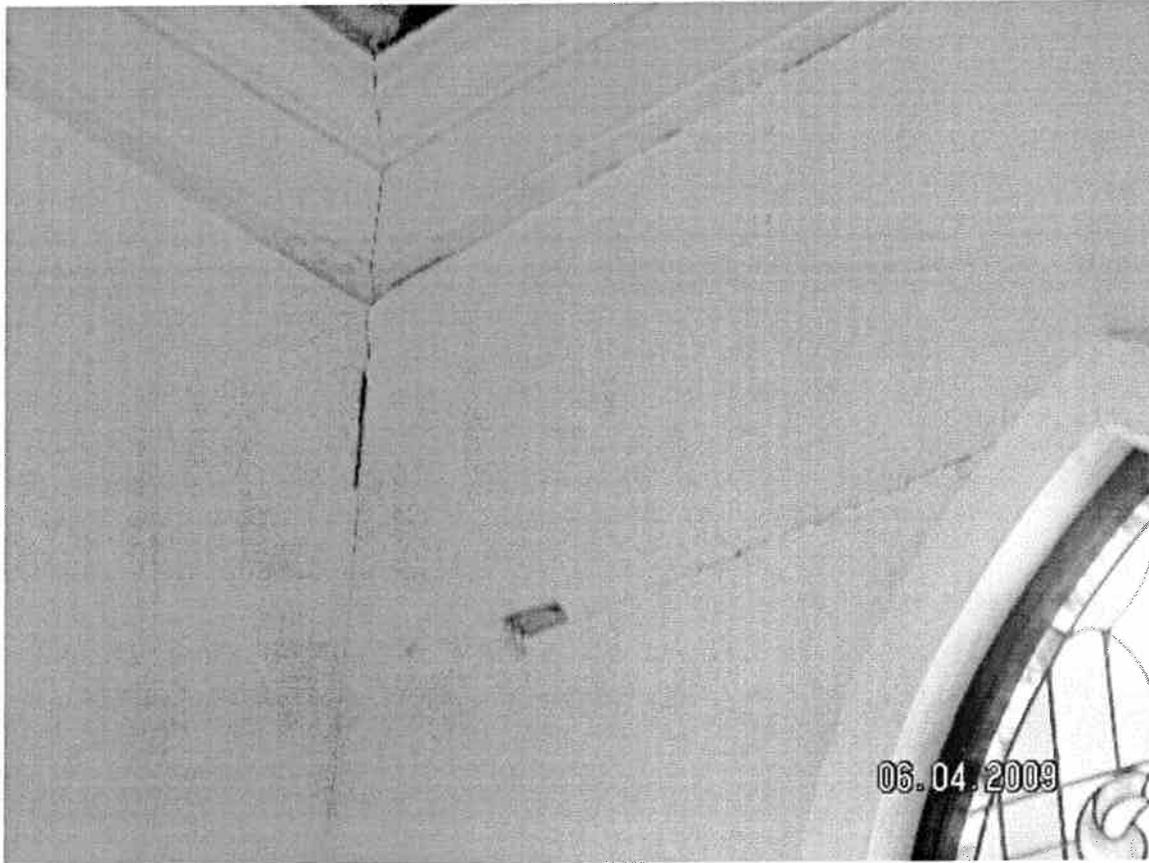
Nave wall, SW corner

The main walls of the church in the Nave are 16' from floor to roof truss attachment. The wall studs are 2x6 (actual) at 18-24" on center with 1"x6" diagonal sheathing. With the large roof load and long span, the wall studs must be over-stressed. This is particularly true when the walls must resist lateral wind loads. This can be evidenced by the cracks on the interior face of the walls. Along with the roof trusses, it is critical that the exterior walls be strengthened by additional studs or additional sheathing or a combination of the two.

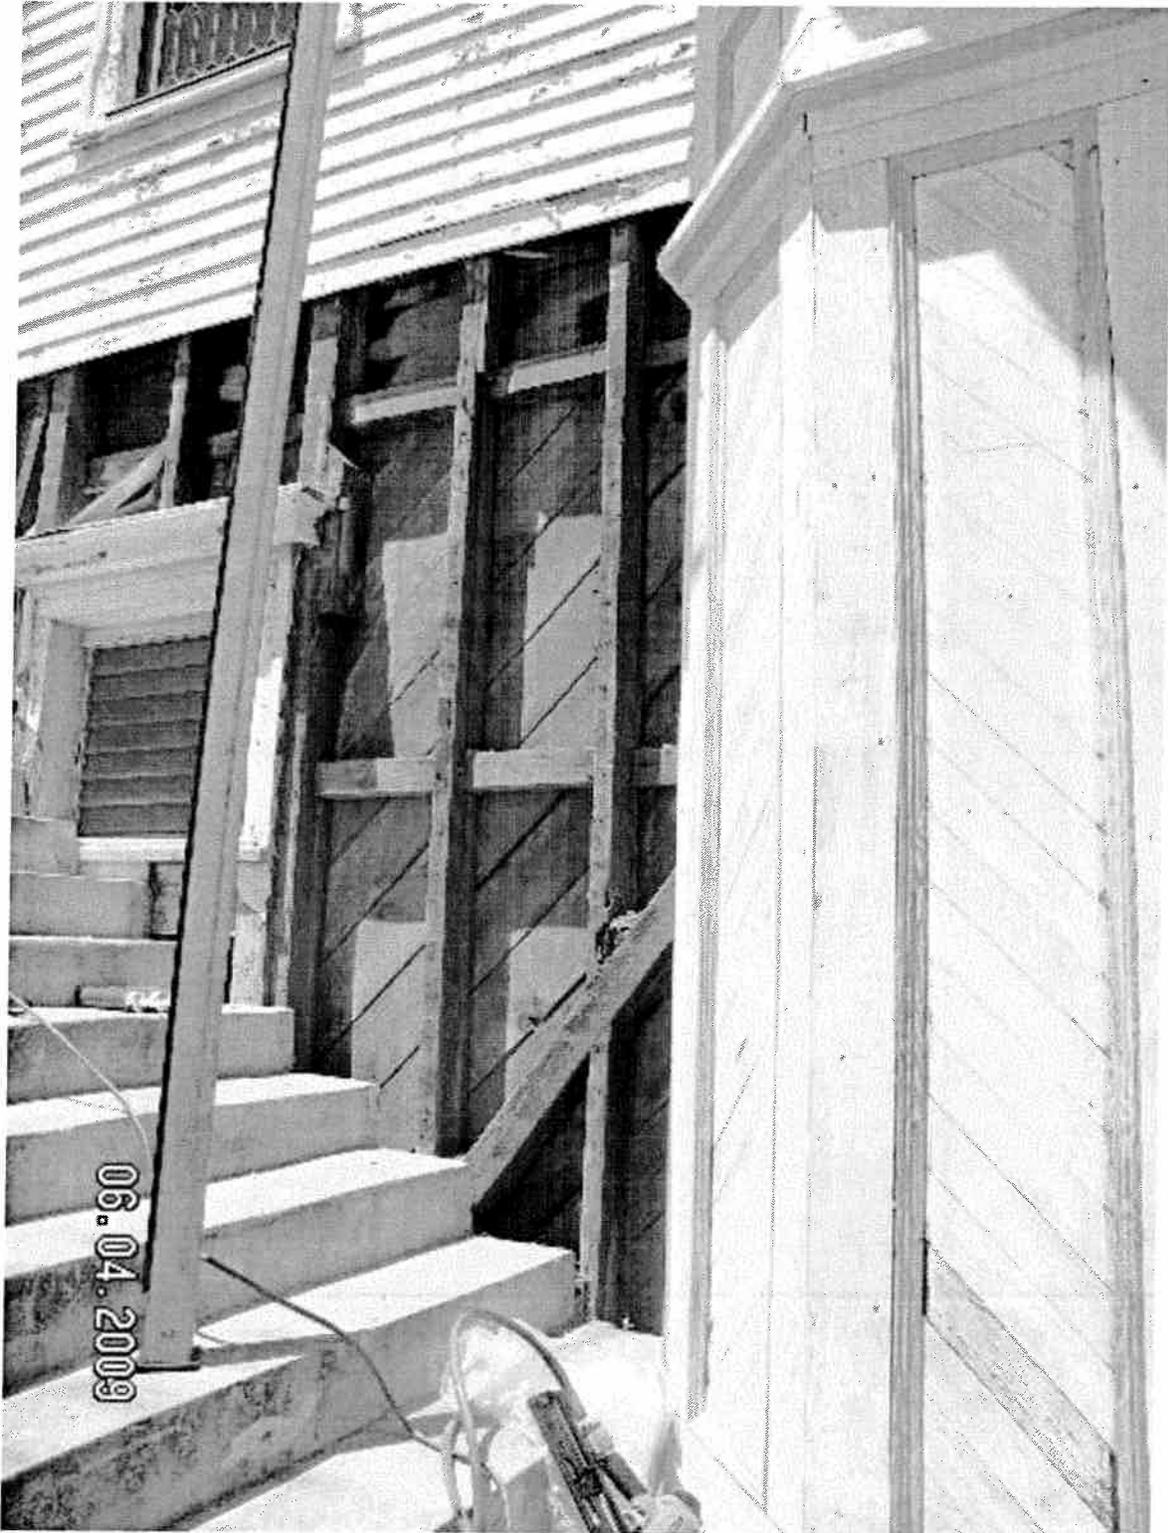
Front wall by entrance.

The truss style X-bracing below the AC Loft near the entrance may be removed with the proper strengthening of the AC Loft and the exterior walls. See Page 8 & 11).
