THE CITY OF KEY WEST

Peary Court Housing Complex

Floodplain Management

Site Visit Observations

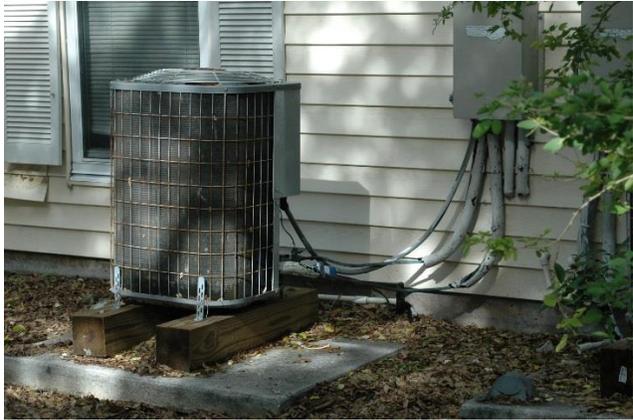
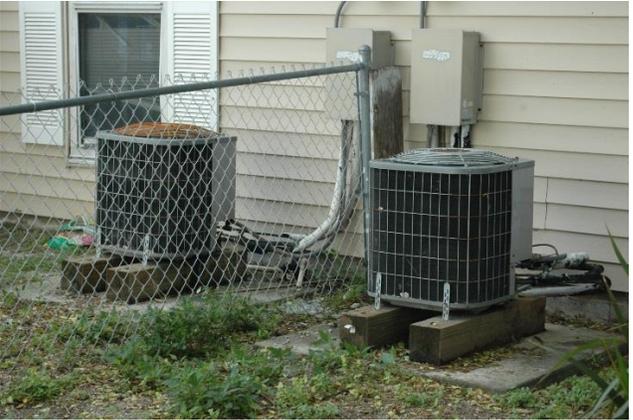
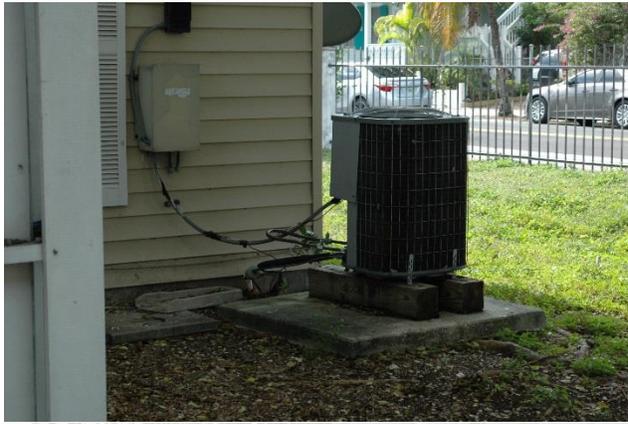
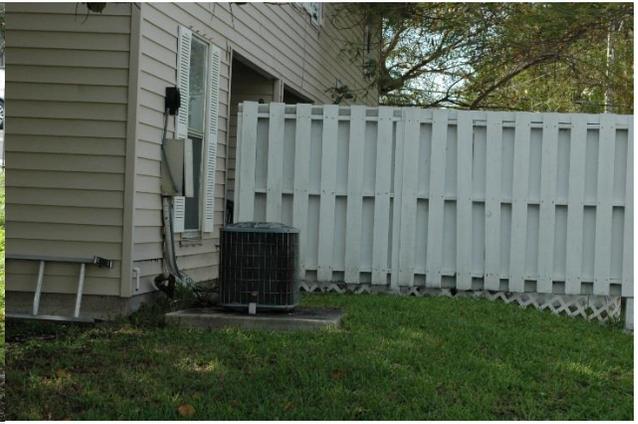
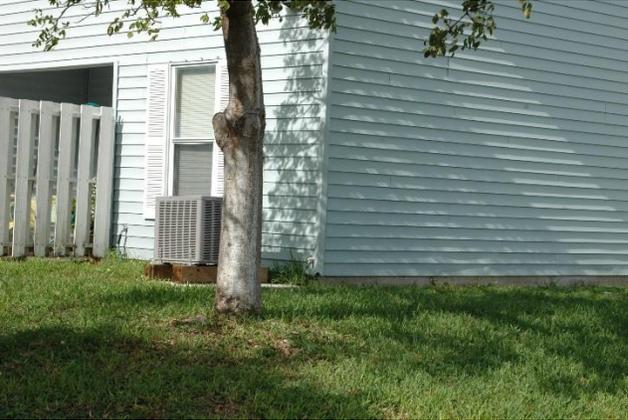
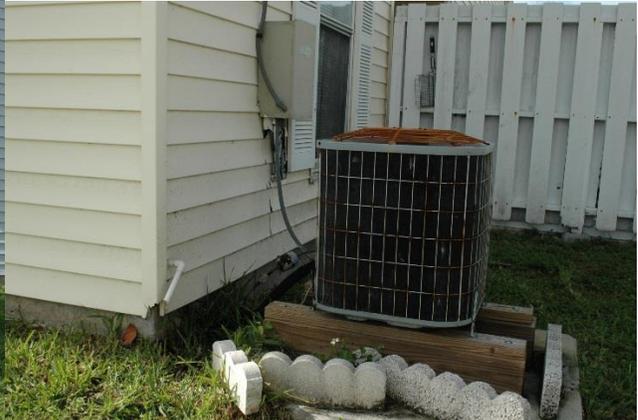
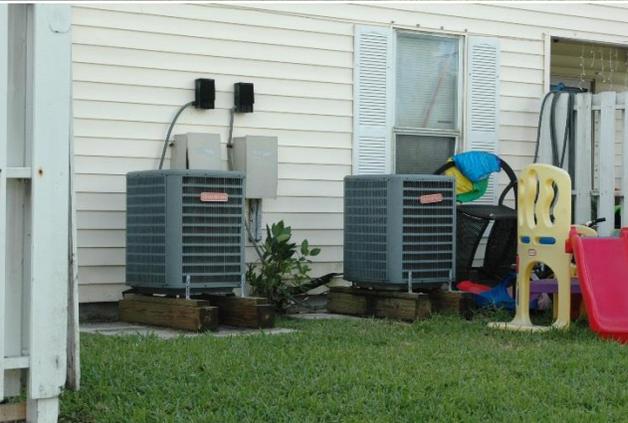
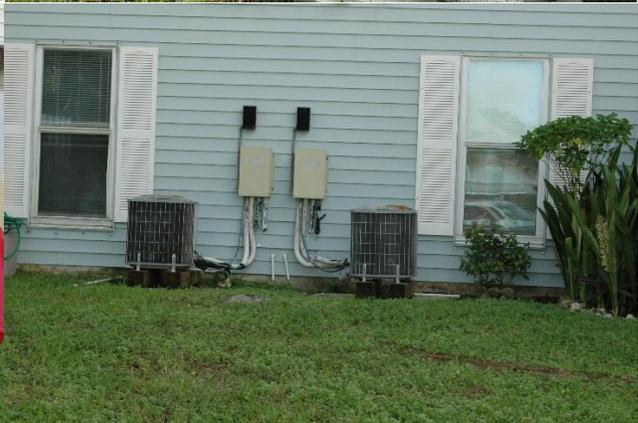
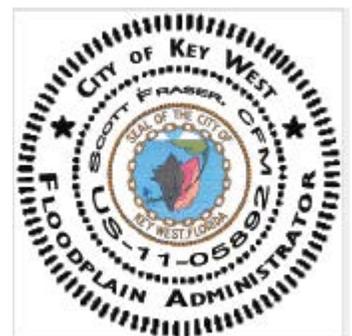
While not all the exterior compressors were found to have been elevated, it was apparent those with the greatest flood vulnerability had been elevated. In particular, more of the compressor units for buildings in the higher AE-7 flood zone area were observed to have been elevated. Fewer units in the lower AE-6 flood zone had been elevated, but those may not have required elevation.

At one location, where the compressor was elevated by two wooden blocks between the compressor and concrete, a firm grasp and shaking of the compressor demonstrated the unit was securely mounted.

A more comprehensive examination of each air-conditioning compressor unit and related Elevation Certificates would result in a more definitive report, if deemed necessary. Such is not deemed necessary at this time.
