## THE CITY OF KEY WEST

February 4, 2016

Peary Court Property Infrastructure Review  
City of Key West Engineering Services Department

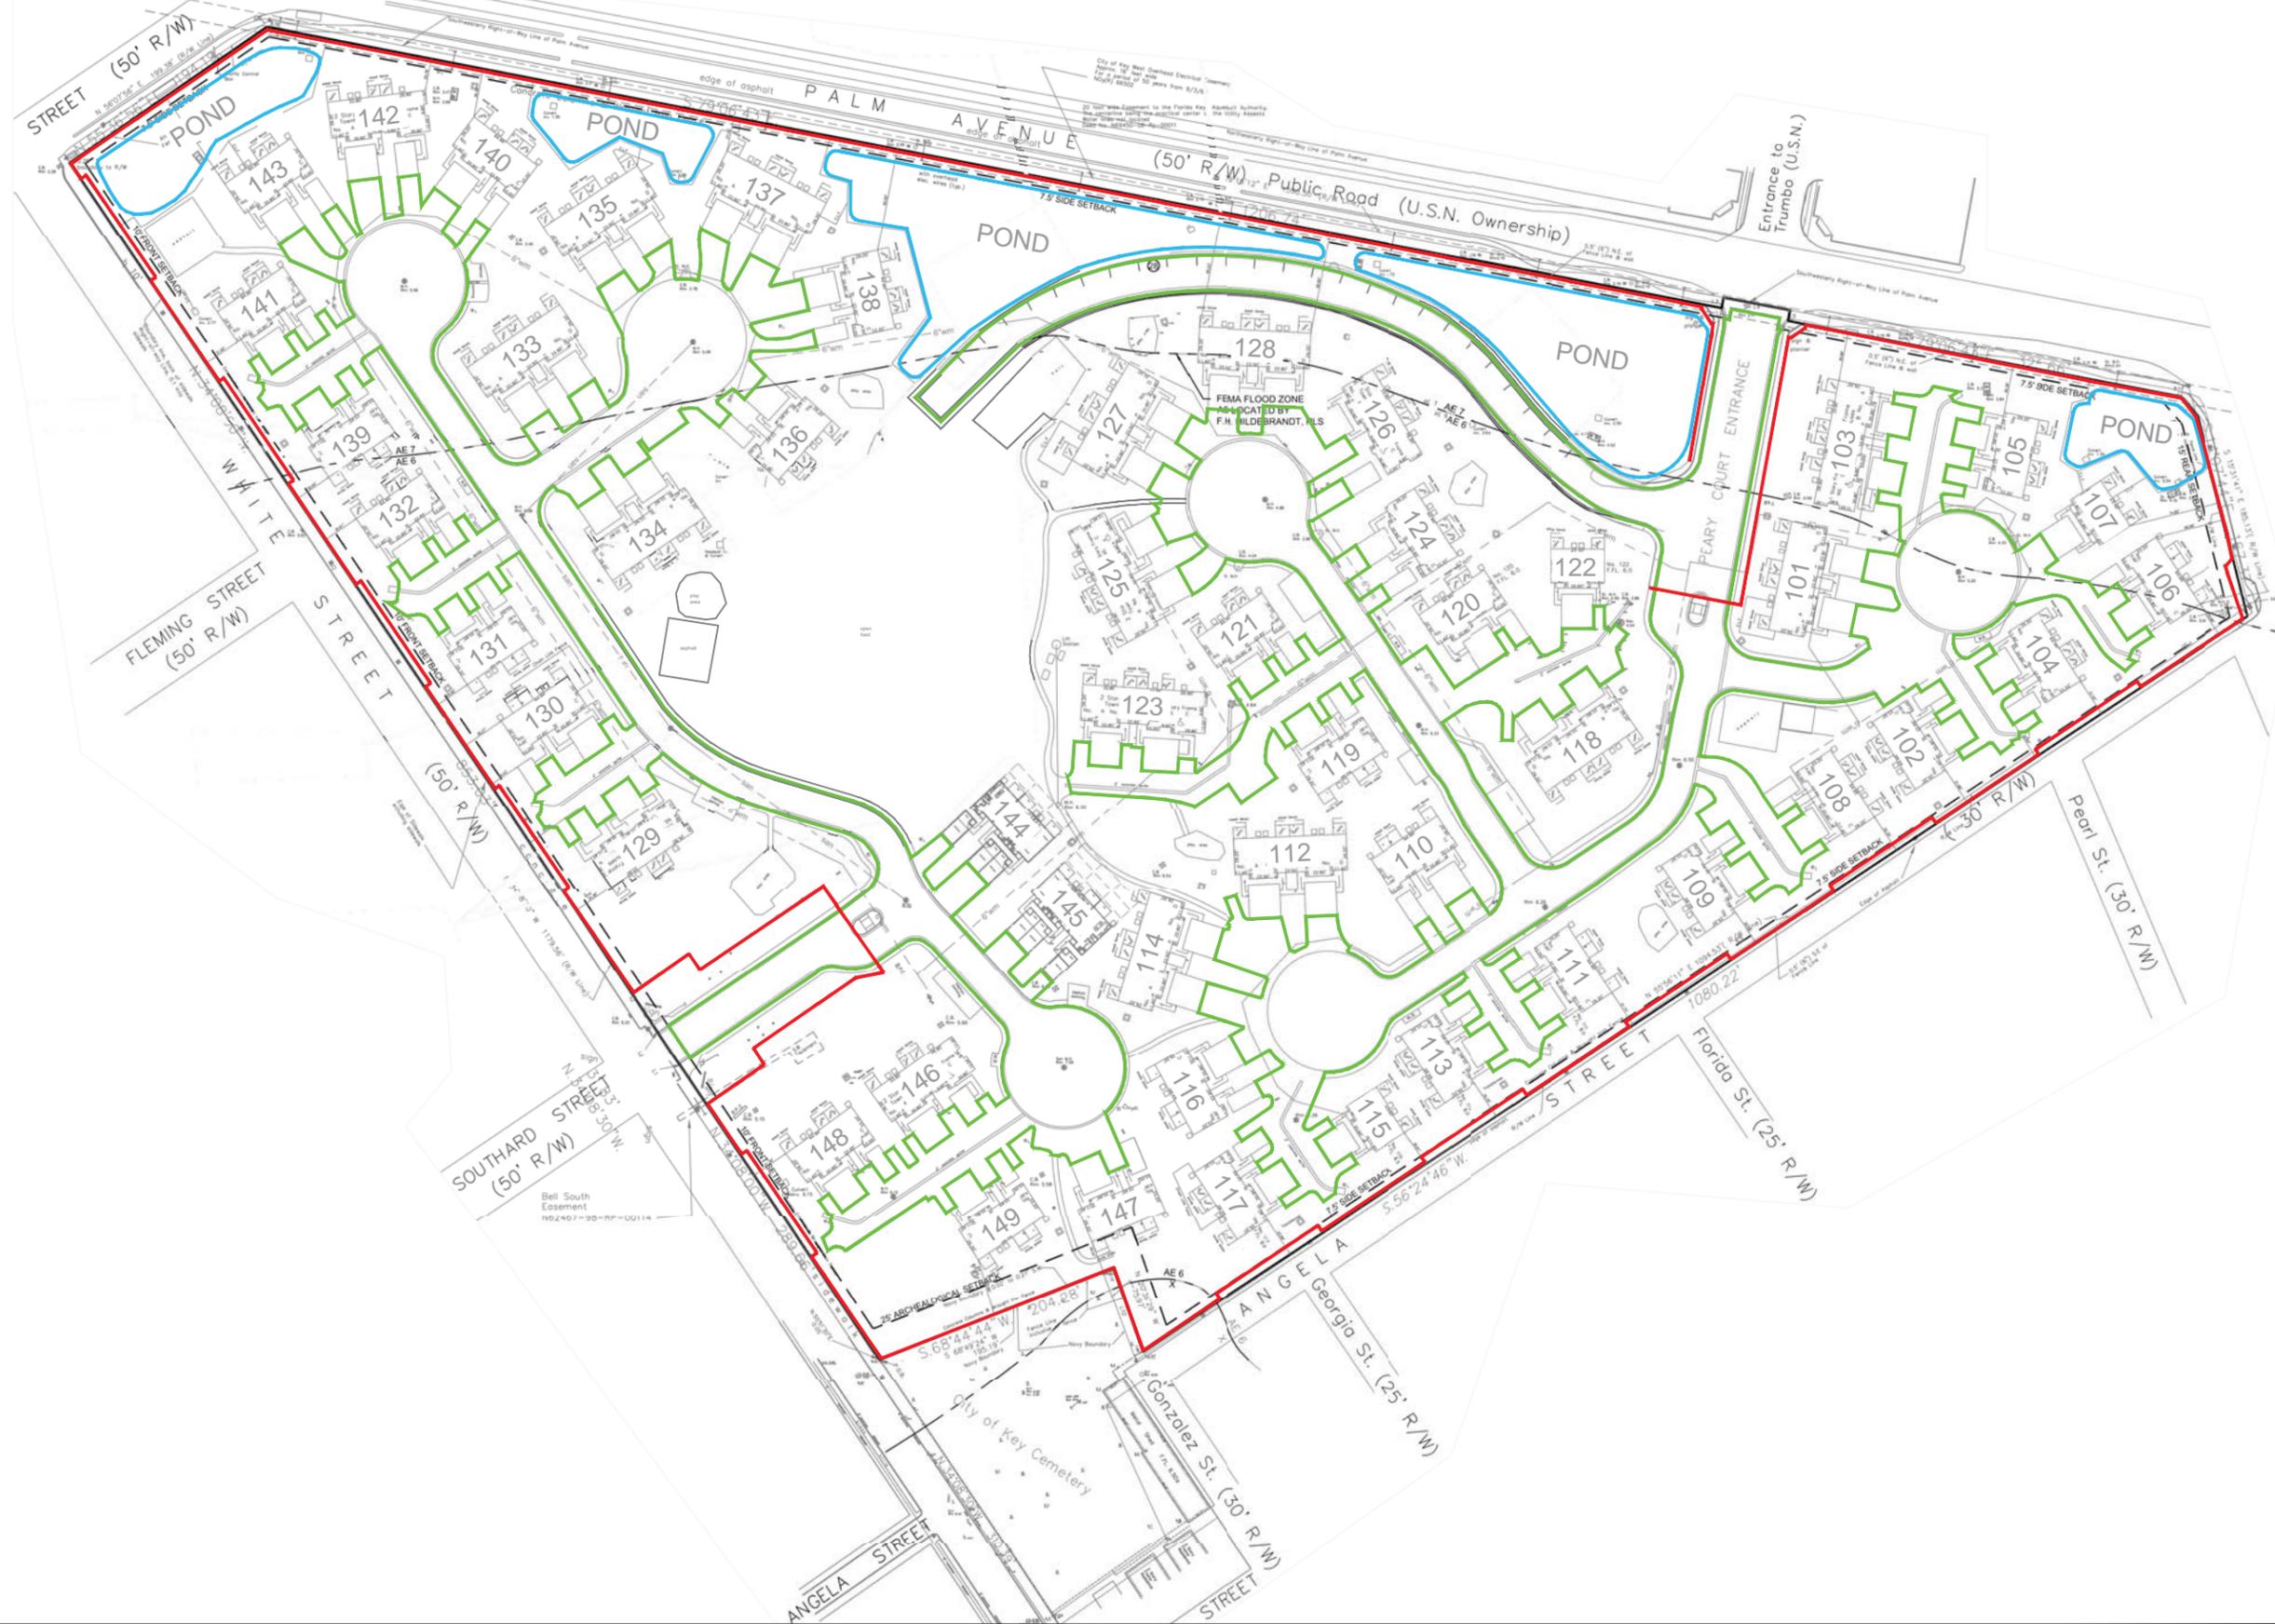
TITLE  
**FIGURE 1: SITEWORK LAYOUT**  
**PEARY COURT**

This property's legal address is 541 White Street and property is located on 24 acres southeast of the street intersection of White Street and Palm Avenue. Development of this property includes over a mile of perimeter fencing, 49 townhouse style residential buildings, nearly half a mile asphalt roadway, and nearly a mile of concrete sidewalks. Supplementary property developments include street lighting, multiple pocket children's playgrounds, four asphalt paved basketball half courts, two racquetball courts, and pet waste container dispensing stations. (Figures 1 and 2 – Sitework Layout and Aerial Site Overview)
