**LIMITED ASBESTOS
INSPECTION SURVEY REPORT**

**GLYNN ARCHER ELEMENTARY SCHOOL COMPLEX
CITY HALL PLANNING PROJECT
1302 WHITE STREET
KEY WEST, FLORIDA 33040**

August 29, 2012
EE&G Project No. 2012-2373

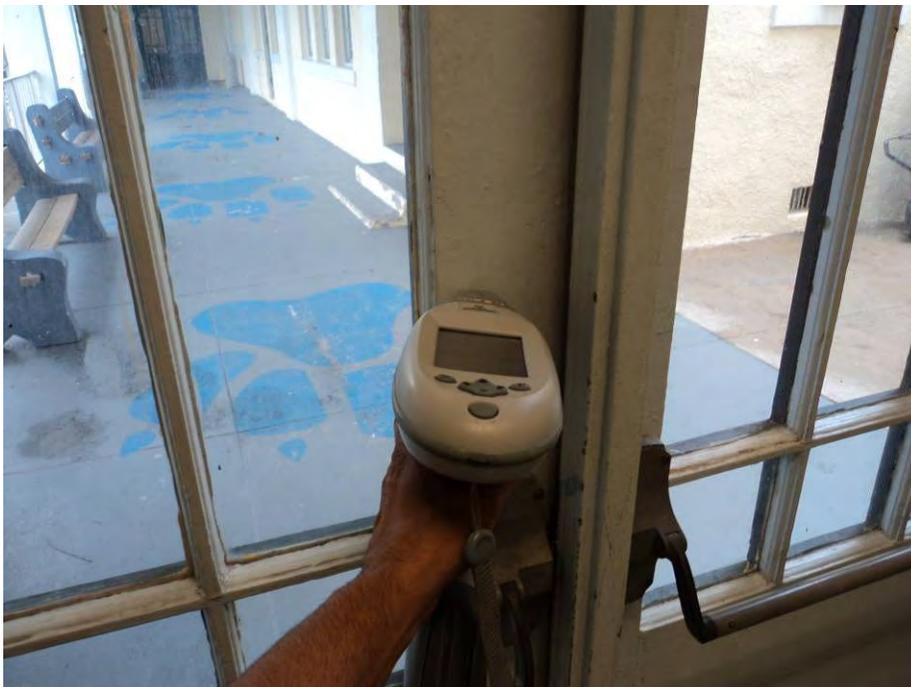
Photograph #10: Typical wood door identified with LBP during this inspection (XRF #196, 219, 220).

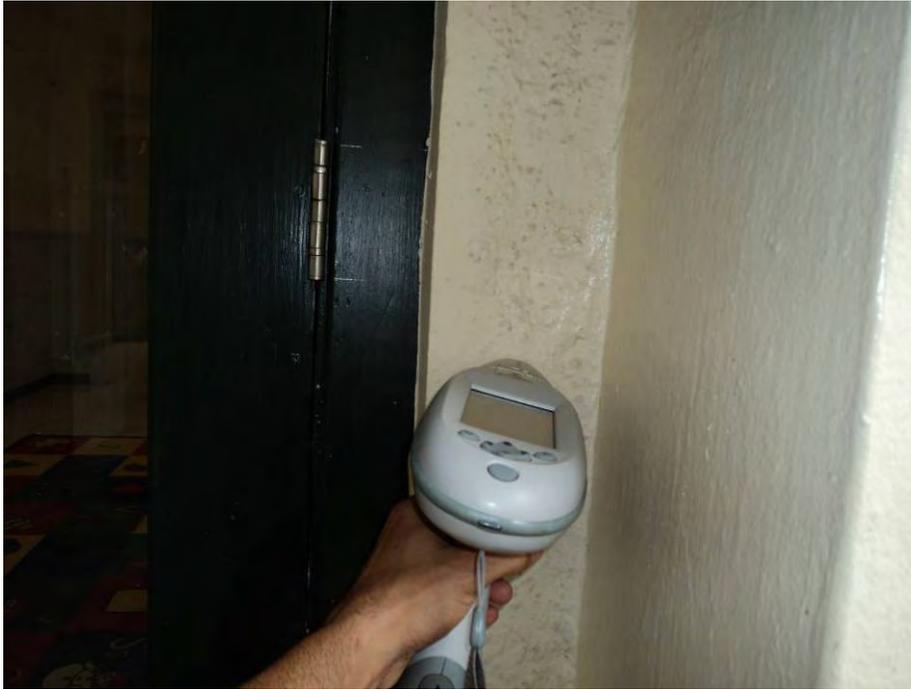
Photograph #17: LBP identified on exterior stucco

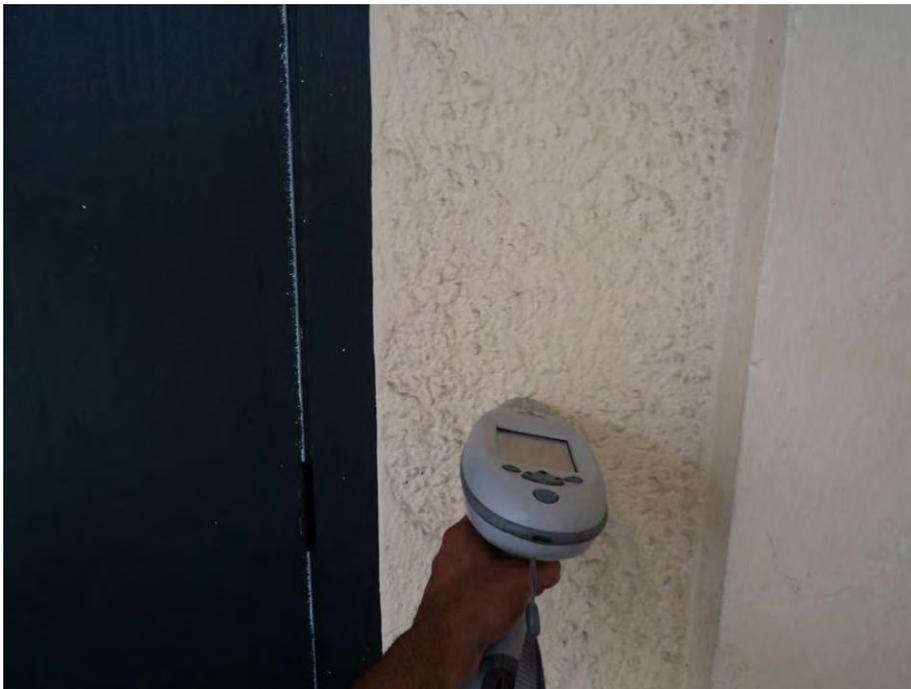
Photograph #18: LBP identified on exterior stucco

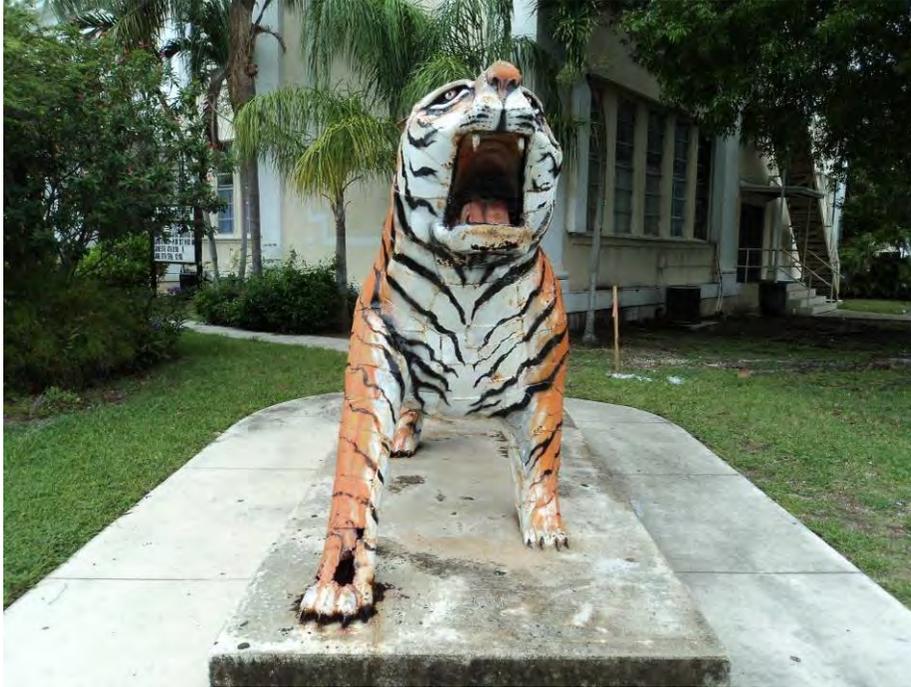
Photograph #25: Exterior metal tiger statue paint identified with LBP during this (XRF #548).

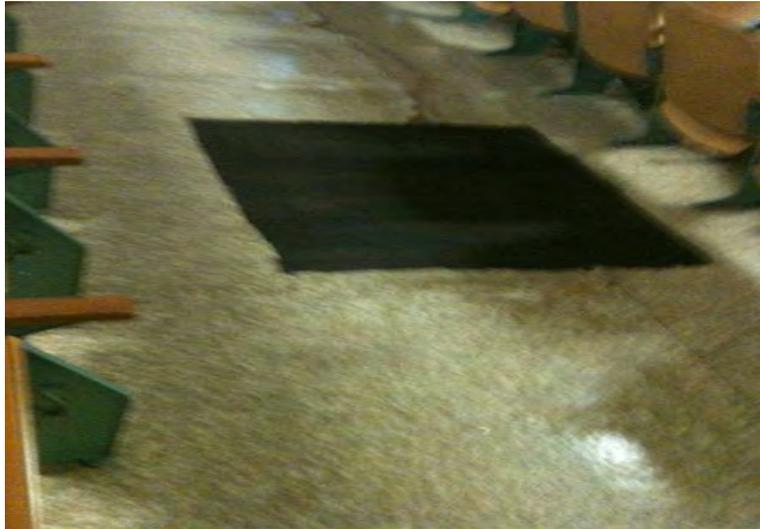
Photo #1: Auditorium area abated near center

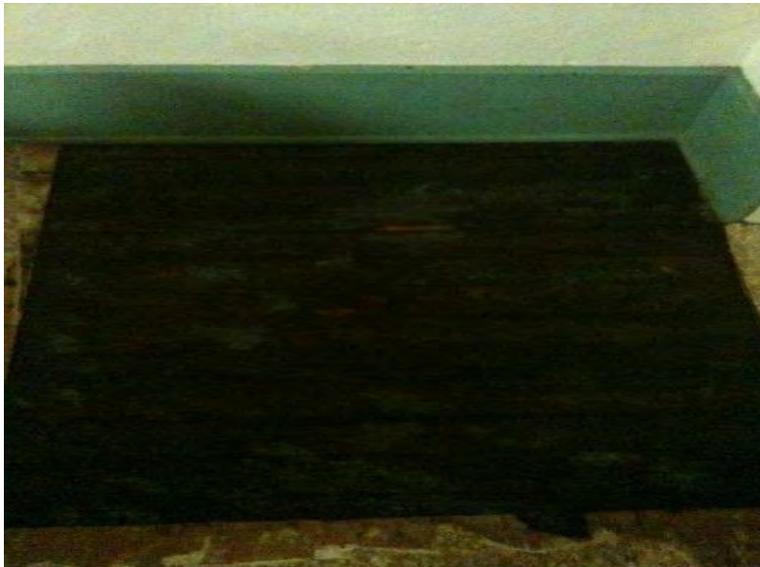
Photo #2: Auditorium area abated near NW corner

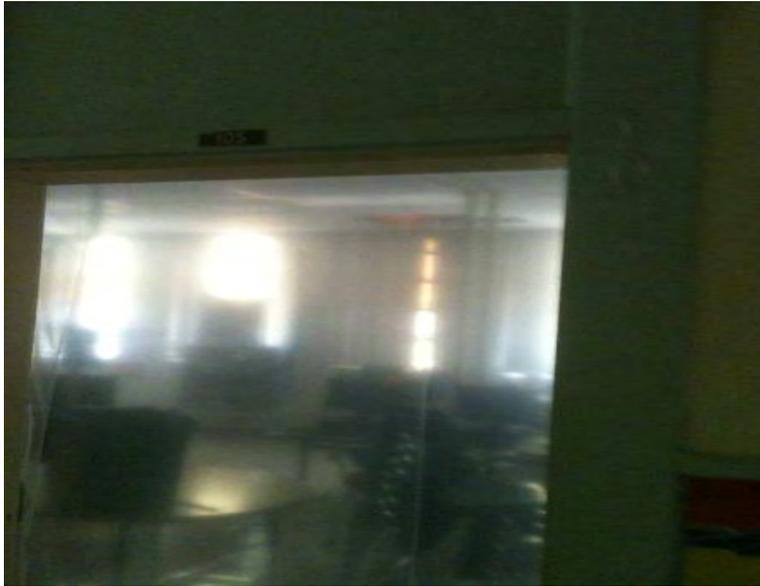
Photo #3: B105 sealed off for abatement in 2 spots on 7/15

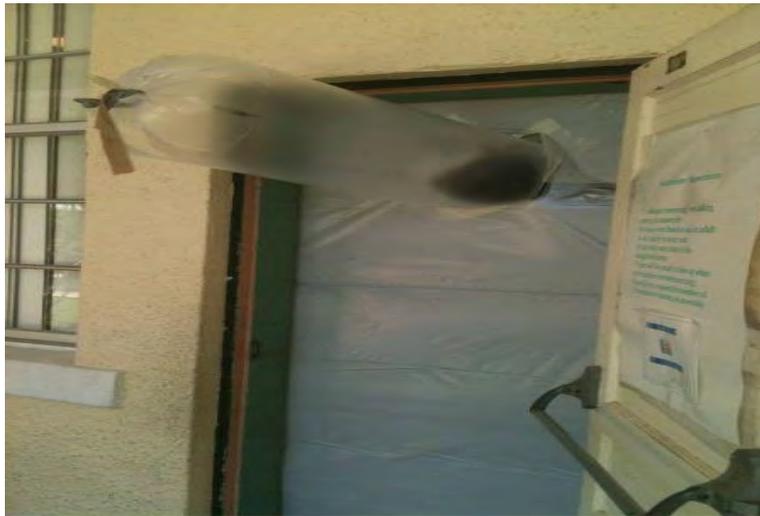
Photo #4: Auditorium HEPA exhaust outside

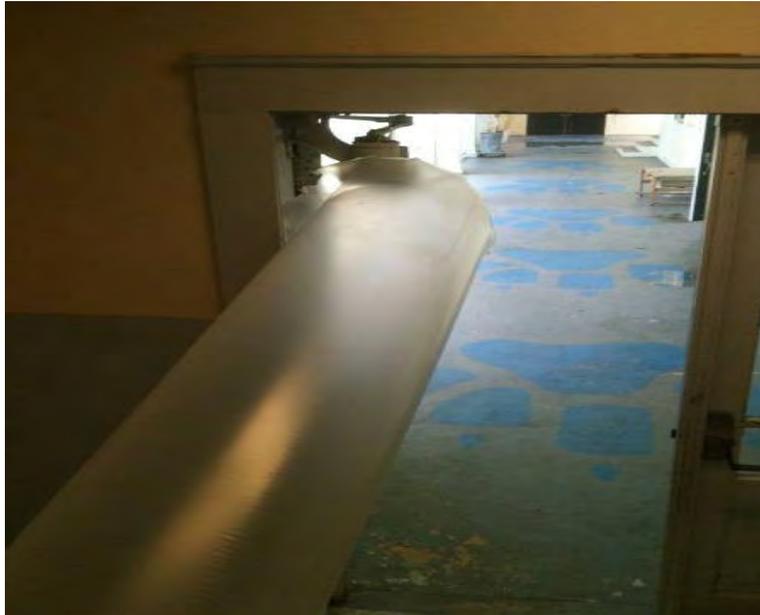
Photo #5: A Building HEPA exhaust to outside

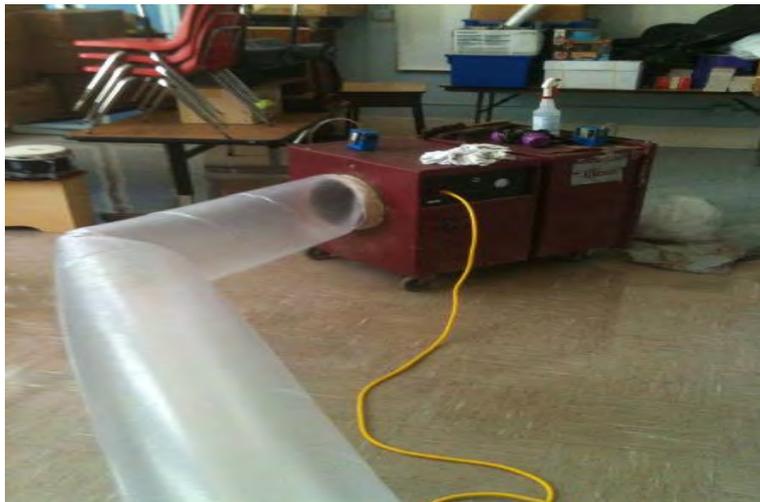
Photo #6: Typical HEPA exhaust in each room
