**PRE-DEMOLITION
REMOVAL OF NONFRIABLE
ASBESTOS-CONTAINING
FLOORING AND ROOFING MATERIALS**

**GLYNN ARCHER ELEMENTARY SCHOOL COMPLEX
(CITY HALL PLANNING PROJECT)
1302 WHITE STREET
KEY WEST, FLORIDA 33040**

September 24, 2013
EE&G Project Number 2012-2373

**GLYNN ARCHER ELEMENTARY SCHOOL
PRE-DEMOLITION ABATEMENT
SCOPE OF WORK**

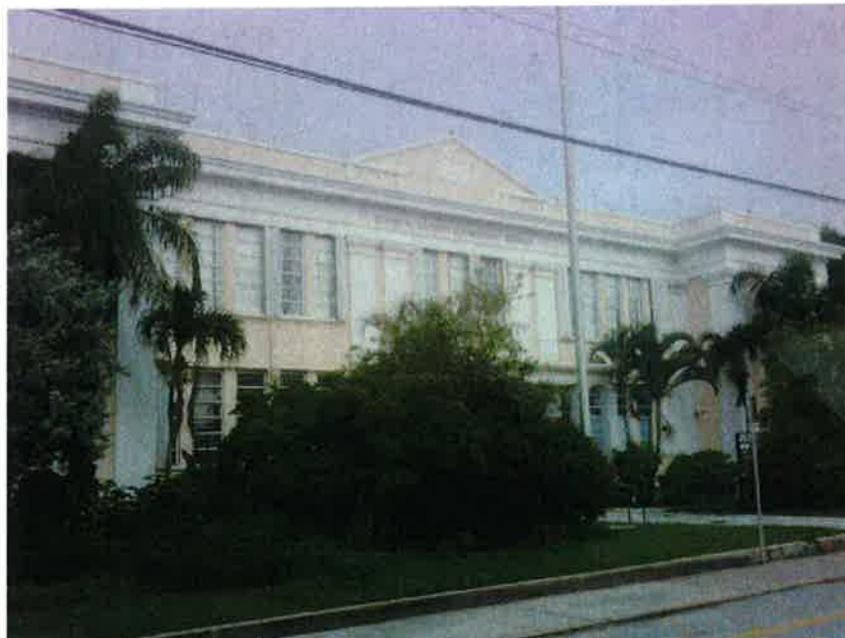
Photo 1: Former Glynn Archer ES at 1320 White Street, Key West

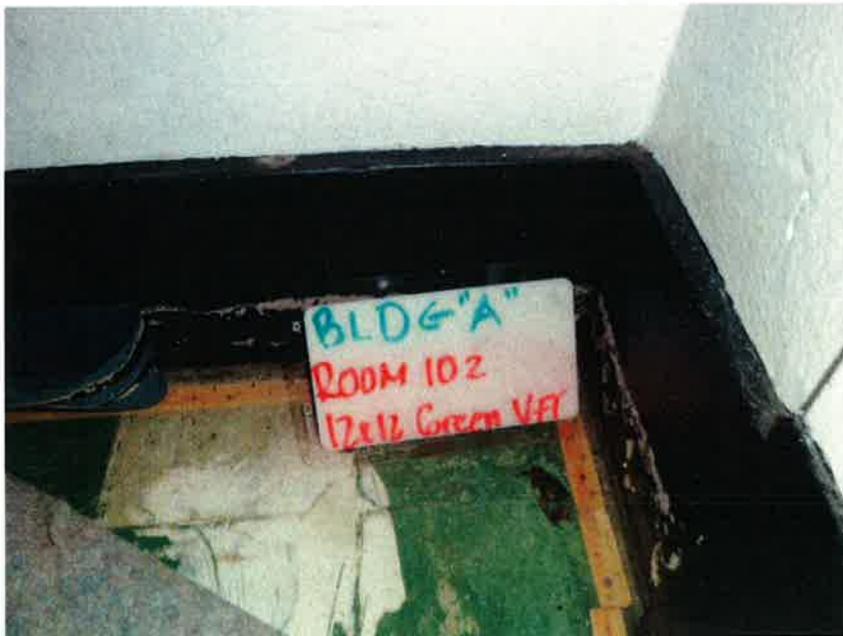
Photo 4: ACM VFT under carpet in A-102

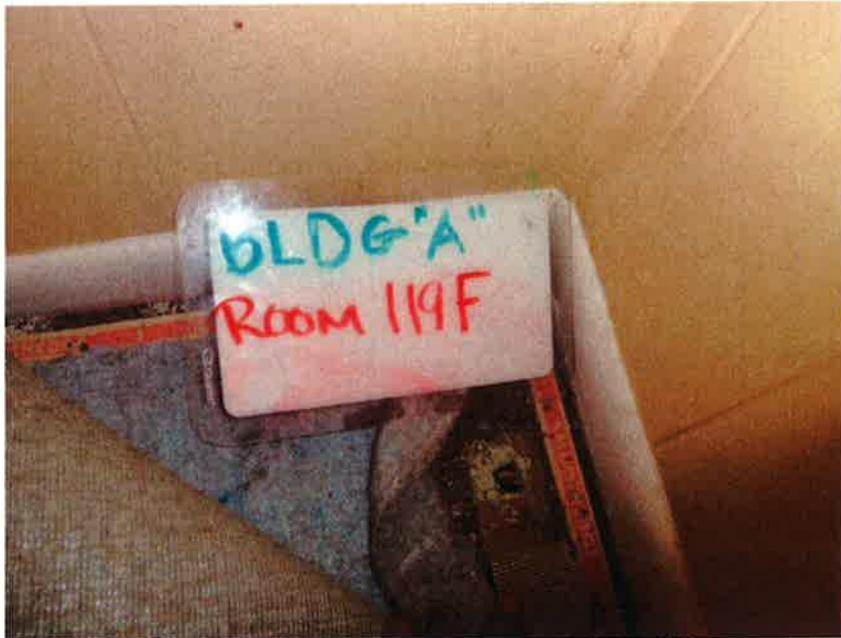
Photo 5: ACM VFT under carpet in Admin 119F

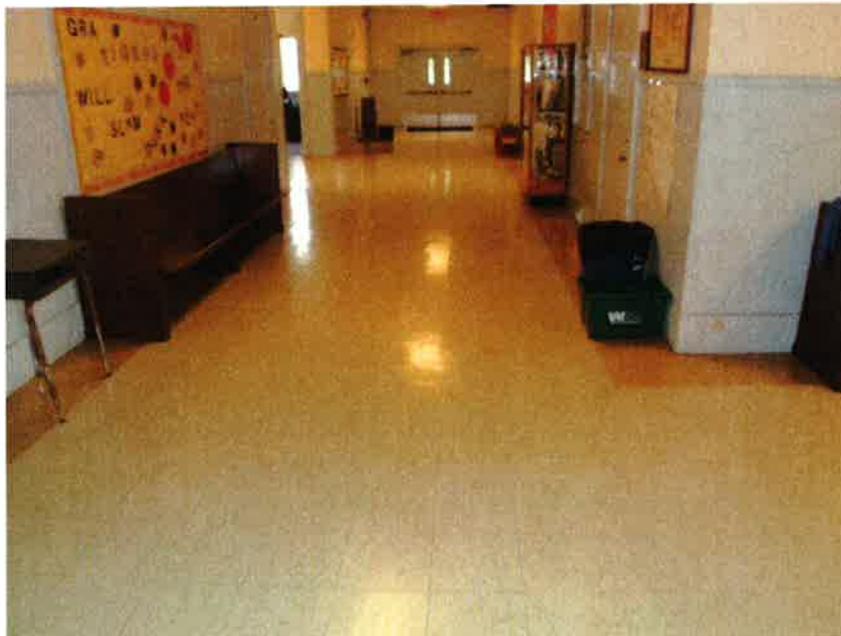
Photo 6: ACM Vft under nonACM VFT in A corridors

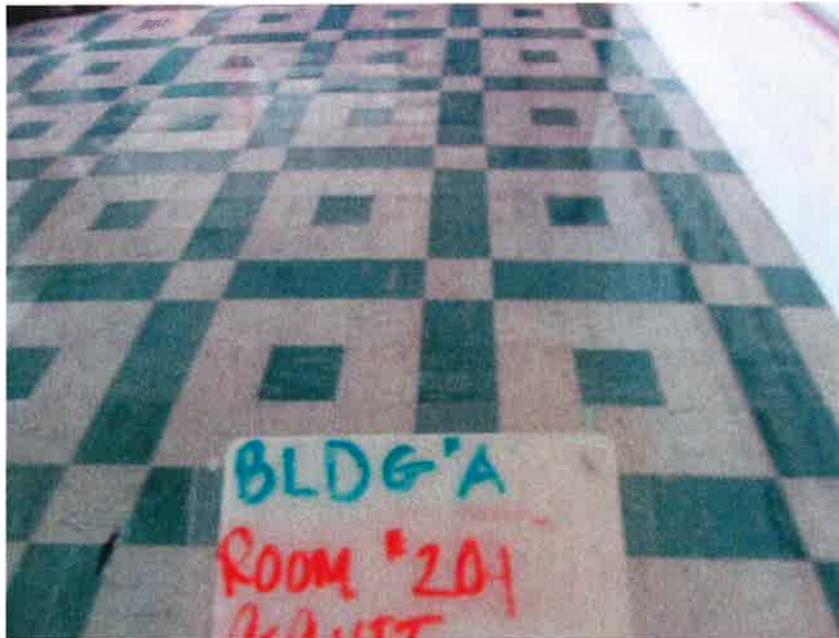
Photo 7: ACM 9" VFT in 204

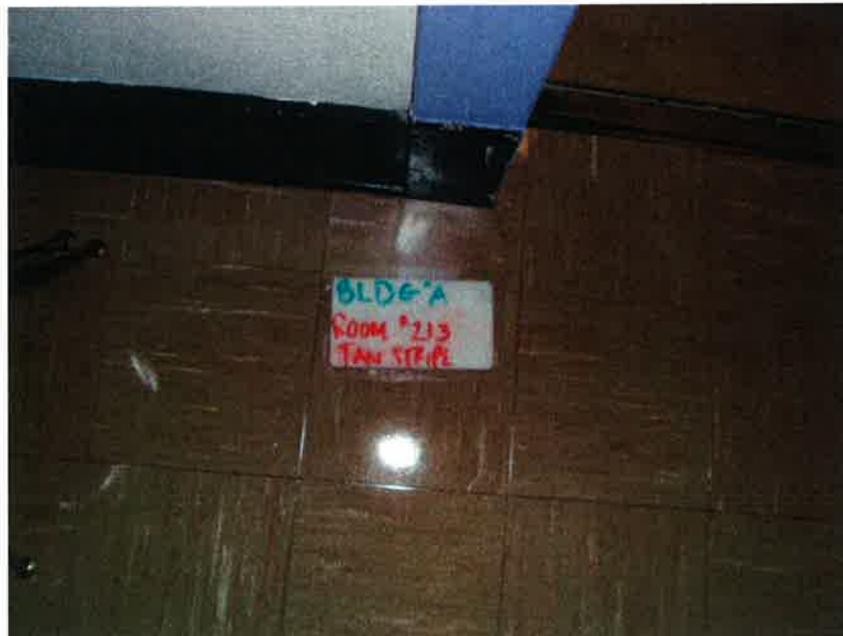
Photo 8: VFT over ACM VFT in 203

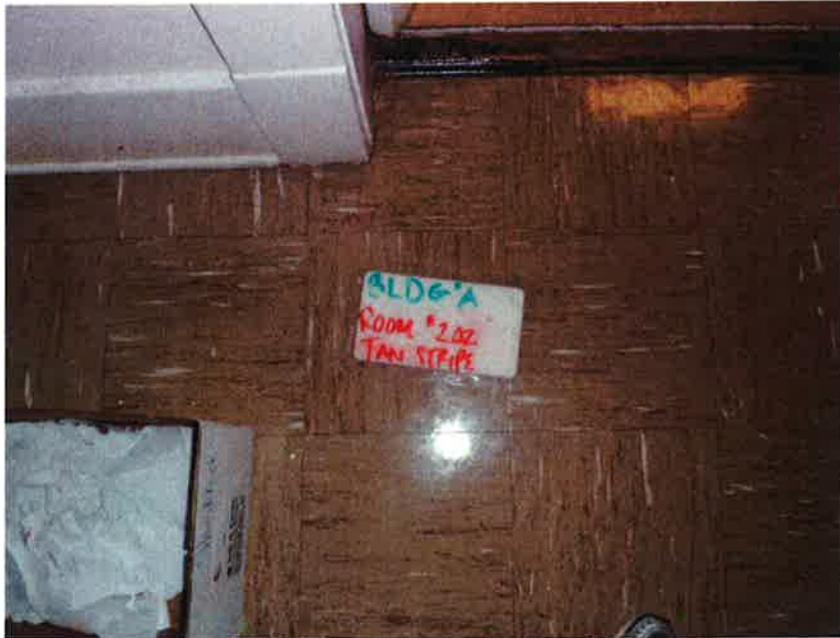
Photo 9: VFT over ACM VFT in A-202

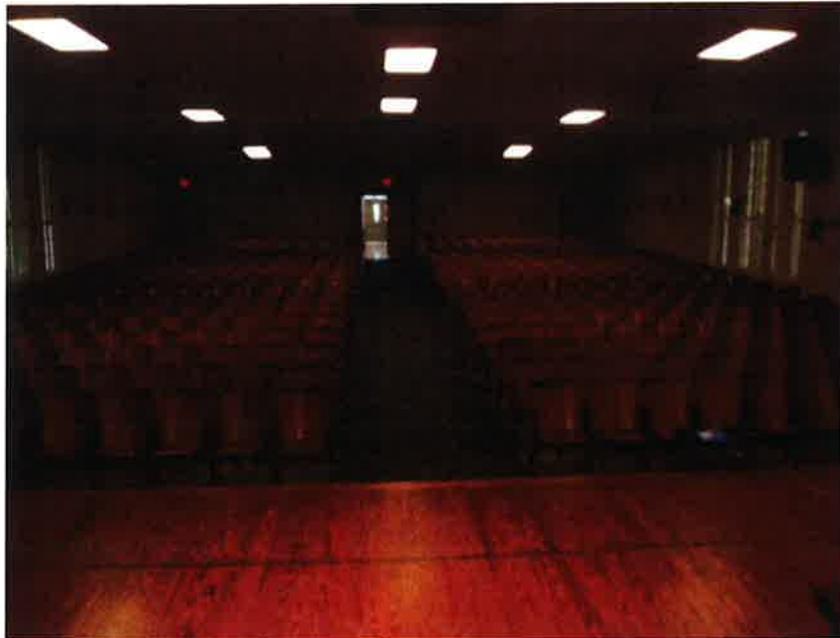
Photo 11: Auditorium as seen from stage

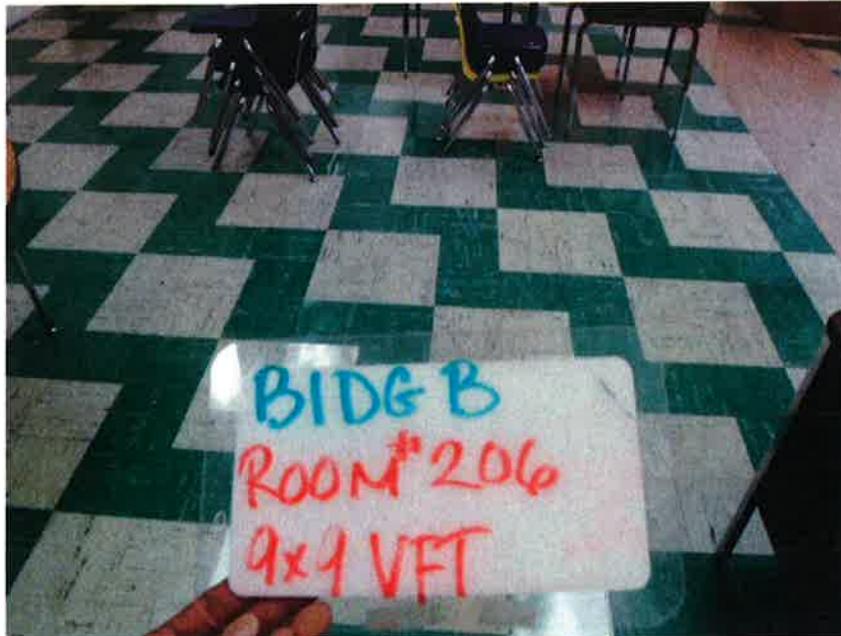
Photo 13: AACM 9" VFT on B-206

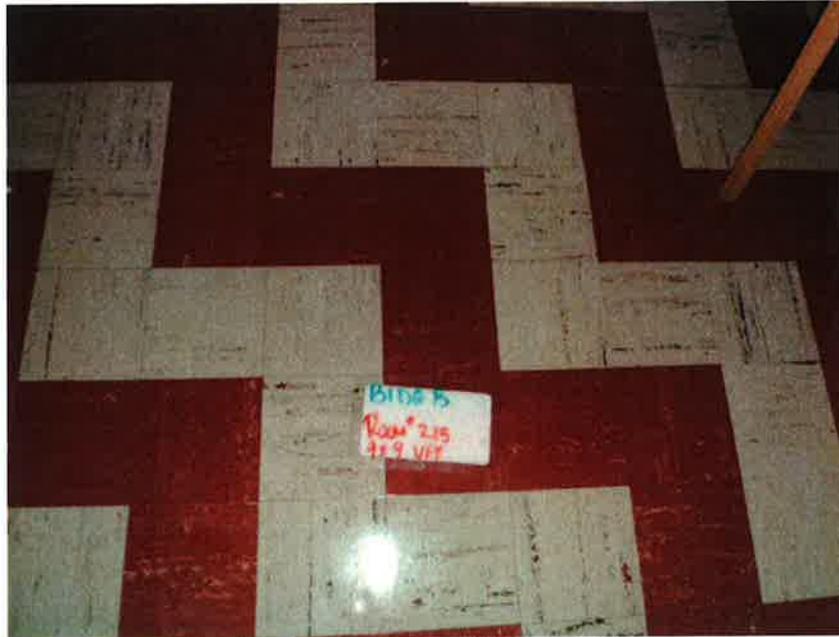
Photo 16: ACM 9" VFT in B-215

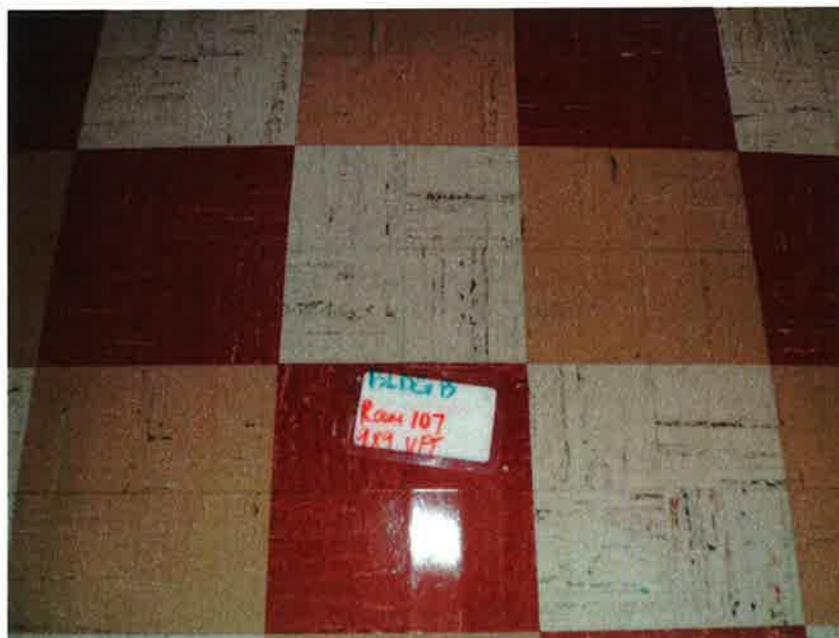
Photo 18: ACM 9" VFT in B-107

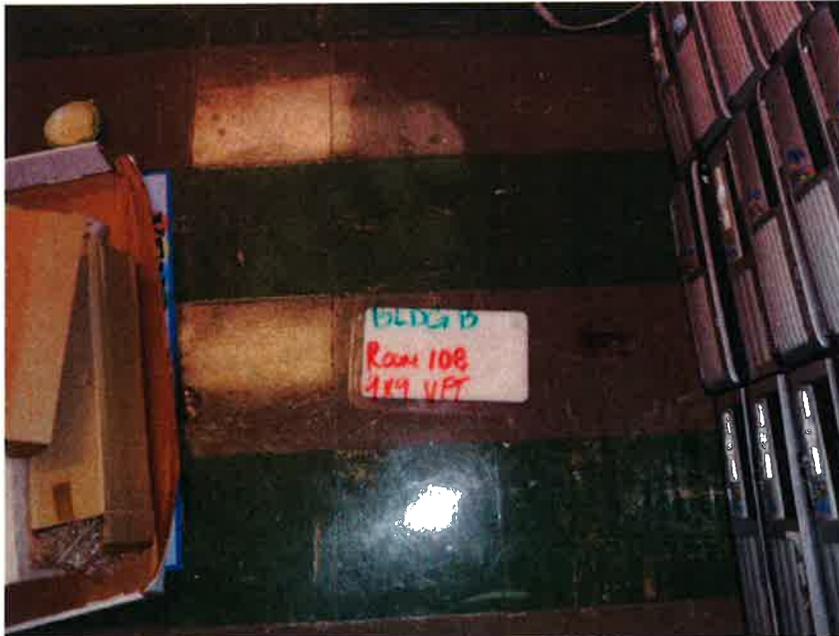
Photo 19: ACM VFT in partial 108

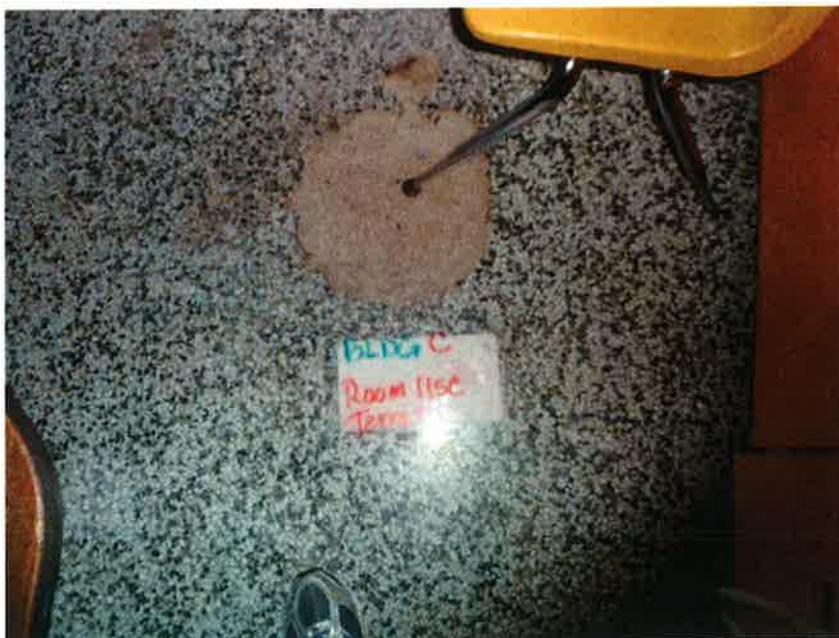
Photo 22: Terrazzo marble in C-115C

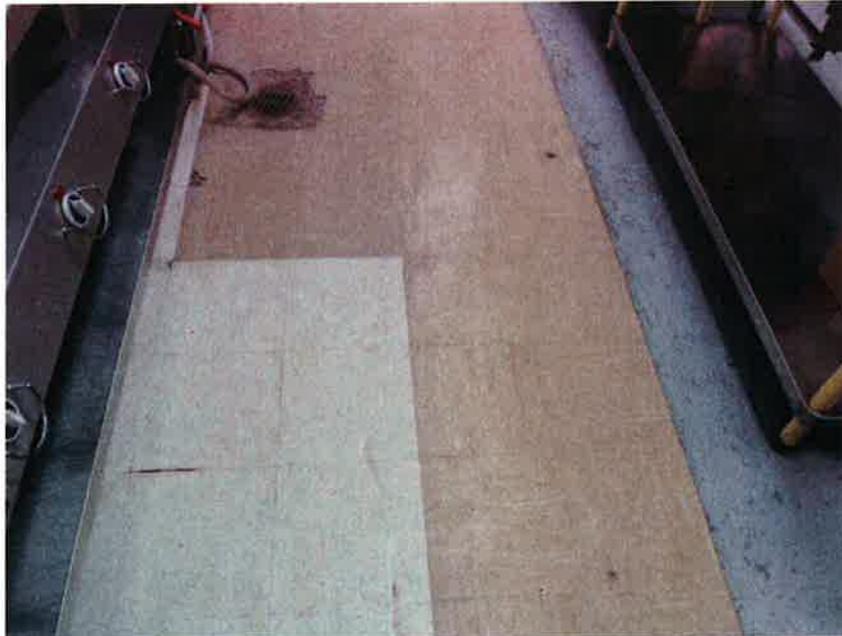
Photo 25 ACM mastic under VFT ends behind Servery line

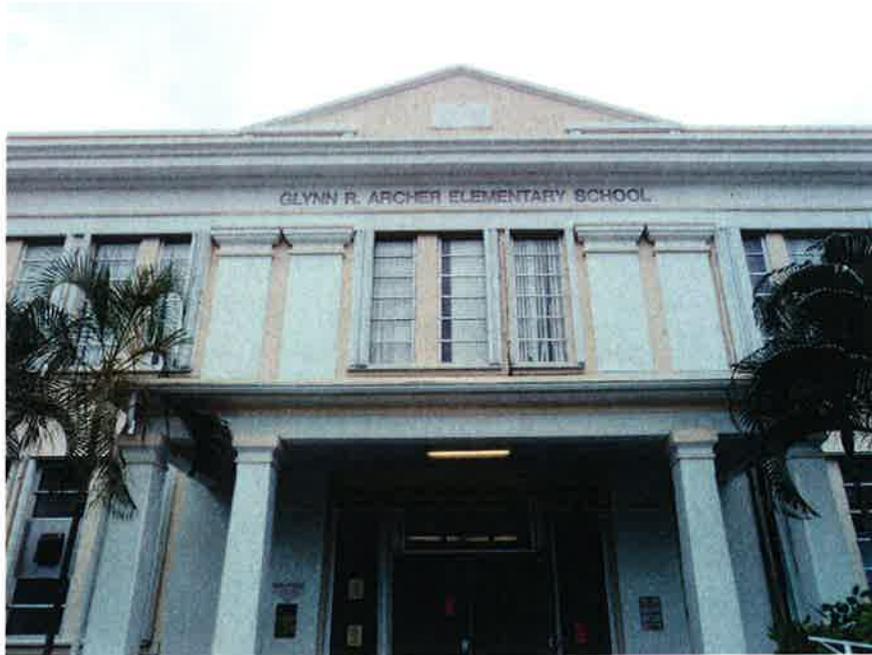
Photograph #23: Front entrance to Glynn R. Archer elementary school.

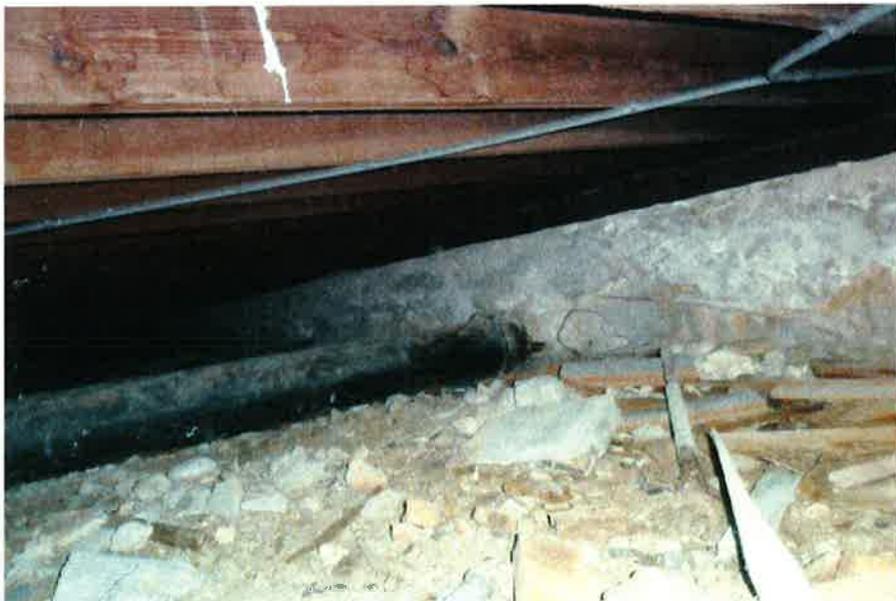
PHOTOGRAPH 4

During our investigation of the ground floor, crawl space and foundations, cisterns were discovered in the southeast corner of Building A (see photographs 4 and 5) and the southeast corner of Building B (see photograph 6). The cistern in Building A was not noted in the CH2MHill report. Also, in Building A, an old abandoned cistern was discovered from a previous structure on the site (see photograph 7). The ground floor timber is in excellent condition and many of the 5-1/2" x 5-1/2" timber beams noted in the CH2MHill report are actually 8"x 8" timber beams (see photograph 8). There were also many framing discrepancies noted from the CH2MHill report. As can be seen in the crawl space photographs, the ground surface is weathered rock and the concrete foundations bear on the rock or are socketed into the rock.

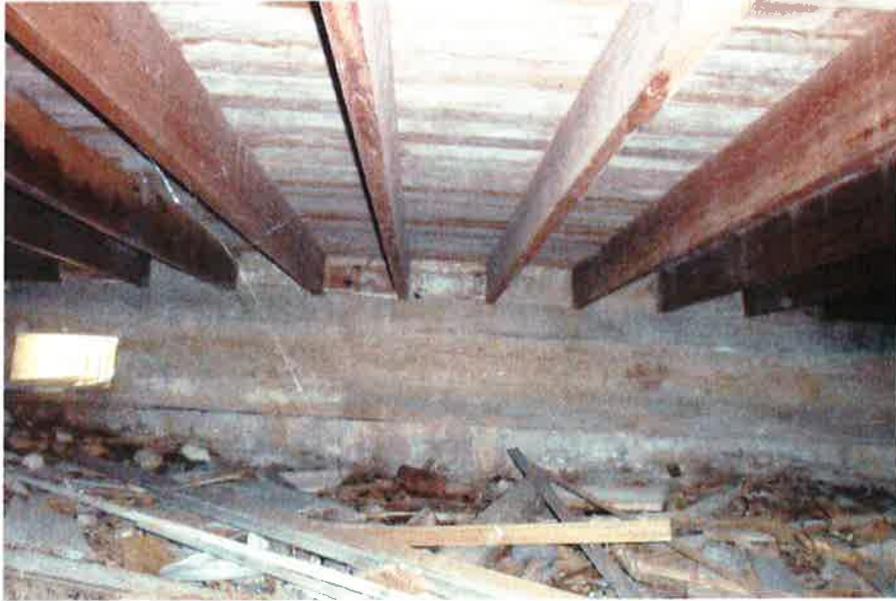
PHOTOGRAPH 9

The perimeter concrete walls consist of 11 inch concrete, which widens to 1'-6" or wider at the ground floor and widens again to 2'-0" or wider just above the ground surface and in many cases, the concrete walls widen again in the bearing rock (see photograph 9). The only place in the facility with a thinner concrete wall is the rear wall of the auditorium. The walls observed are in excellent condition with minimal cracking, no spalling and no signs of distress. The CH2MHill report documents 8 inch, concrete walls throughout the facility and recommends that they be reinforced if supporting floor loads, and that the perimeter wall foundations are undersized and need to be underpinned with piling, due to the rock bearing capacity of 4,000 psf. There are no signs of distress in the perimeter concrete walls and they have performed adequately for nearly one hundred (100) years supporting gravity and lateral loads. I see no reason that they cannot continue to support gravity and lateral loads. With their actual thickness of 11 inches, they are significantly stronger and more durable than reported in the CH2MHill report. If the recommendation of the AMEC, rock bearing capacity is in the 6,000 psf to 8,000 psf range, the existing wall foundations are adequate and will not require underpinning with deep foundations. In the CH2MHill report, augercast piles, pile caps and grade beams had a combined cost of \$398,500.00 and if the existing foundations are adequate and new foundations can bear directly on, or in the rock, augercast piles, pile caps and grade beams will not be required. If only conventional shallow foundations bearing on, or in the rock are needed, this will bring significant savings to the project.

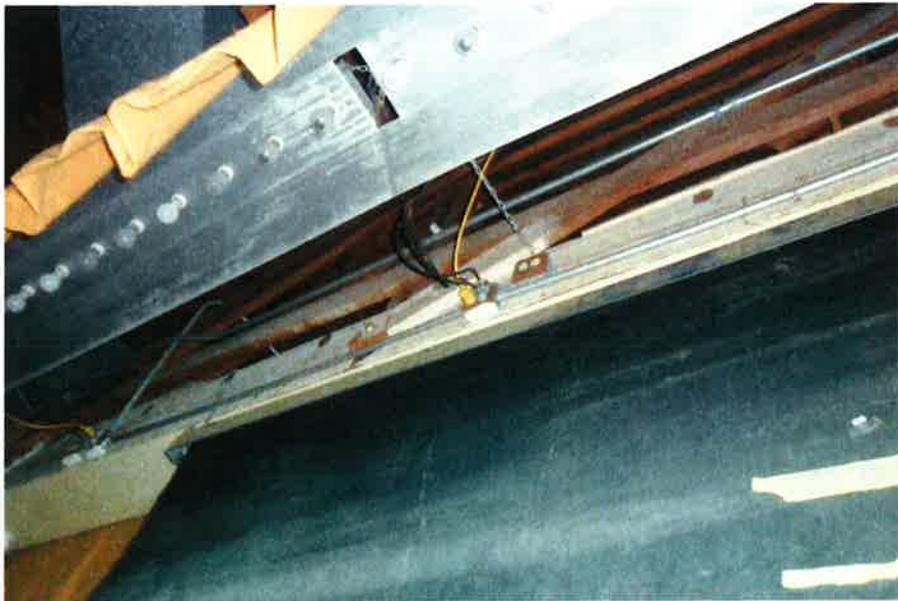
PHOTOGRAPH 10

The historic proscenium beam at the auditorium is a 5'-2" deep, wood truss and is in excellent condition (see photographs 10 and 11). This truss is not documented in the CH2MHill report. The auditorium roof consists of roof sheathing on 1- 5/8" x 7-1/2" roof joists at 2'-0" on center, which bear on four rows of two, 1- 5/8" x 11-1/2" wood beams, supported by 6'-6" deep steel trusses in which the bottom chord drops below the historic ceiling and created a coffered auditorium ceiling. The ceiling joists consist of 1-5/8" x 5-1/2" joists at 2'-0" on center, supported by four rows of two, 1-5/8" x 9-1/2" wood beams, also supported by the steel trusses. The CH2MHill report presents 1-5/8" x 5-1/2" roof joists at 2'-0" on center, supported by five rows of wood trusses, supported by 48" deep steel trusses.

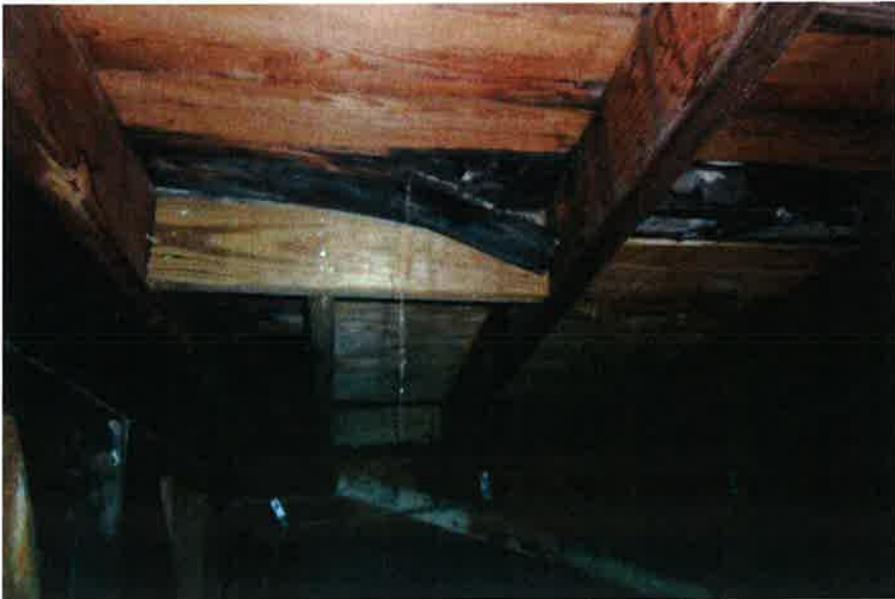
PHOTOGRAPH 12

At the auditorium roof interface with the second floor, there is an area with an active roof leak and deteriorated roof sheathing (see photograph 12). In this area, there are termite damaged ceiling joists. The auditorium roof beams are in excellent condition and the ceiling beams are in good condition with areas of termite damage (see photograph 13). At the proscenium beam, a diagonal from the ceiling beam to the roof beam has been cut to accommodate ductwork (see photograph 14) and no distress is apparent. It appears that these verticals and diagonals were installed for ease of construction and may not be acting as a truss. The roof and ceiling joists are fire cut into the 11 inch concrete walls and the concrete walls are in excellent condition (see Photographs 15 and 16). The steel trusses, roof and ceiling beam connections to the trusses are in excellent condition with minimal surficial rust (see photographs 17, 18 and 19). The truss bearings are placed integral with the concrete walls and are totally encapsulated in the walls (see photographs 20 and 21). There was one area of corrosion noted in one of the trusses, but this corrosion is surficial and can easily be cleaned and coated (see photograph 22).

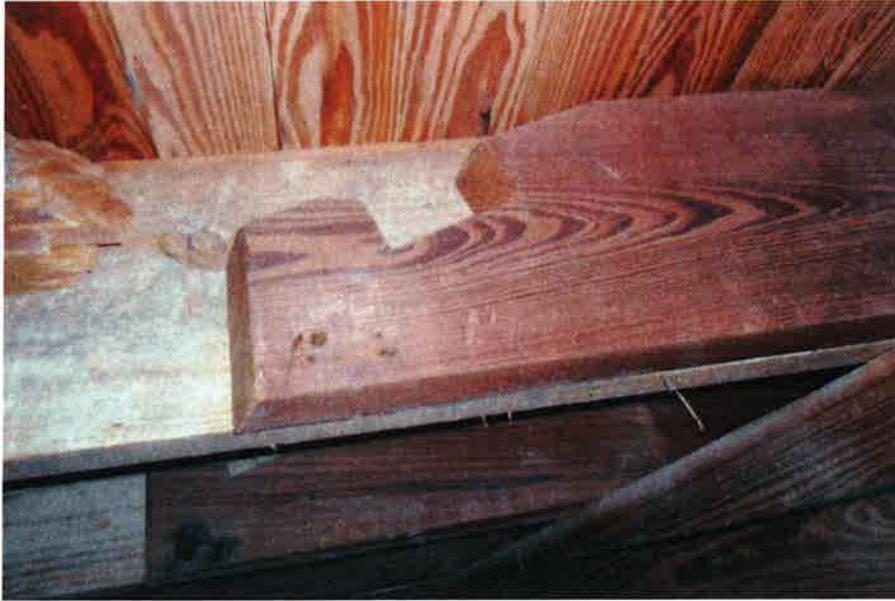
PHOTOGRAPH 23

The historic stage was a thrust stage with angled end rafters for foot lights (see photograph 23) and the historic stage has been enlarged to its present size. The CH2MHill framing in this area does not correctly depict the actual framing in this area. The stage framing is in excellent condition. The main auditorium floor framing at the stage could not be reviewed due to low crawl room. Its framing and condition could not be confirmed.
